**Canadian Natural Resources Limited  
GENERAL PRESSURE VESSEL INFORMATION**

**Job# 10.113336**

<b>District: Grande Prairie AB.</b>	Skid No.
<b>Facility: Clear Hills Gas Gathering</b>	<b>Location (LSD): 6-15-88-12W6M</b>
<b>Vessel Name Equipment Number: Separator</b>	
<b>Orientation: Vertical</b>	
<b>Status: Out of Service</b>	<b>Regulatory Inspection</b>

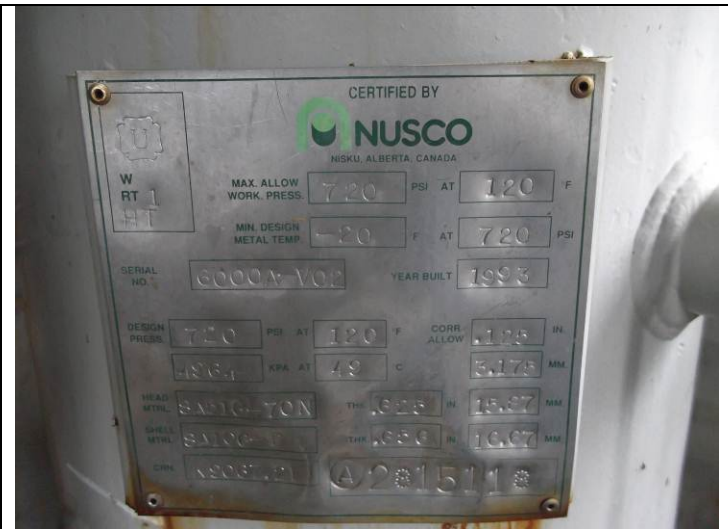
Data Plate

"A" or "G" or "S" (Sask.) or BC Registration Number.  <b>A2815118</b>		CRN Number:  K9067.21	
Vessel serial number: 6000A-V02		Size: 16 in. X 90 in.	
Shell thickness: 16.67mm		Shell material: SA 106-B	
Head thickness: 15.87mm		Head material: SA 516-70N	
Tube wall thickness:		Tube material:	
Tube diameter:		Tube length:	
Channel thickness:		Channel material:	
Design pressure	Shell: 720 PSI	Operating pressure	Shell:
	Tubes:		Tubes:
Design Temp.	Shell: 120 Deg F	Operating temperature	Shell:
	Tubes:		Tubes:
X-ray: RT 1		Heat treatment: yes	
Code parameters: ASME VIII, Div 1		Coated: no	
Manufacturer: Nusco		Year built: 1993	
Corrosion allowance: 3.2mm		Manway: no

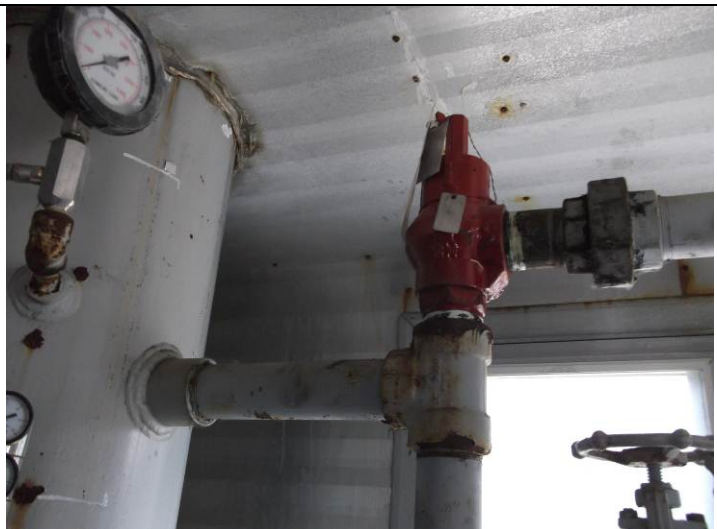
PSV Tag #	Manufacture / Model / Serial	Set Pressure (PSI / kPa)	Capacity (scfm)	Size	Block Valve	Location	Service Date
C-545	Taylor/T-7900-2/C545	720PSI	2992	2X2	No	Side Shell	10/2010

<b>External Piping</b> Ensure pipe is well supported. All clamps, supports, shoes, etc. in place. Look for evidence of structural overload, deflection, etc. Paint condition, external corrosion?	X				<b>Piping is well supported; no deflection, all clamps and supports are in place. Paint peeling to 20% of area- corrosion on exposed metal.</b>
<b>Valve:</b> Ensure no leaks are visible. Valves are properly supported and chained if necessary.	X				<b>Valves are supported properly – no leaks.</b>
<b>PSV</b> Ensure PSV is set at pressure at or below that of vessel.	X				<b>Located on upper shell of vessel. Set at MAWP of vessel – PSV seal in place. Discharge piping is same size as valve outlet. No block valve between vessel and PSV.</b>

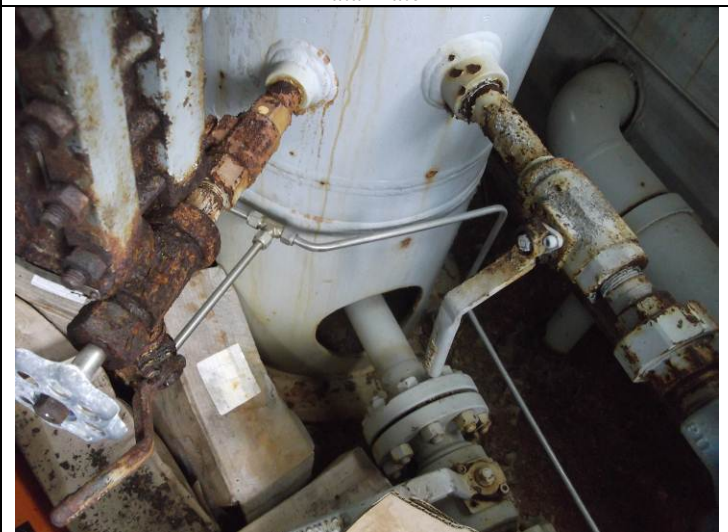
Base

<b>Anchor Bolts</b> Hammer tap to ensure secure. Look for cracking in treads or signs of deformation.	X				<b>Anchor bolts are securely fastened. No deformation.</b>
<b>Concrete foundation</b> Check for cracks, spalling, etc.				X	<b>Steel skid</b>
<b>Ladder / Platform</b> Describe general condition, ensure support is secure to vessel, describe any hazards.				X	<b>No ladder</b>
<b>Nozzle</b> Assess paint, look for leakage, and ensure stud threads are fully engaged. Record any damage, deflection, etc. Are nozzles gusseted?	X				<b>Stud threads are fully engaged to nuts – no short bolts. No damage or deflections – no leaks. Nozzles are not gusseted.</b>
<b>Gauges</b> Ensure gauges are visible, working, no leakage, and suitable for range of MAWP/ Temp.	X				<b>Gauges starting to have residue buildup – no leakage. Suitable for operational range of vessel. Pressure gauge 0 – 2000 PSI/ temperature gauge -40 – 120 Deg F.</b>
