C38332_Name Plate_18March2013

Field Inspection Report

Client	CNRL		Date of Inspection	March 18,2013			
Prov. Reg.#	C38332		Inspection Type	VE, UT			
Equipment	Flare Knock Out Drum		Location				
Tag/Equip. #			LSD	04-01-013-13W4M			
Vessel Status	Out of Service		Comp./Unit #				
Manufacturer	Tornado Technologies		MAWP / Temp				
Serial #	8024B	CRN #	MDMT@ Pressure				
Corrosion Allowance		Shell Material		Shell Thickness			
Year Built	2006	Head Material		Head Thickness			
Diameter	5' OD	Length	10'	Height		RT	HT
Service	Sour	Next Inspection		Next Insp. Type			
ASME Stamp	No	Next Inspection		Next Insp. Type			
PSV Tag #		CRN#		Set Pressure			
Manufacturer				NB#		ASME Stamp	
Type/Model		Serial #		Inlet Size			
Capacity		Service Company		Outlet Size			
Service Date			Next Service Date				
Valve Location	On Vessel On Piping Vents to Flare Vents to Atmosphere	Valve Connection	Threaded Flanged Welded	ABSA CODE TYPE			
				Plant		Process	
				Vessel		Special	
PSV Tag #		CRN#		Set Pressure

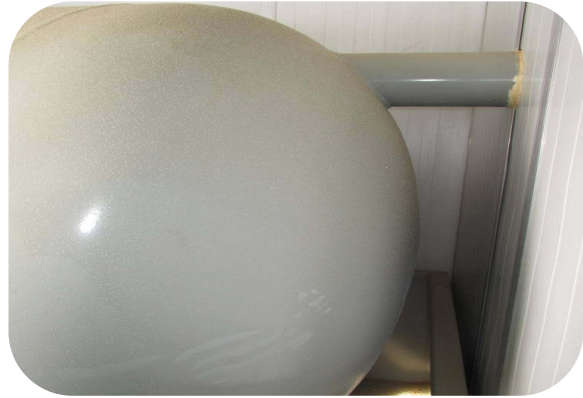
C38332_North end Head and 6" Inlet Nozzle_18March2013

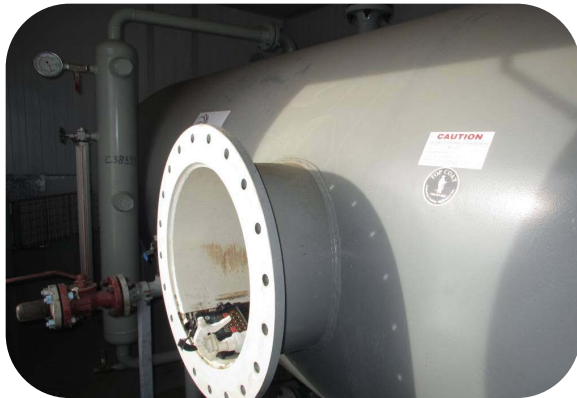
C38332_Side view_18March2013

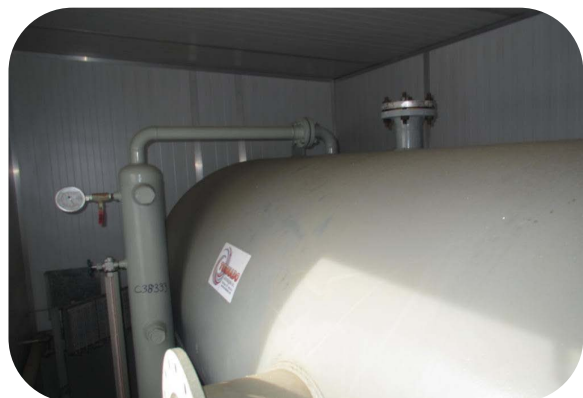
C38332_Top Shell and Bridle associated piping_18March2013

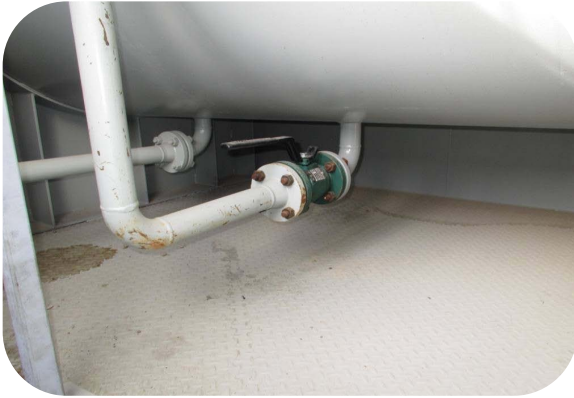
C38332_Bottom 2" Outlet Piping
intact_18March2013

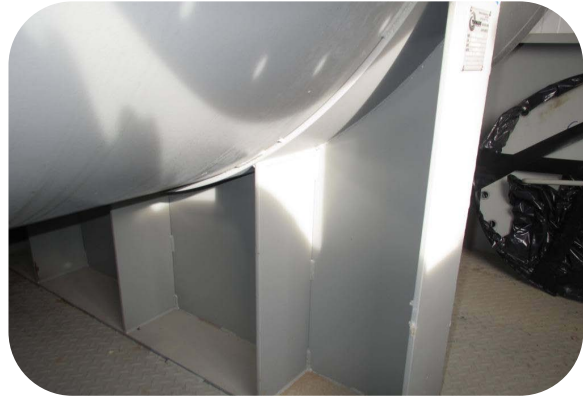
C38332_Saddles welded securely to floor and
shell_18March2013

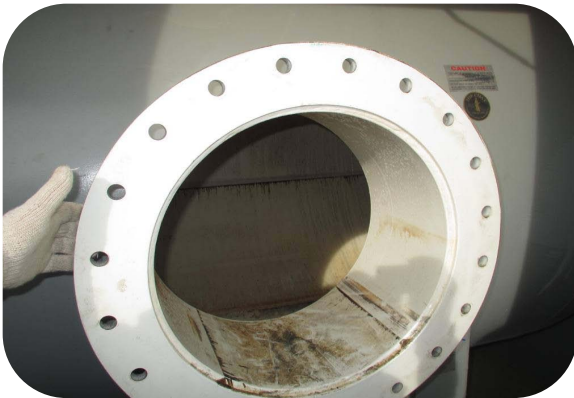
C38332_Manway Nozzle and gasket surface
internal coating intact_18March2013

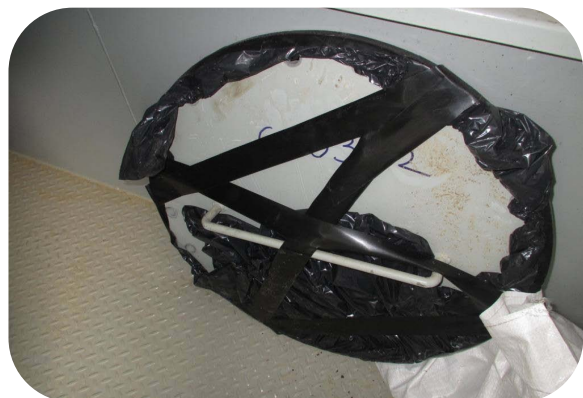
C38332_Manway cover_18March2013

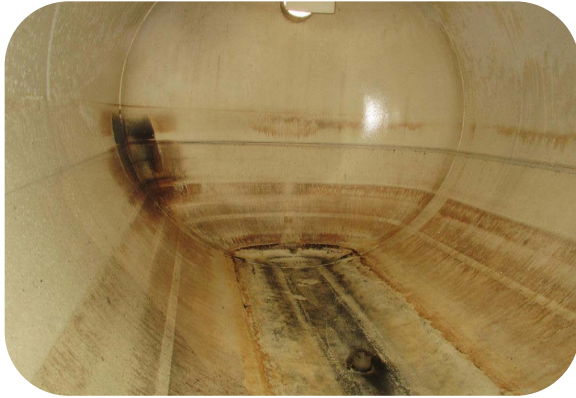
C38332_Internal view of south shell , head and internal coating intact_ 18March2013

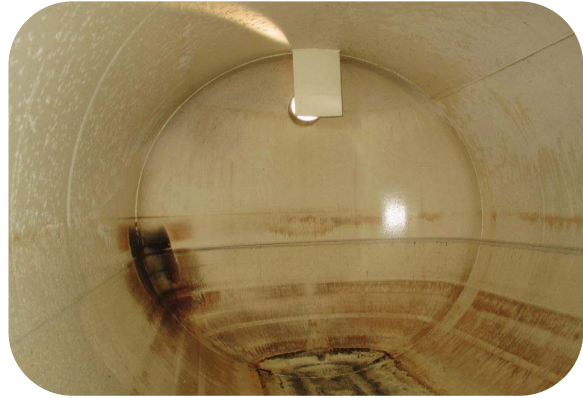
C38332_South end 6"Outlet Nozzle deflector Plate intact_18March2013

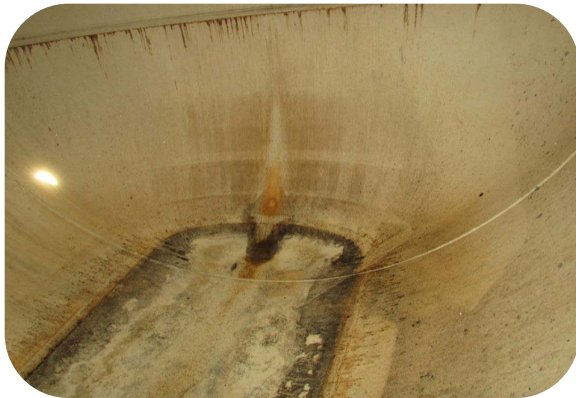
C38332_North End shell and head coating intact_18March2013

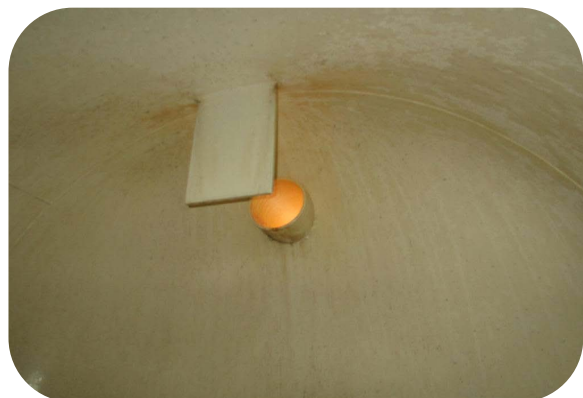
C38332_North End 6" Inlet Nozzle and deflector plate intact_18March2013

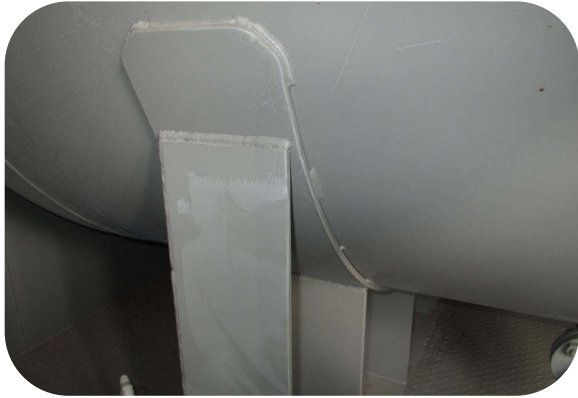
C38332_Saddles welded securely to floor and shell_18March2013

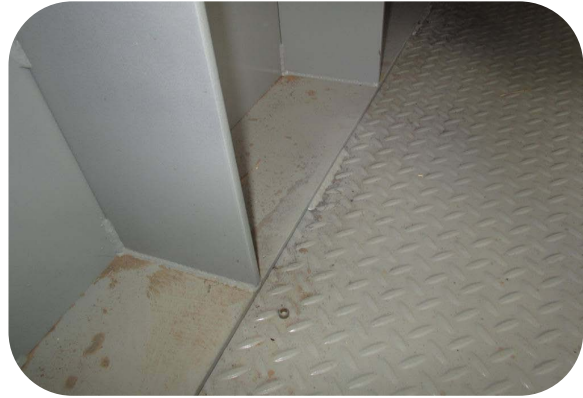
C38332_Saddles welded securely to floor and shell_18March2013

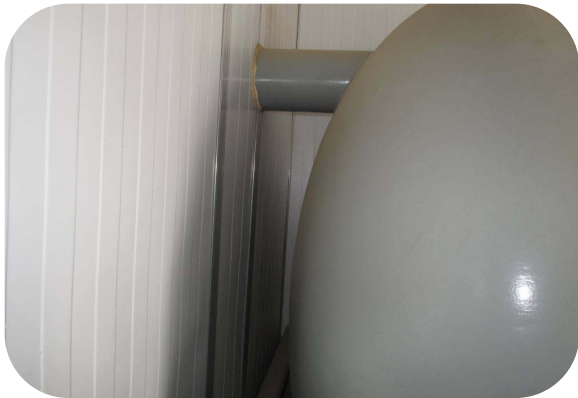
C38332_South End 6"Outlet Nozzle and south head_18March2013

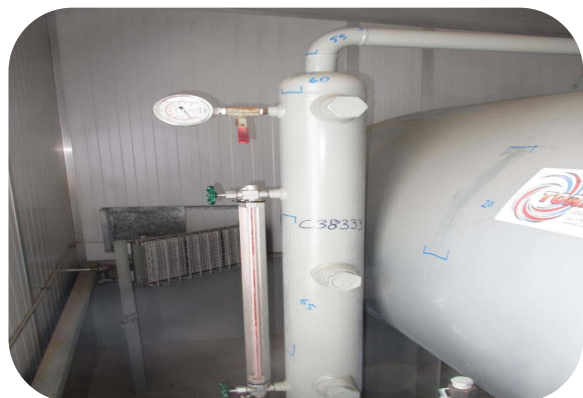
C38332_6" Bridle intact secure and Liquid level sight glass intact_18March2013

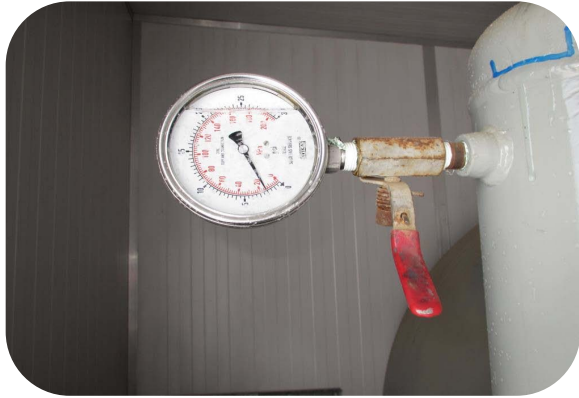
C38332_Pressure gauge not working properly
_18March2013

Replace the pressure gauge located on the bridle.

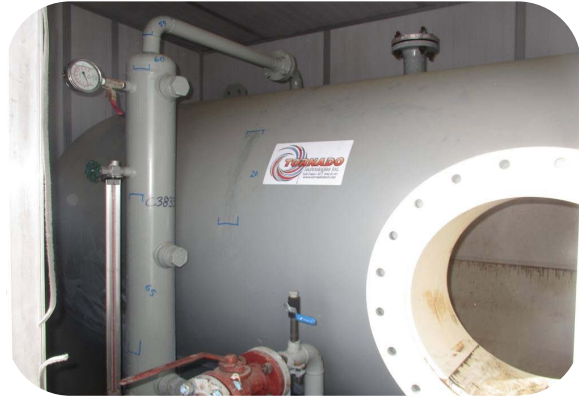
C38332_UT TML locations_18March2013

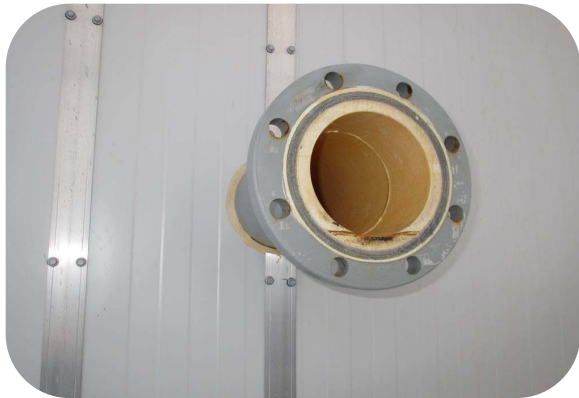
C38332_North End 6" Inlet nozzle coating and
gasket surface intact_18March2013

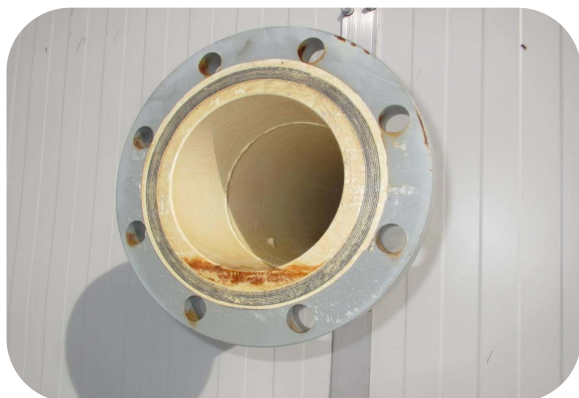
C38332_South End 6" Inlet nozzle coating and
gasket surface intact_18March2013
