**Canadian Natural Resources Limited  
GENERAL PRESSURE VESSEL INFORMATION**

**Job 4017058**

District: <b>Grande Prairie, AB.</b>	Skid No.
Facility: <b>North Wapiti Field</b>	Location (LSD): <b>08-36-68-09 W6M</b>
Vessel Name Equipment Number: <b>3 Phase Separator</b>	
Orientation: <b>Vertical</b>	
Status: <b>In Service</b>	<b>Regulatory Inspection</b>

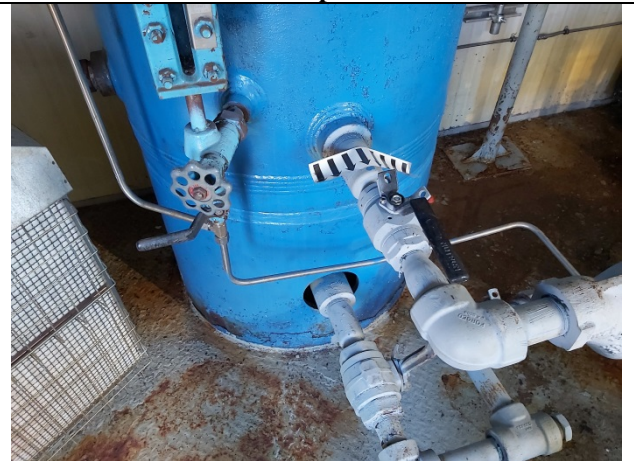
External Inspection Items	G	F	P	N/A	Comments
<b>Insulation</b> Verify sealed around manways, nozzles, no damage present, and there is no egress of moisture.				X	Vessel is not insulated.
<b>External Condition</b> Assess paint condition, areas peeling, record any corrosion, damage, etc (record location, size and depth of corrosion or damage)		X			Paint in fair condition – corrosion at upper shell – no pitting.
<b>Leakage</b> Record any leakage at flanges, threaded joints, weep holes on repads, etc.	X				No leaks observed.
<b>Saddle/Skirt</b> Assess condition of paint, fire protection, concrete. Look for corrosion, buckling, dents, etc. Look at vessel surface area near supports. Verify no signs of leakage at attachment to vessel and attachment welds are acceptable. Ground wire attached?	X				Skirt: No distortion or buckles. No corrosion at head to skirt weld – no leaks.  Skid package is grounded.

Skirt

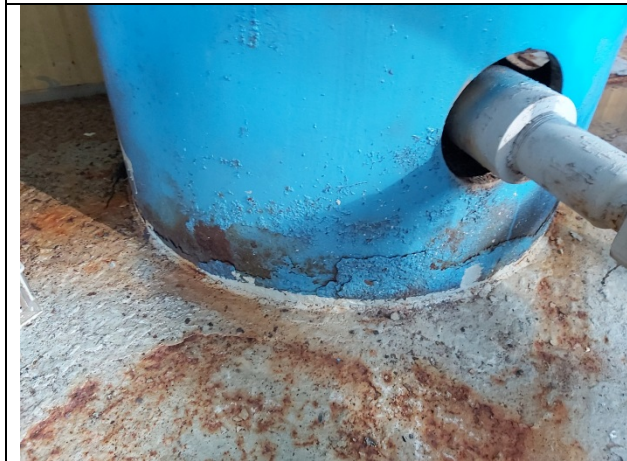
<b>Anchor Bolts</b> Hammer tap to ensure secure. Look for cracking in treads or signs of deformation.	X				Firmly welded to skid deck.
<b>Concrete foundation</b> Check for cracks, spalling, etc.				X	
<b>Ladder / Platform</b> Describe general condition, ensure support is secure to vessel, describe any hazards.				X	
<b>Nozzle</b> Assess paint, look for leakage, and ensure stud threads are fully engaged. Record any damage, deflection, etc. Are nozzles gusseted?	X				Threaded and flanged connections fully engaged. No deflection – no leaks. No gussets.
<b>Gauges</b> Ensure gauges are visible, working, no leakage, and suitable for range of MAWP/ Temp.	X				Pressure gauge: 0 to 1500 PSI
<b>External Piping</b> Ensure pipe is well supported. All clamps, supports, shoes, etc. in place. Look for evidence of structural overload, deflection, etc. Paint condition, external corrosion?		X			Piping is well supported; no deflection, all clamps and supports are in place. Paint is in fair condition – 40% surface corrosion on outlet / inlet piping – no pitting.

Base welded to floor

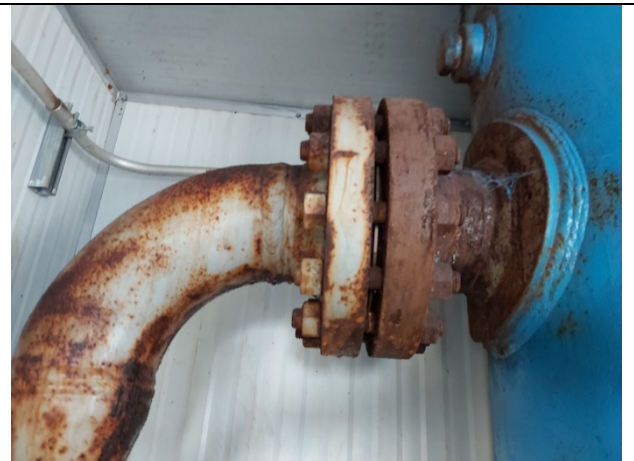
Inlet – surface corrosion present – no pits

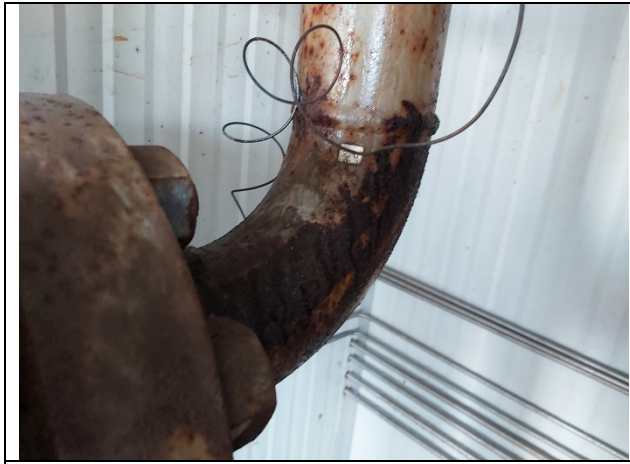
**Outlet piping – surface corrosion – no pits**

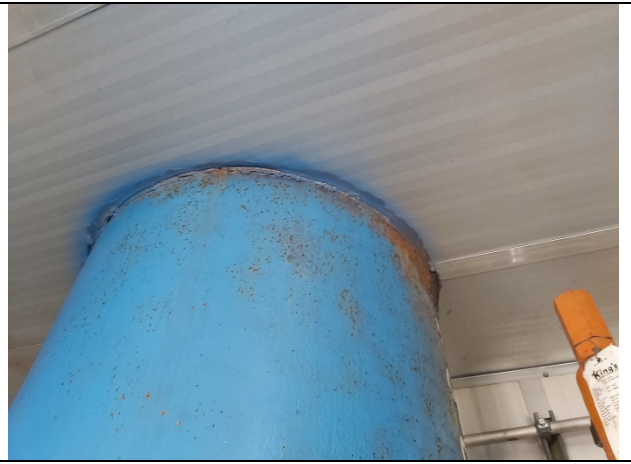
**Roof sealed**

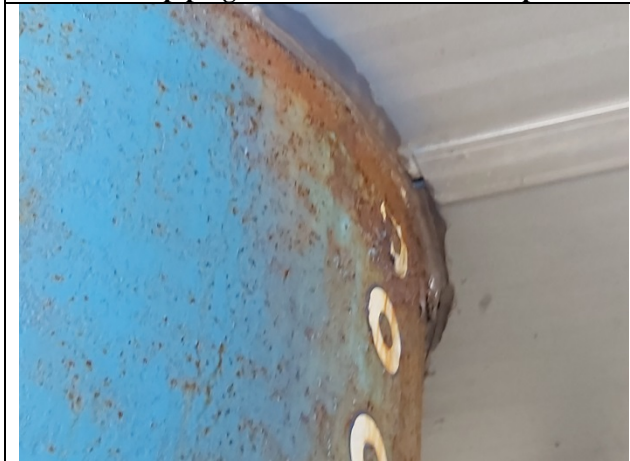
**Surface corrosion below roof**

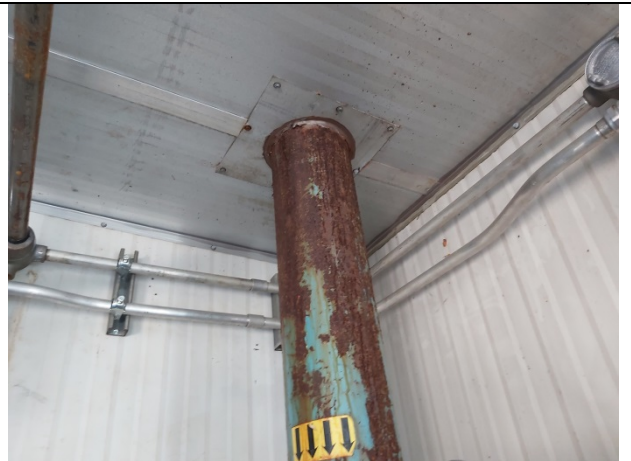
**Outlet piping – surface corrosion**

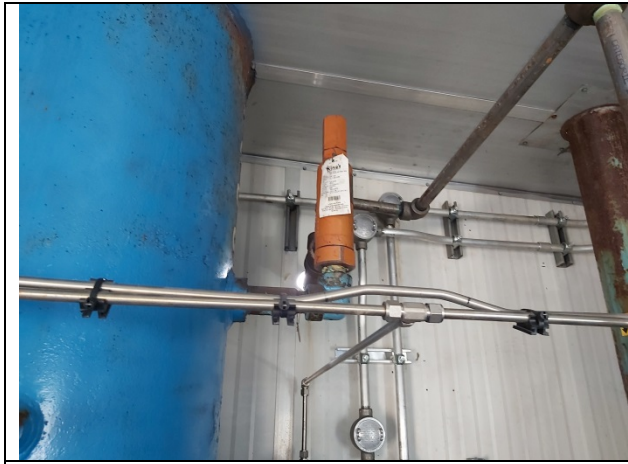
<b>Valving</b> Ensure no leaks are visible. Valves are properly supported and chained if necessary.	X				Well supported – no visible leaks.
<b>PSV</b> Ensure PSV is set at pressure at or below that of vessel.	X				Location: upper shell – set at MAWP of vessel. Discharge piping is same size as valve outlet. PSV seal in place – no block valve between vessel and PSV.
<b>NDE methods</b> was UT/ MPI done on vessel (MI coordinator to review results)	X				Ultrasonic corrosion survey carried out – no metal thickness detected below nominal minus corrosion allowance.
<p><b>Recommendations or corrective actions: (Vessel is Fit for Service or describe corrective actions required)</b> (MIC to review corrective actions with Operations, discuss with Chief Inspector where necessary, and get remedial action implemented)</p> <p><b>Recommendations: 1. Clean up pipe and repaint. 2. Service PSV</b></p> <p><b>Summary:</b> Vessel is in overall good condition, visual external inspection and ultrasonic corrosion survey performed—no metal thickness detected below nominal minus corrosion allowance. Thickness calculations carried out to ensure sufficient metal exists for safe operation.</p> <p>Corrosion rate based on greatest thickness loss – no corrosion rate to assess.</p> <p><b>Vessel is fit for service.</b></p>

PSV location
