VESSEL SHEAR WAVE REPORT				
CLIENT	CNRL	Equip Ident:	A0191662	
		Inspec Date m/d/y	09/16/2015	
CLIENT REP	Carson Petersen	Facility	Ralston 5-14 Battery	
	Ralston 5-14	LSD	05-14-018-10W4MW4M

Equip Ident: A0191662 Equip Descrip: Treater Firetube

Work: Complete shear wave UT on steel blisters on firetube. Determine if blister has caused cracks within the

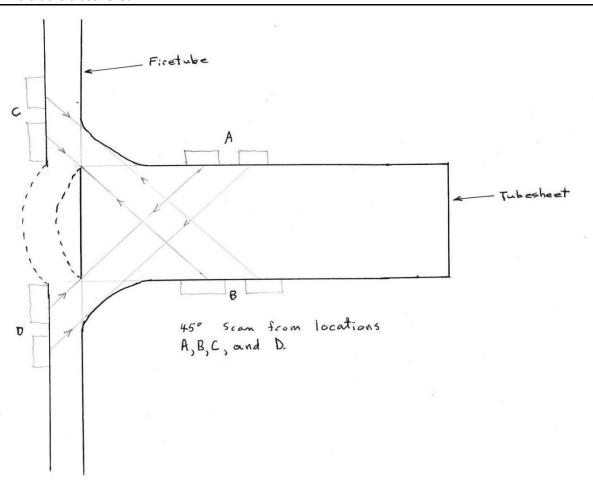
45 Degree Scan

Scan from position A and B, large and small blister, small blister scan area limited

Results: No cracks discovered.

Scan from position C and D, large blister only, surface too rough for small blister

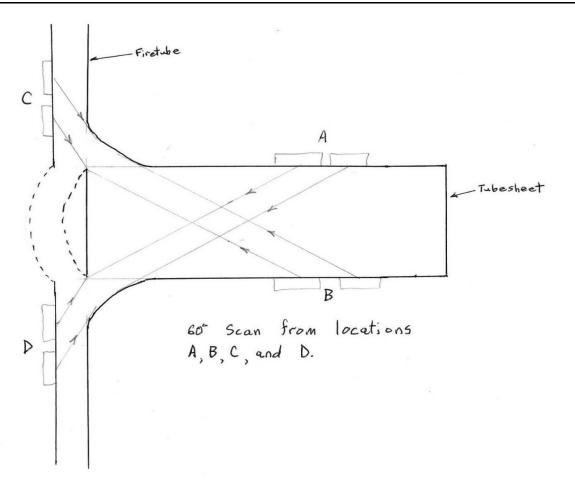
60 Degree Scan

Scan from position A and B, large blister complete, small blister scan area limited

Results: No cracks discovered.

Scan from position C and D, large blister only, surface too rough for small blister

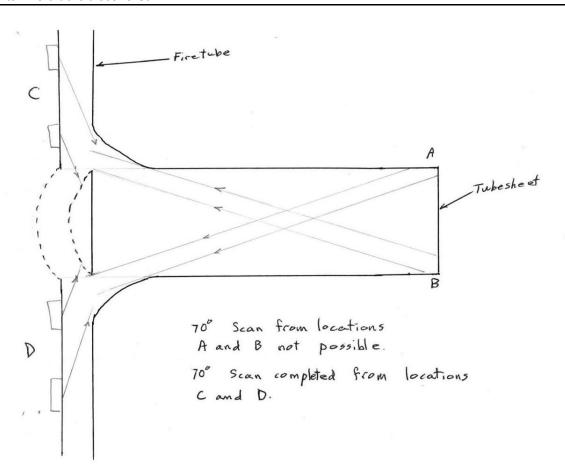
70 Degree Scan

Scan from position A and B

Not possible.

Scan from position C and D, large blister only, surface too rough for small blister

Results: No cracks discovered.
