VESSEL INSPECTION REPORT

CLIENT	CNRL 2500, 855 - 2nd Street SW Calgary, Ab T2P 4J8	Inspec Date m/d/y	11/22/2012
CLIENT REP	KYLE HUCULAK MEDICINE HAT	Client Work Order	
		Client Cost No	
		Facility	RAHLSTON BATTERY
		LSD	05-14-018-09W4M

A Number	A0191862	Eq Number		Equipment	Treater
Ser Number	81-7900-A	Alt Jur #		CRN	E1466.2
MDMT		MAWP	517 kPa	MAWT	93 C
Year Built	1981	Radiography	RT1	PWHT	No
Shell Thick	12.7 mm	Shell Material	SA-516 70	Cor Allow	3.18 mm
Head Fire	28.57 mm	Head Nonfire	15.87 mm	Head Material	SA-516 70

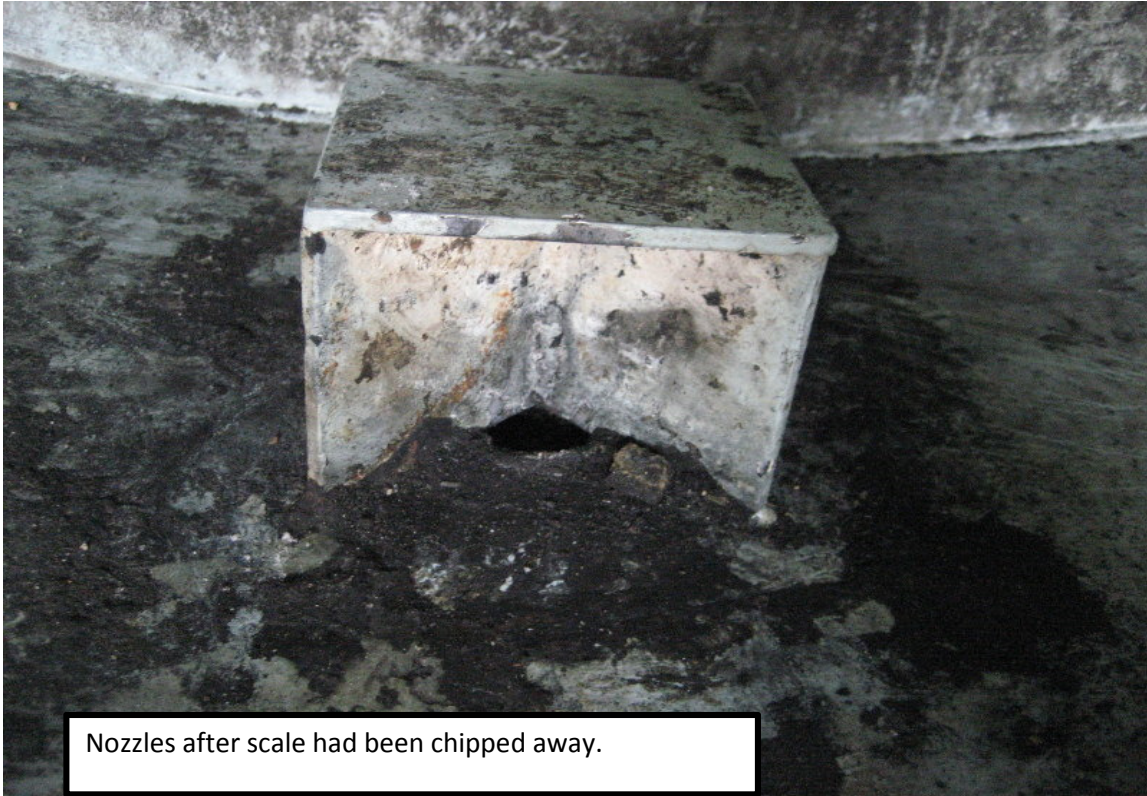
Repairs Required - If yes, ensure procedure and copy of AB-40 is on file, and one sent to local ABSA Inspector.				X	
NDE - Was any NDE done.				X	MT of firetube completed by others.
Other Observations: Liquid out nozzles (with vortex breakers) at 6:00 were filled with what appeared to be scale. Scale was chipped away. Operations was informed.

Nozzles after scale had been chipped away.

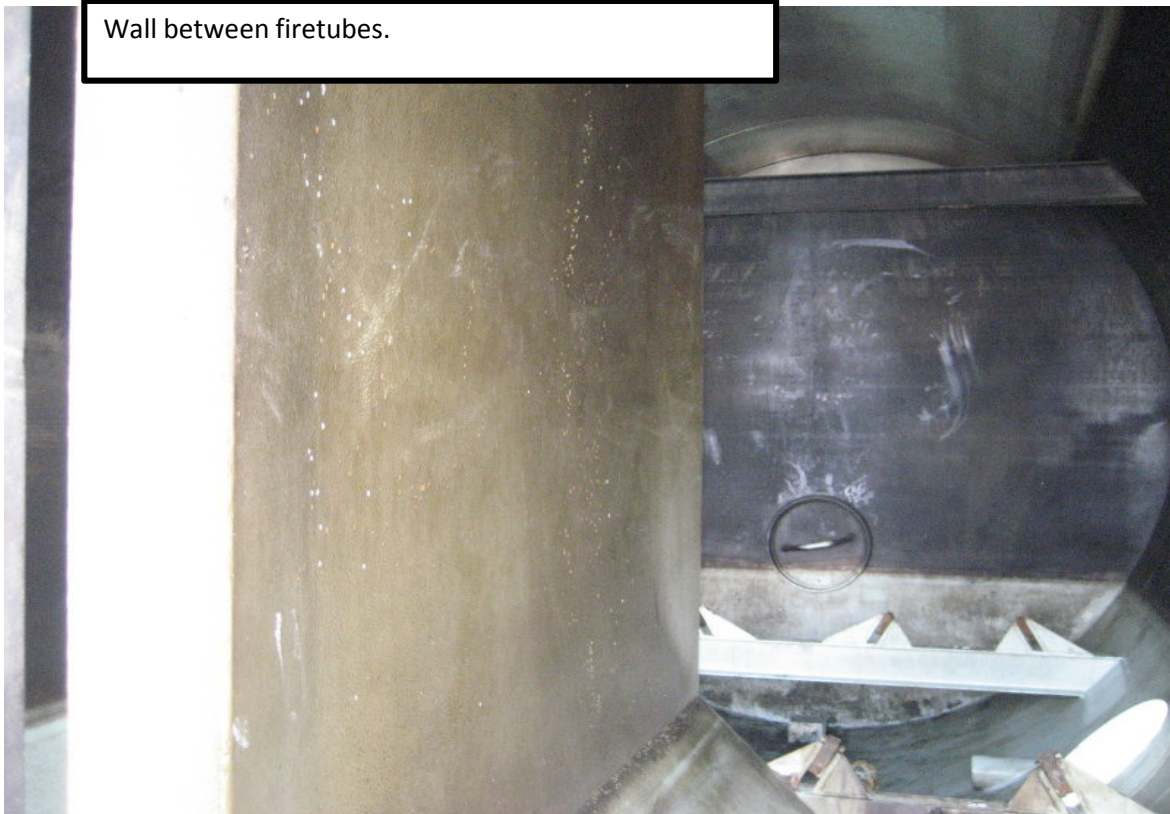
Wall between firetubes.

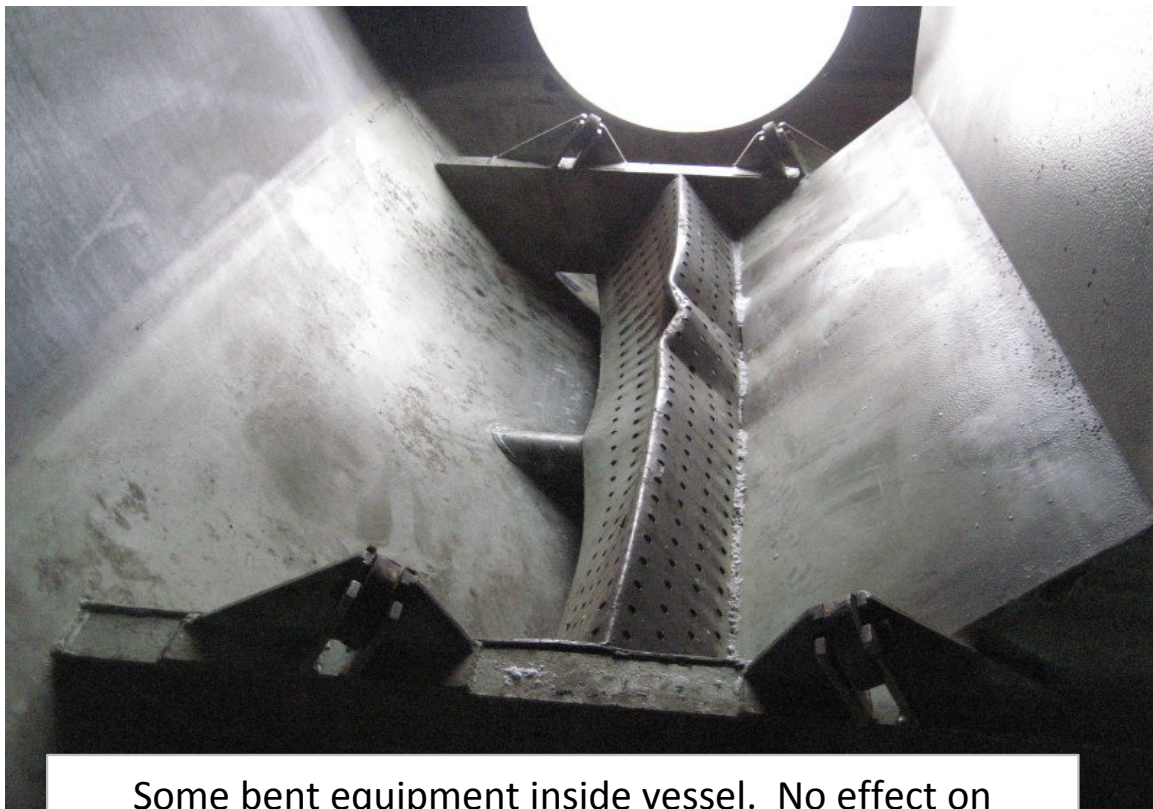
Some bent equipment inside vessel. No effect on pressure boundary.

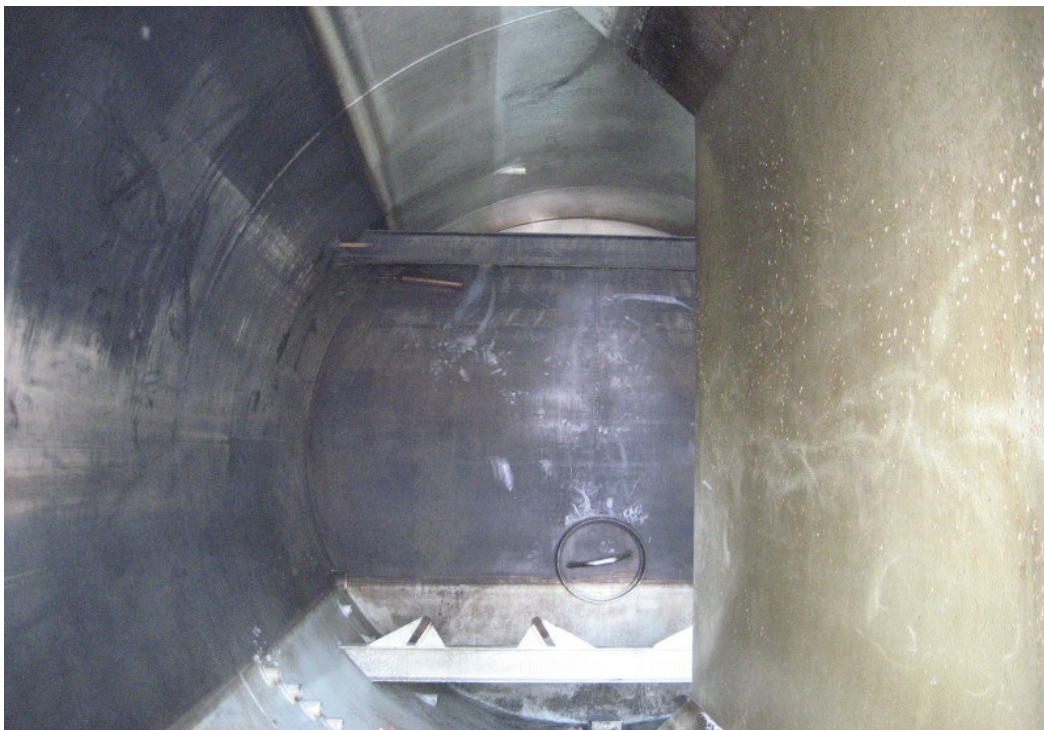
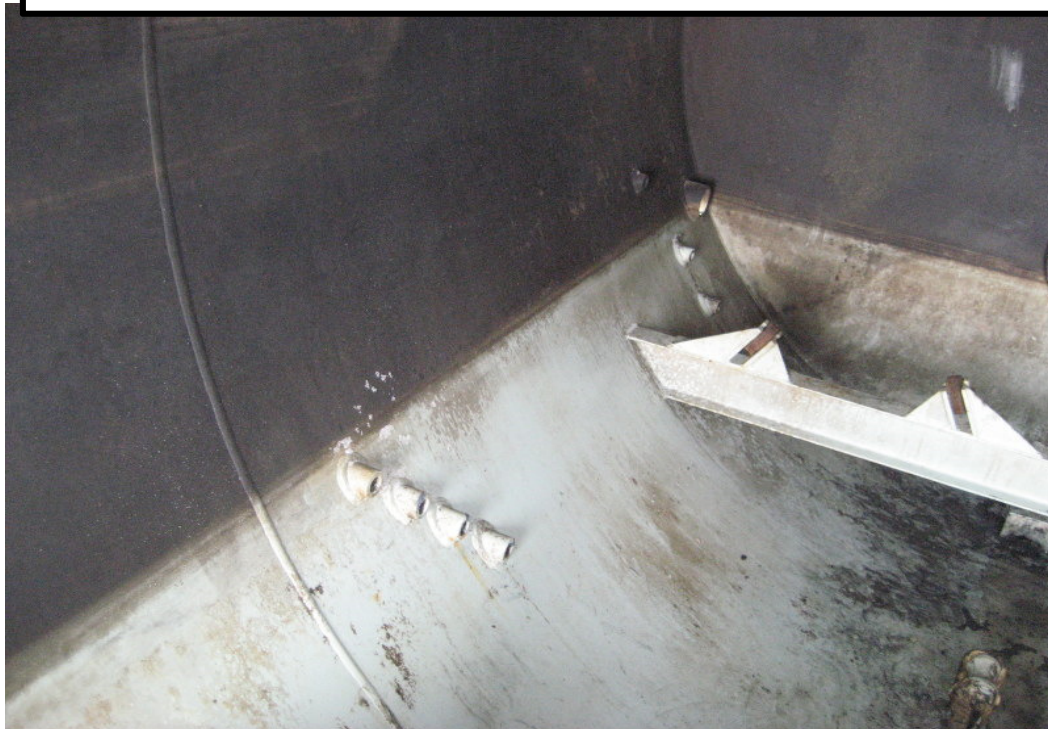
Vessel internal photos, no concerns.

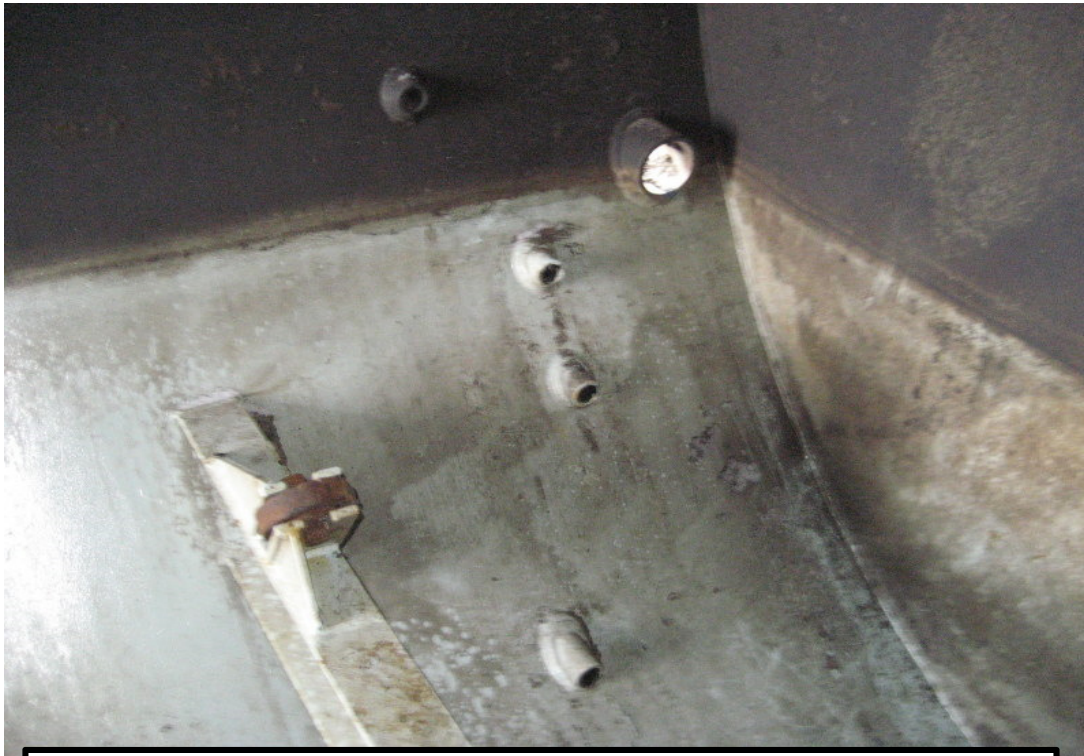
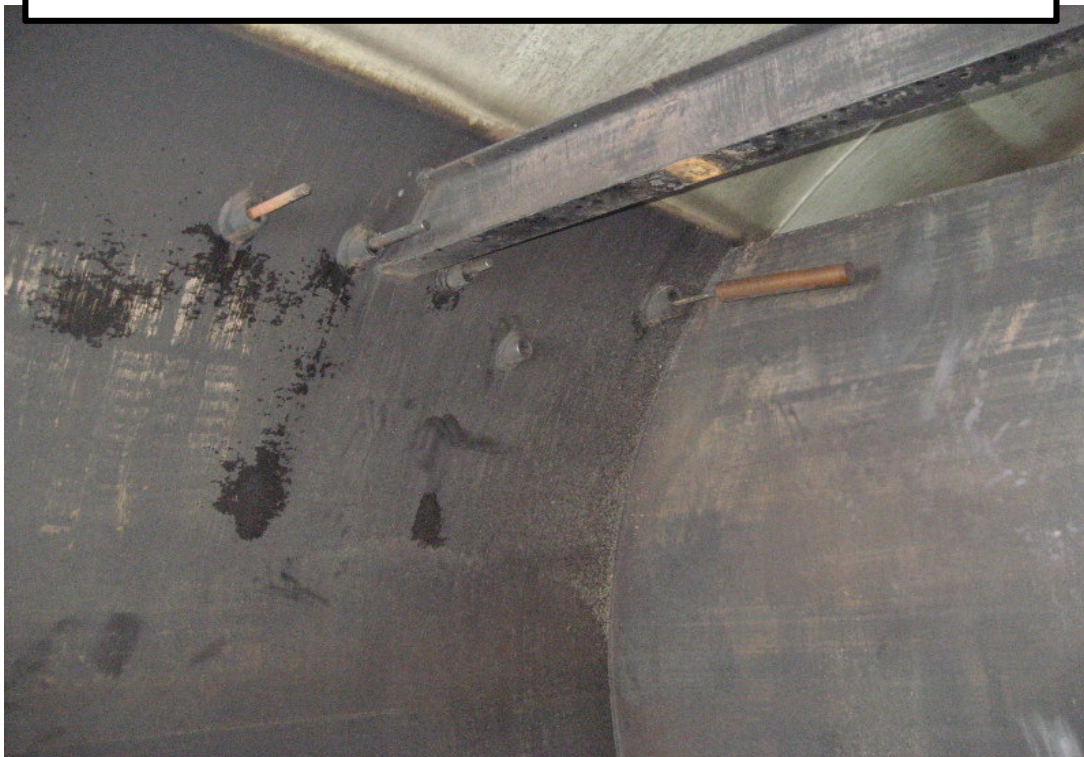
Vessel internal photos, no concerns.

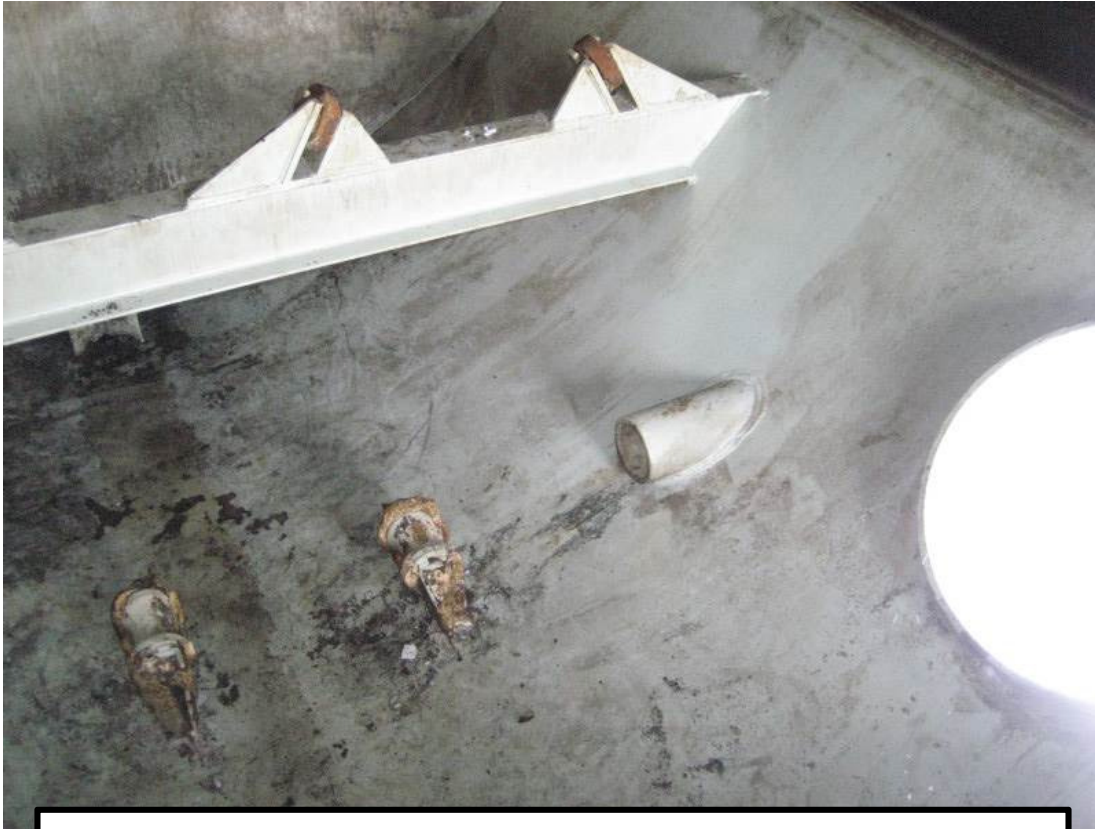
Vessel internal photos, no concerns.
