**Canadian Natural Resources Limited
GENERAL PRESSURE VESSEL INFORMATION**

Job # 10.112250

District: GP South	Equipment number:
Facility: Firebird Battery	Location (LSD): 08-11-98-08 W6M
Vessel Name Equipment Number: Oil Treater	
Orientation: Horizontal	
Status: In service	Regulatory Inspection

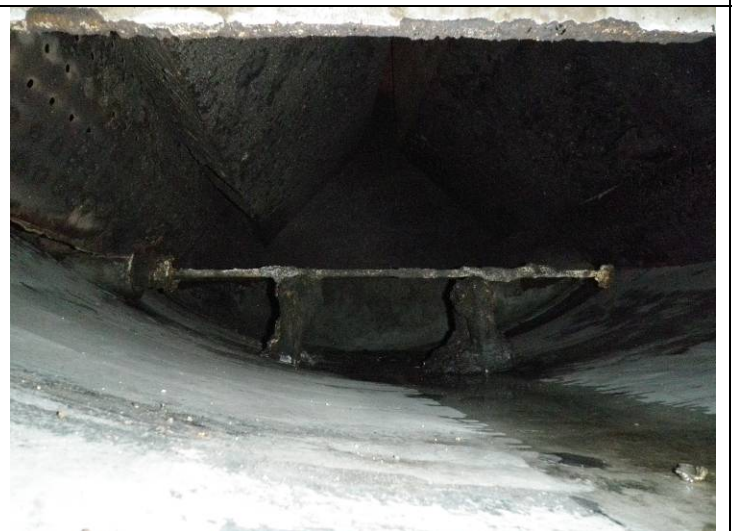
Anode - 100% loss (looking towards Fire Tube end)

Oil drain has calcium buildup restricting flow. Sample points have buildup of asphaltenes.
Demister pad Is it in place? Is it clean? If any corrosion is apparent in vessel, lift pad and check top head for corrosion.				X	No access to vapour boot.
Welds Inspect all welds, including attachment welds. Record all service-related damages and if there is any discuss with Chief Inspector before closing.	X				All welds are coated, no corrosion staining or peeling at welds.
Fire Tubes: Pitting? General corrosion – spot check with ultrasonic thickness to ensure sufficient metal exists for operation.	X				Fire tubes were installed for this internal inspection resulting in a limited access. No signs of damage or distortion. No corrosion or pitting observed.
Repairs Required. If yes, ensure procedure and copy of AB 40 is on file, and one sent to local ABSA, and Chief Inspector	X				1. Coating repair patches required. 2. Clean out all nozzles of obstructions. 3. Replace anodes.

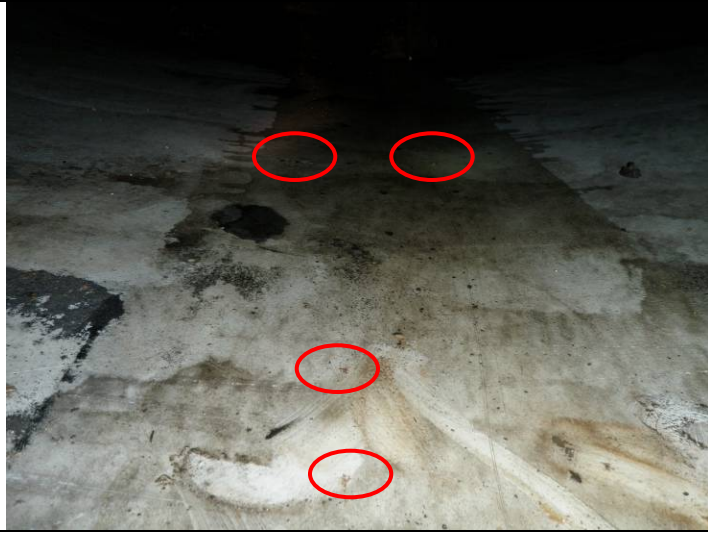
Internal Inspection Items	G	F	P	N/A	Comments
Coating Assess coating. Describe area coated, general condition of coating.		X			Coating failures noted on floor around the 6 o'clock position. Corrosion present.
Anodes. How many, type, condition. % consumed. Are they being replaced?			X		2 anodes in the front end and 2 in the back end. The two front end anodes are completely consumed. The 2 back end anodes are 30% consumed.
Internal Piping Is there any? If so, carbon or stainless steel. Describe condition, dents, corrosion, erosion, etc. Ensure supports are secure and any bolts are suitable for future use.	X				No signs of deflection. Coating is intact.
Trays How many? Type of material. Are valves in place. Check for erosion/ corrosion; wear on tray valve legs. Cleanliness?	X				There is a single strainer tray section in the back end but all other trays and grid sections have been removed in the past. There are 2 sparging chutes in the back end – these are in place, well supported, and coated with epoxy.

Coating failures

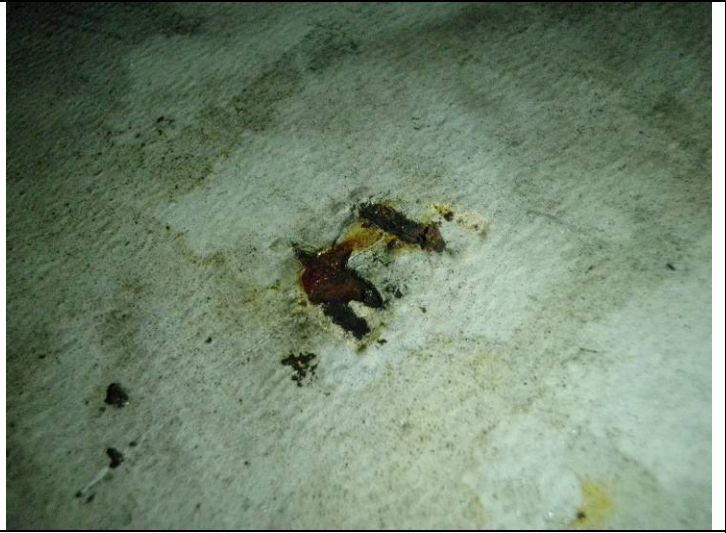
Corrosion present

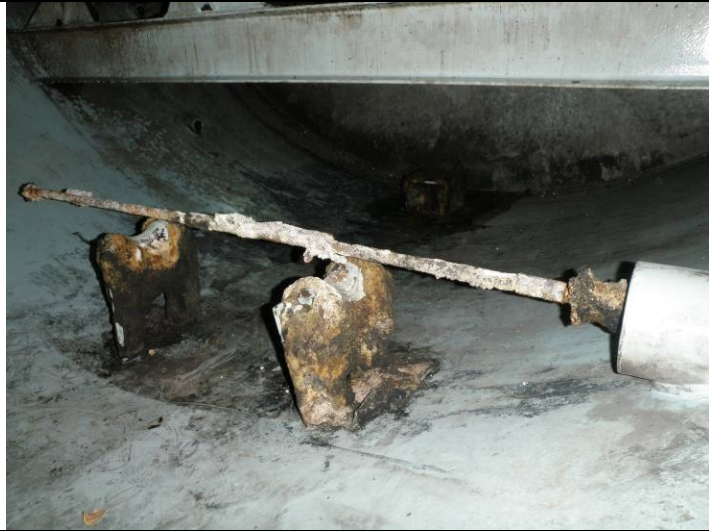
Anode – 100% loss

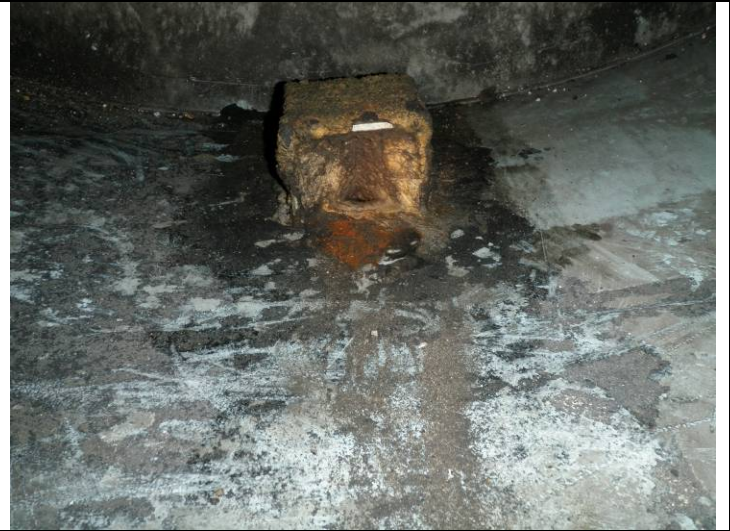
Oil drain/vortex – calcium buildup – flow restricted

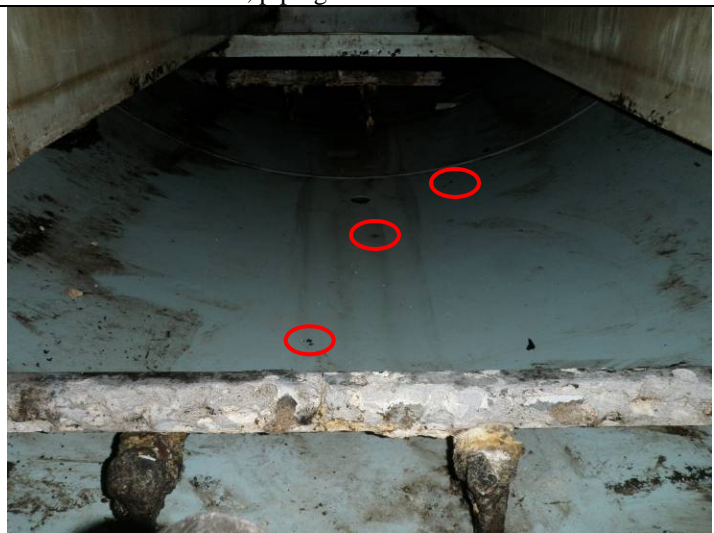
Anodes - 30% loss - coating failures
