VI VE MT VESSEL INSPECTION REPORT

CLIENT	CNRL 2500, 855 - 2nd Street SW Calgary, Ab T2P 4J8	A Number	A0191862
CLIENT REP	Kyle Huculak RALSTON 5-14 (1339)	Ser Number	81-7900-A
		Equipment	FREE WATER KNOCK OUT
		Inspec Date m/d/y	09/08/2015
		Facility	RALSTON 5-14 BATTERY
		LSD	05-14-018-10W4 BATTERY

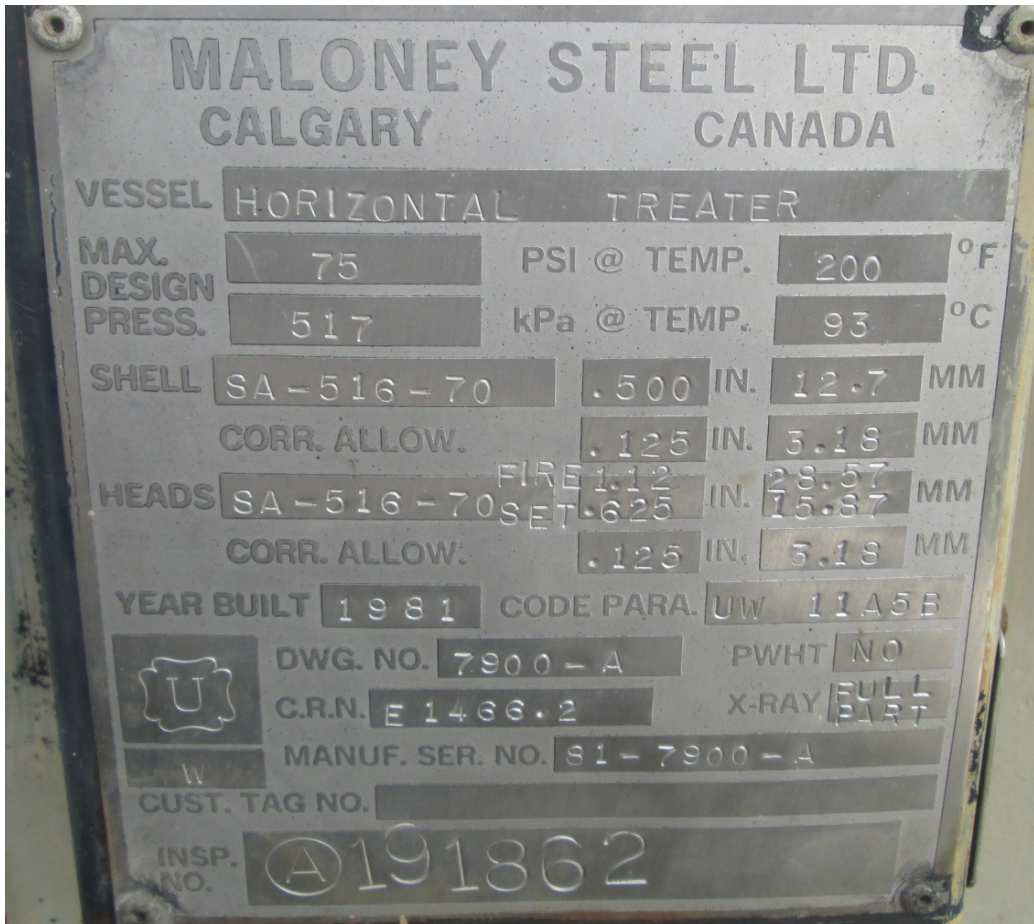
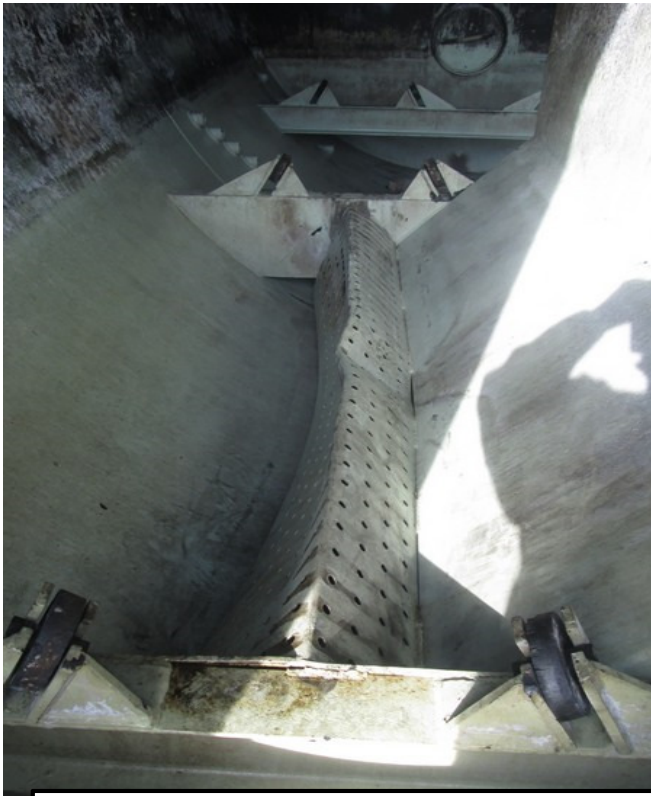
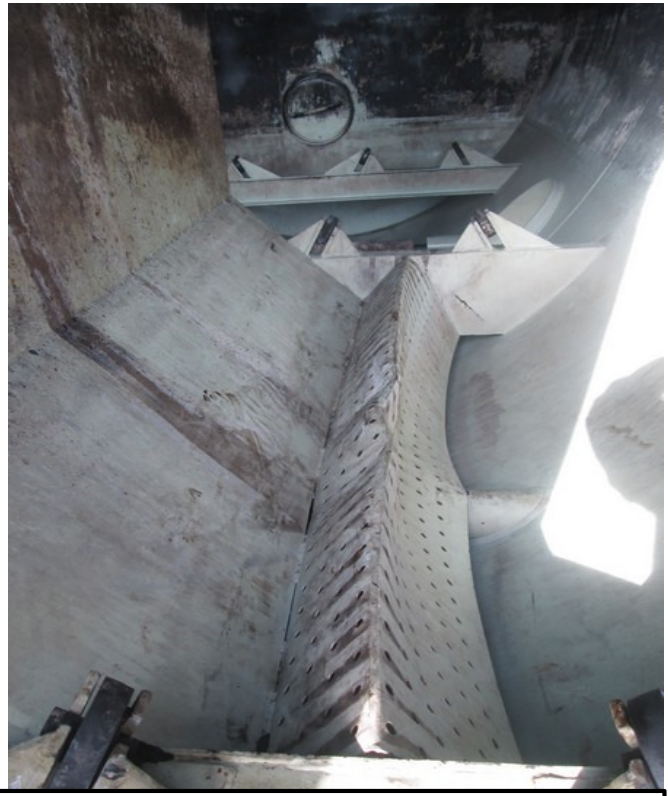
Both left and right shrouds below firetubes are bent. Coating damage is limited to shroud and nozzles/anode holders. No coating damage to pressure boundary.

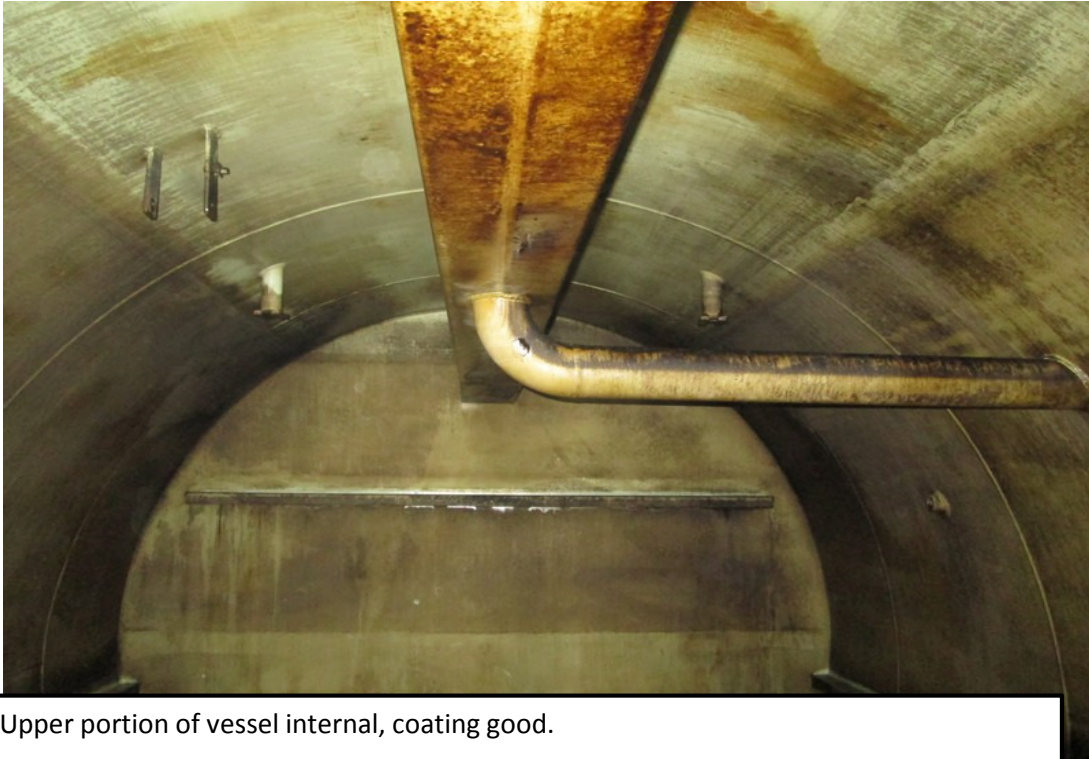
Upper portion of vessel internal, coating good.

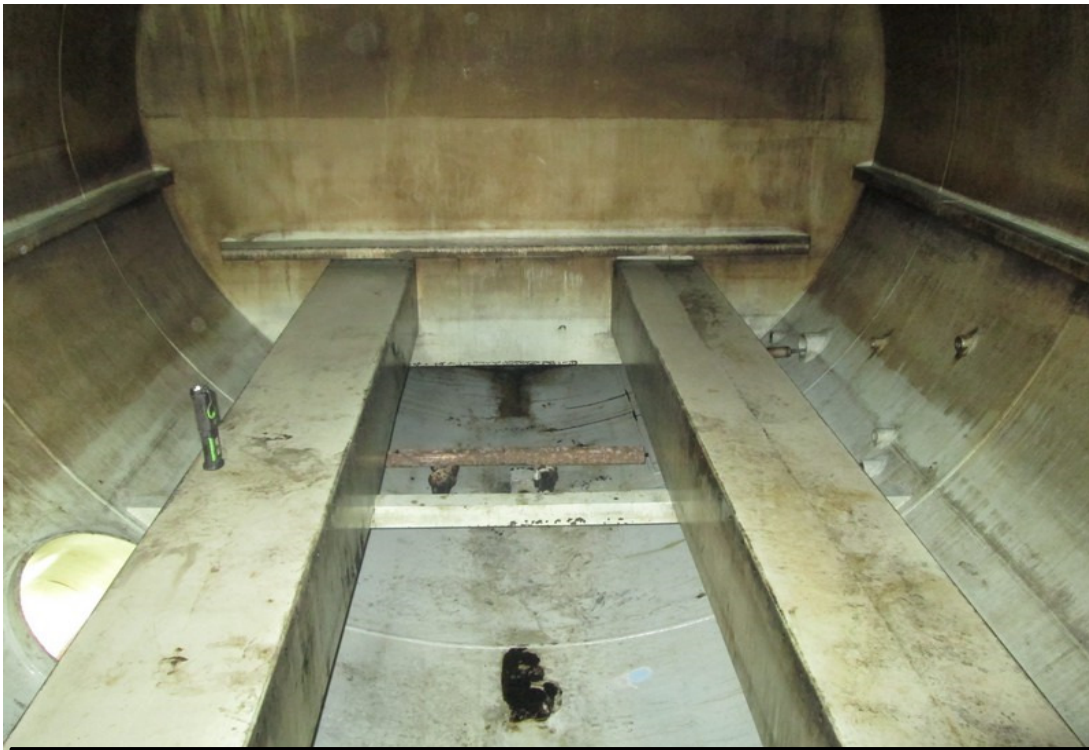
About 10 holidays along 6:00 shell, cleaned and Devoe 142 applied.

Minor holidays at 6:00 position in shell were cleaned and Devco 142 applied.

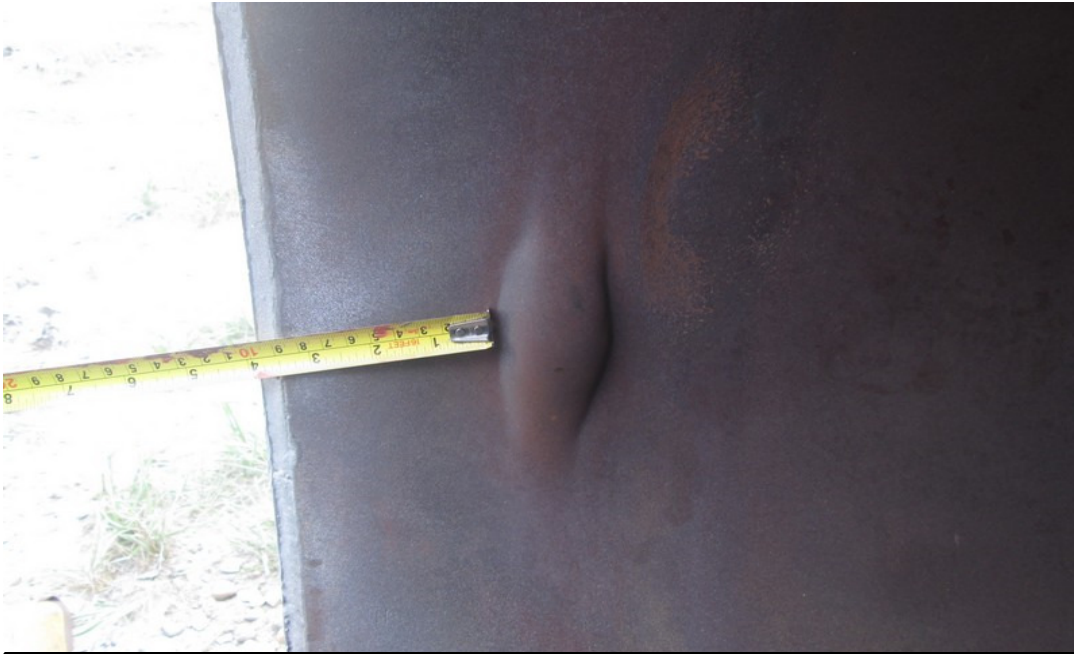
Inside 1 firetube, 2 blisters, 4 inch from end of tube. Firetube removed from service.

Repairs Required - If yes, ensure procedure and copy of AB-40 is on file, and one sent to local ABSA Inspector.				X	
NDE - Was any NDE done.			X		MT examination of firetube. Minor crack indication removed with die grinder. On inside of 1 firetube, 2 blisters, see photos. That firetube not returned to service. Vessel bypassed to continue with start up. Detaiol inspection of blisters under other Perilon report.
Other Observations:

Firetube bulge/blilster on internal diameter of firetube (coldside) at same position as tubesheet. Height of bulge/blister is about 15 mm above parent metal, thickness of tube is 12.6 mm.

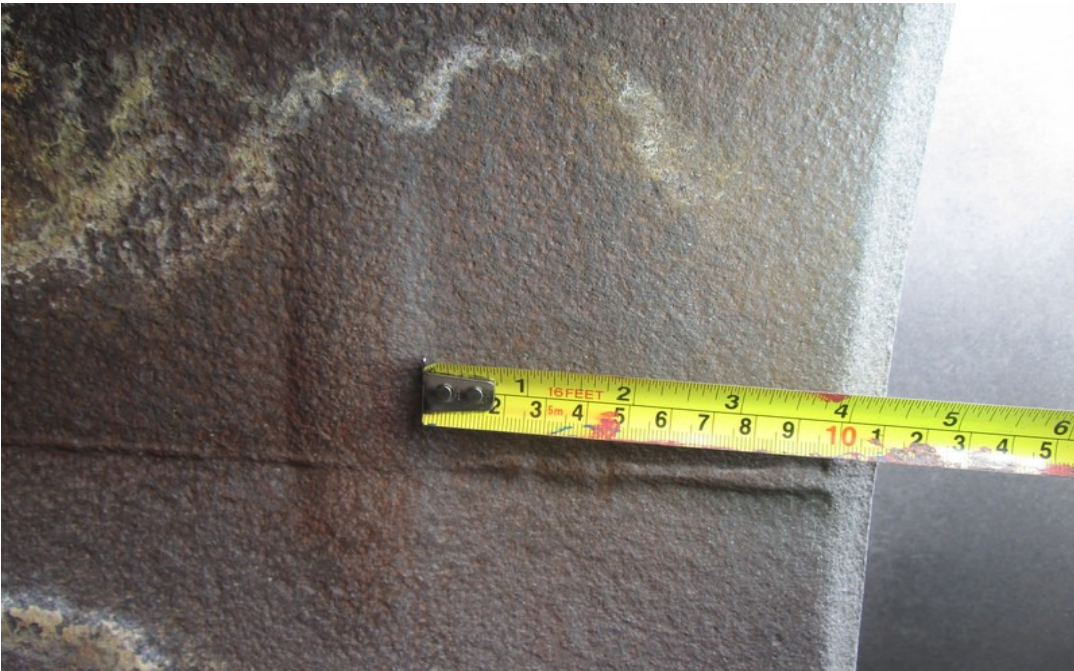
Firetube bulge/blilster on internal diameter of firetube (coldside) at same position as tubesheet. Height of bulge/blister is about 4 mm above parent metal, thickness of tube is 12.6 mm.
