**Enerplus Resources
GENERAL PRESSURE VESSEL INFORMATION**

Job # 105.00090

District: B.C. and North	Equipment number: 23465
Facility: Firebird Battery	Location (LSD): 08-11-98-08 W6M Skid: 3219
Vessel Name Equipment Number: Oil Treater	
Orientation: Horizontal	
Status: In service	Regulatory Inspection

Photo Table for E-23465 Oil Treater

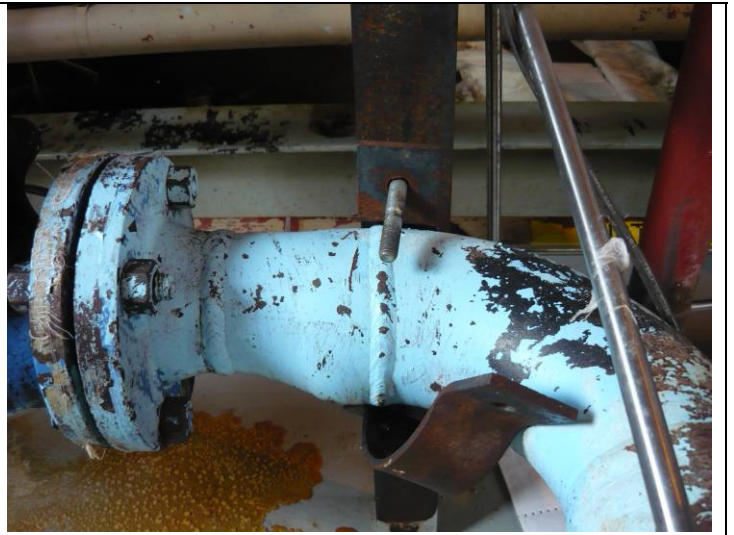
Loose support clamp

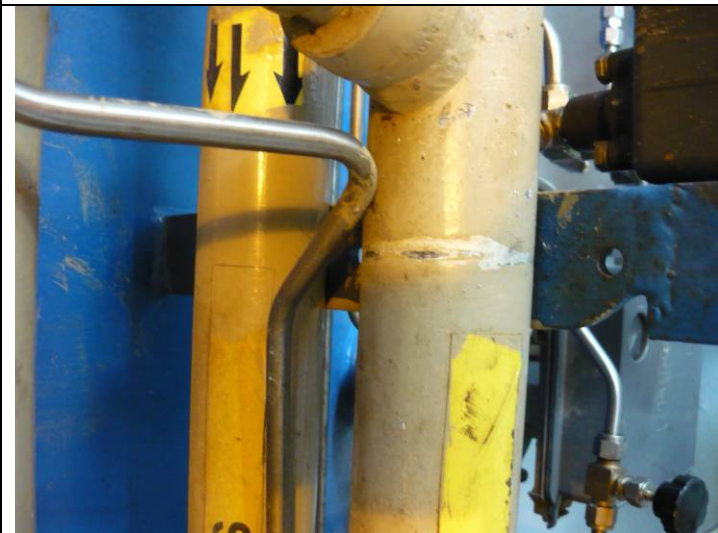
Missing piping clamp

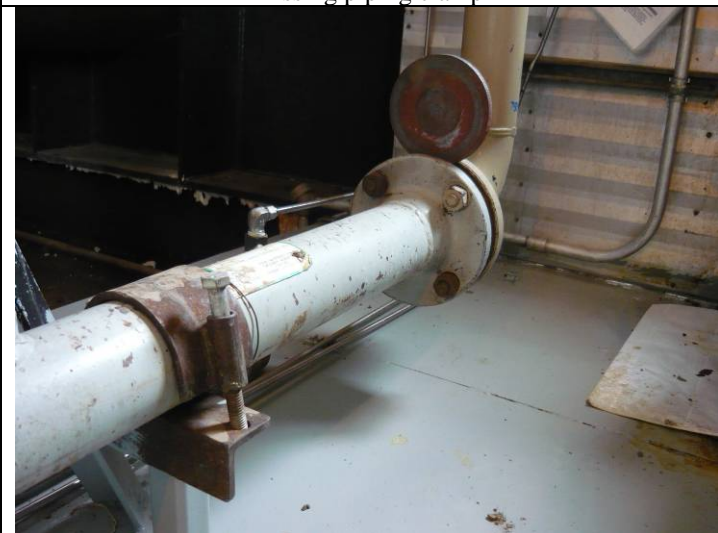
Loose Piping Clamp

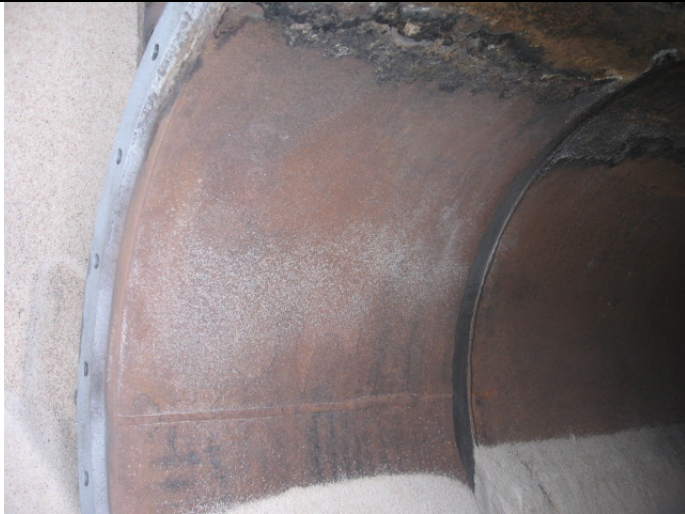
Internal of burner side of fire tube – some general scaling on impingement area but no real wall loss.

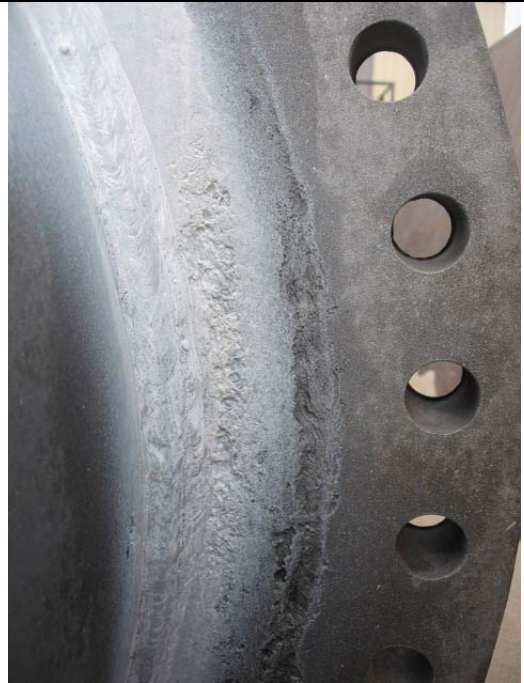
Pitting on internal side of flange but no on gasket seating face to .140 inches deep

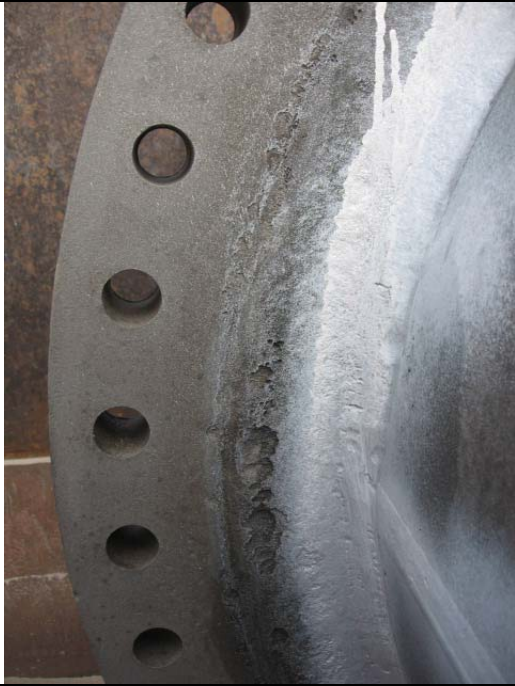
Deep pitting to .220 inches on fire tube flange area outside of gasket seating area.

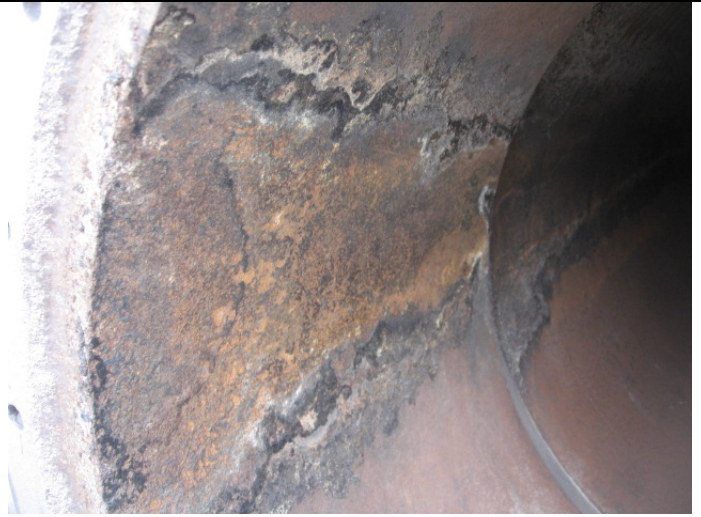
Burner impingement area on internal of tube – scaled with some wall loss but is heavily reinforces – 38.2 mm thick.

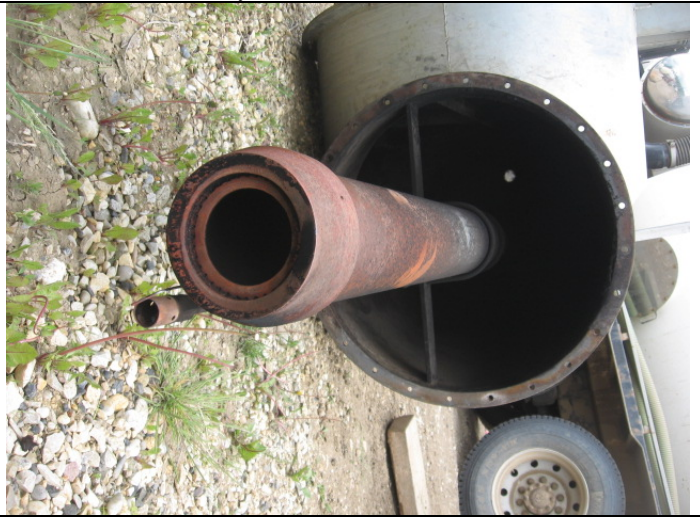
Burner nozzles – free of obstructions

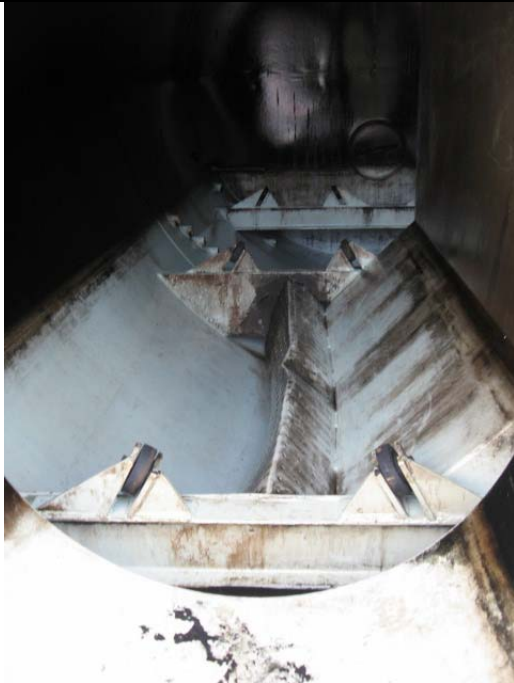
Baffles, deflector plates, etc. If present, describe condition. Look closely at welds attached to vessel wall.	X				Inlet diffuser / chute and weir are intact and in place – coated with epoxy – no failed areas. Both are bent and distorted from upset process conditions – the sparging chutes are bent and distorted as well. This does not represent any process difficulties but does indicate the sudden differential in pressure that this vessel has been subjected to. The coating is blistered on the inlet chute but is still intact and is in the oil phase so does not represent a problem. There are vortex breakers in the front end and the back end – are intact and in place. The water drain nozzle in the back end had a rag stuck in it and was not able to drain water from this area – rag and built up calcium was removed.
Control valves / floats etc... : Ensure all control floats move freely and the nozzle is free of obstructions.		X			The water level control in the front end was restricted in movement and had to be removed to clean out asphalt material.

Opposite side – sparging chute in front end – notice deformation.

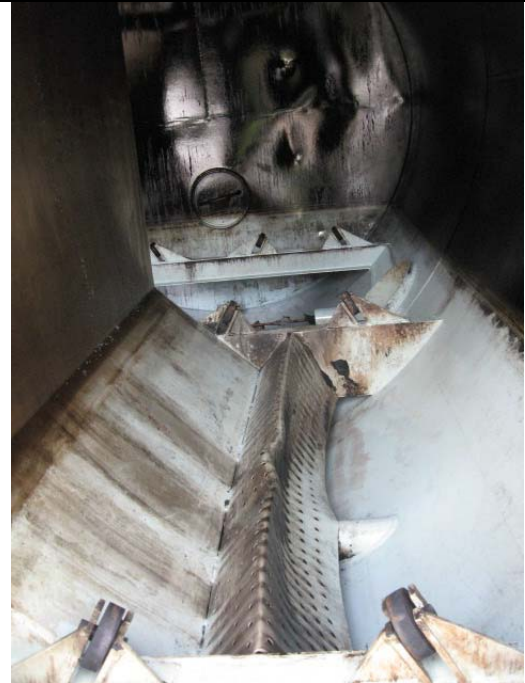
Sparging chute in front end – notice deformation.

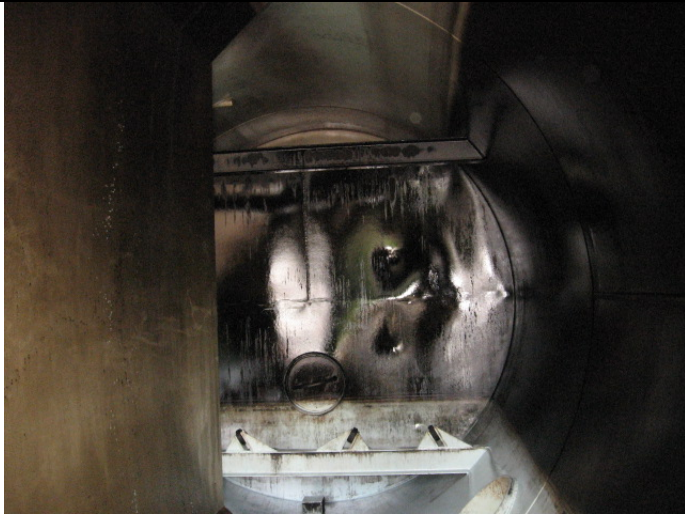
Over view of weir from front end – deflected rearward approximately 1.5 inches over full width.

Repairs Required. If yes, ensure procedure and copy of AB 40 is on file, and one sent to local ABSA, and Chief Inspector	X				<ol style="list-style-type: none"> 1. Hand patch chips in fire tube access area – completed this outage. Completed 2. Clean out all nozzles of obstructions. Completed 3. Clean out all controllers and ensure serviceability. Completed 4. Replace all anodes. Completed 5. Review operational process to ensure internals are not destroyed.
NDE Was any NDE done. (MI coordinator to review results)	X				Magnetic particle inspection carried out on all fire tube welds – no cracking detected.
<p>Recommendations or corrective actions : Vessel is Fit for Service or describe corrective actions required) (MIC to review corrective actions with Operations, discuss with Chief Inspector where necessary, and get remedial action implemented) Recommendations: See repairs required.</p> <p>Summary: Vessel in good overall condition, visual internal and external inspections carried out – internal is 100% coated with epoxy – no failed areas, no corrosion or pitting. There has been some deformation of the internal chutes and weir in the past – this seems to be caused from an increase in differential pressure in process from the sudden surge on inlet pressure – some review may be required to ensure this does not break the weir loose from its welded position. Vessel is fit for service.</p>

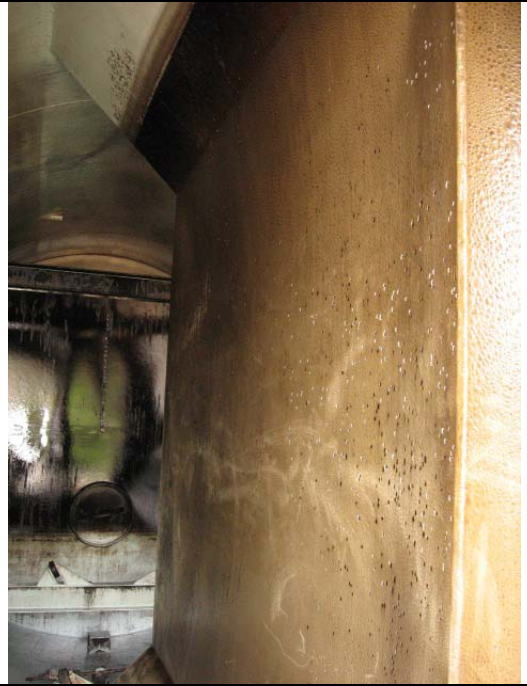
Inlet chute – deformation and blistered coating.

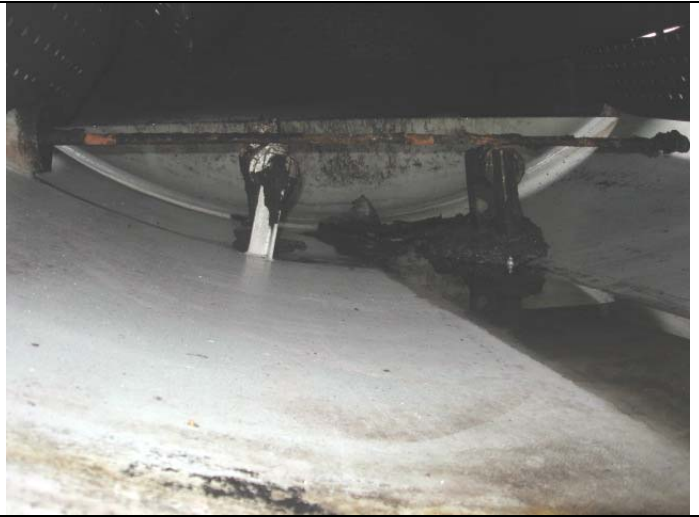
Anode in front end – completely consumed

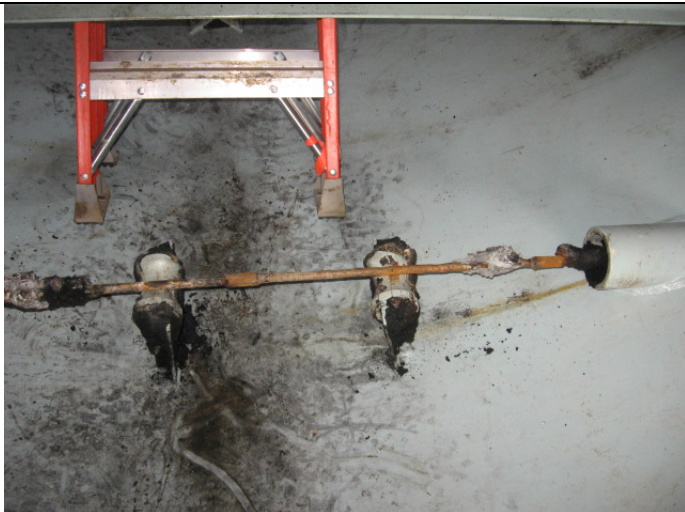
Anode in front end – completely consumed.

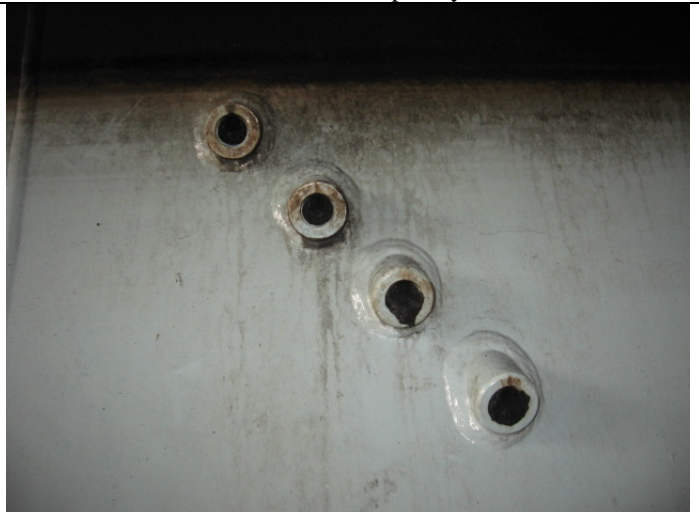
Nozzles: Any obstructions? Coated? Corrosion?	X				Coated with epoxy – no failed areas. 1. Water drain nozzle in the back end was plugged with a rag, most likely from the last internal inspection – Removed this outage. 2. All the sample points (7) were plugged with asphalt in both the front end and the back end – Obstructions were removed this outage.

Sample points in front end – plugged

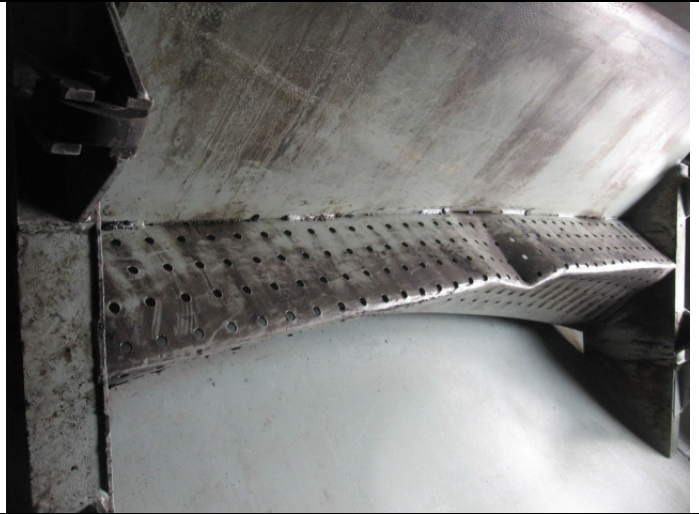
Sparging chutes in front end – severe deflection and distortion.
