Field Inspection Report

Client	CNRL		Date of Inspection	September 9, 2014					
Prov. Reg.#	A2710237		Inspection Type	VI, VE, UT, MPI					
Equipment	Group Treater and Firetube		Location	Ralston Oil Battery					
Tag/Equip. #			LSD	05-14-018-10W4M					
Vessel Status	In Service		Comp./Unit #						
Manufacturer	Natco Canada		MAWP / Temp	75 PSIG @ 200 F					
Serial #	L-8-325	CRN #	H 0995.2	MDMT@ Pressure	-5 F @ 75 PSIG				
Corrosion Allowance	0.0625"	Shell Material	SA516-70	Shell Thickness	0.975"				
Year Built	1991	Head Material	SA516-70	Head Thickness	0.598"/0.667"				
Diameter	8' OD	Length		Height		RT	RT-4	HT	
Service	Sour	Next Inspection		Next Insp. Type					
ASME Stamp	Yes	Next Inspection		Next Insp. Type					
PSV Tag #		CRN#		Set Pressure	75 PSIG				
Manufacturer	Consolidated			NB#		ASME Stamp			
Type/Model	1905JC2-X-SG10	Serial	90C3880	Inlet Size	2"				
Capacity	2271 SCFM	Service Company	Unified Valve	Outlet Size	3"				
Service Date	10/08/2013		Next Service Date

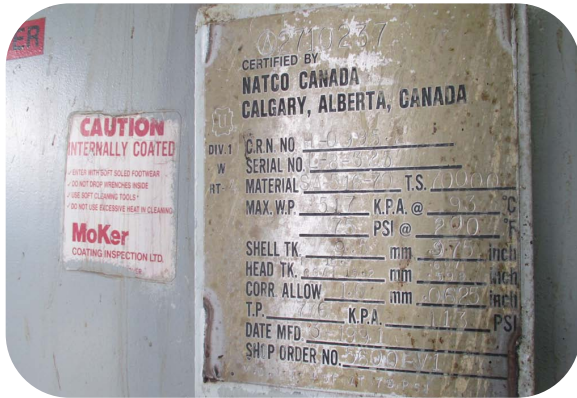
- Name plate was attached and readable.
- External paint was in good condition with no signs of external corrosion noted.
- External insulation was intact and in good shape.

A2710237_Name plate_9Sept2014

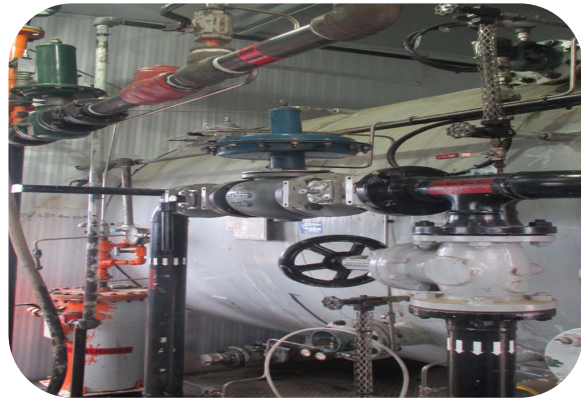
A2710237_North shell inside building_9Sept2014

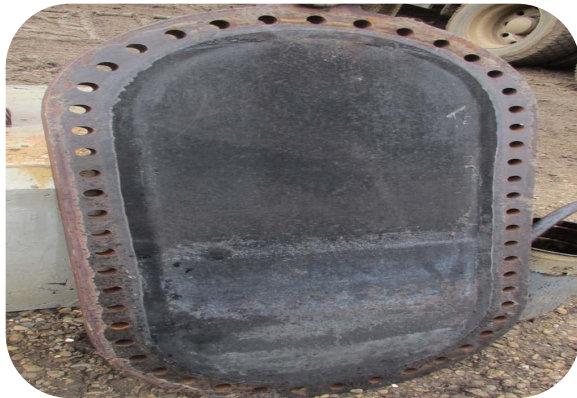
A2710237_Firetube manway cover_9Sept2014

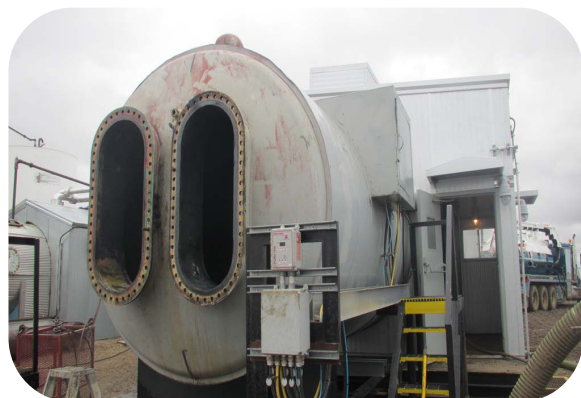
A2710237_East head_9Sept2014

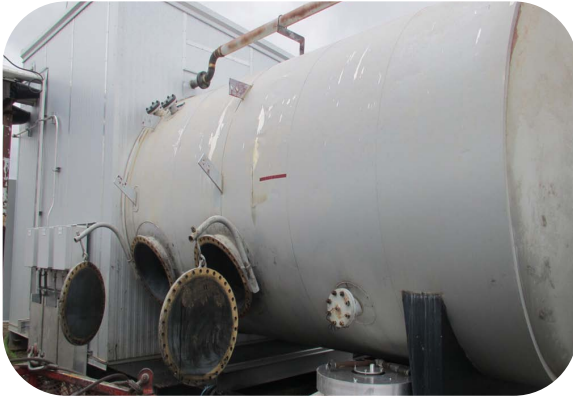
A2710237_South East shell_9Sept2014

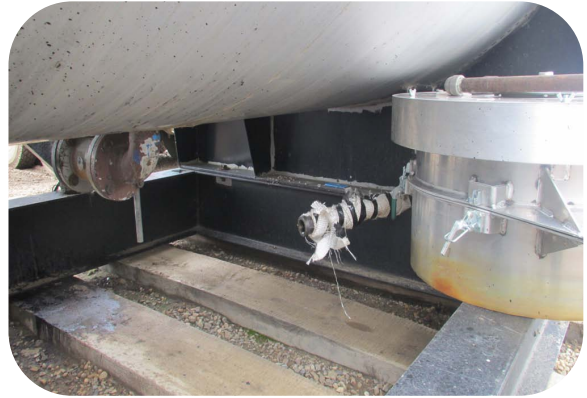
- Vessel is supported securely on saddles welded to the shell and welded to the skid.
- All external nozzles were in good condition, no leaking flanges, gaskets, or threaded connections.

A2710237_Saddle supports_9Sept2014

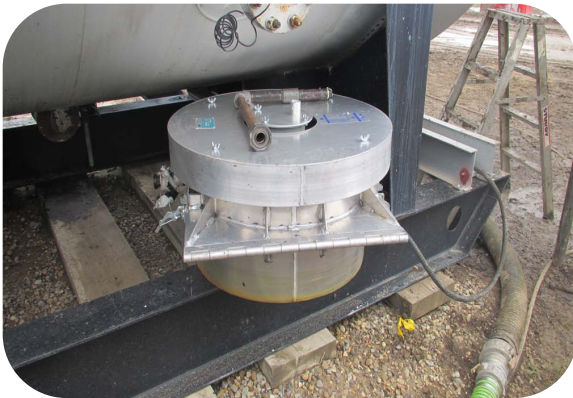
A2710237_Burner Assembly_9Sept2014

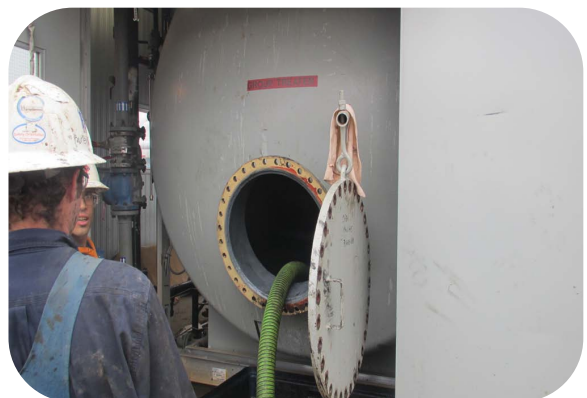
A2710237_West head manway and davit
arm_9Sept2014

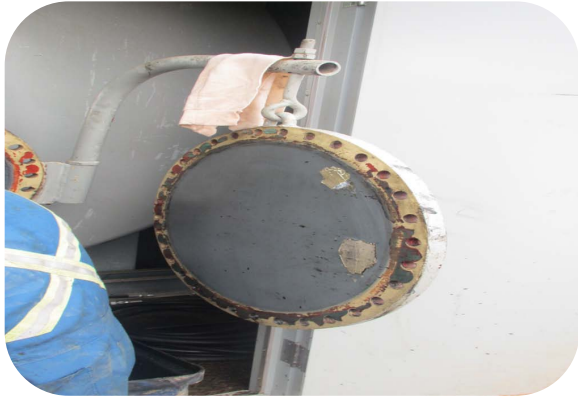
A2710237_West head manway cover and
davit arm_9Sept2014

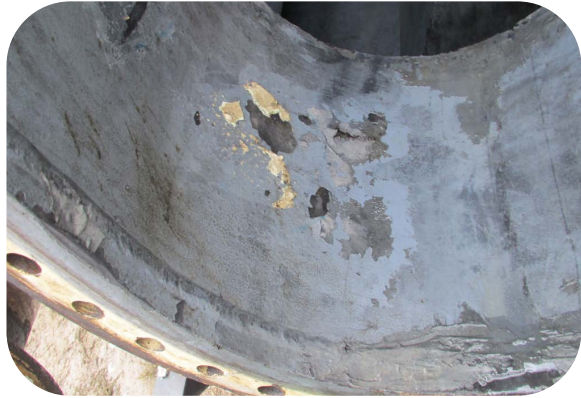
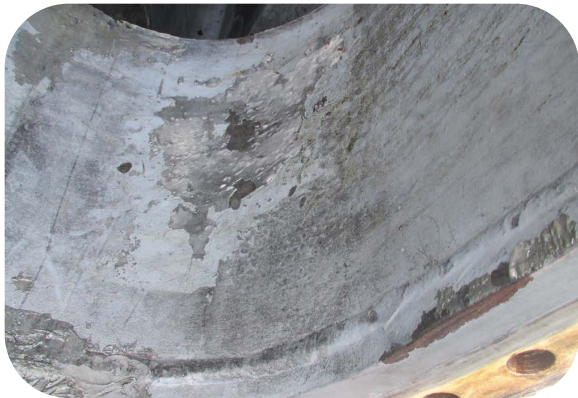
- East head firetube manway nozzle and gasket surfaces were in good shape.
- Minor coating repairs are required on the nozzles.
- All coating repairs were carried out at the time of inspection.

A2710237_Firetube manway
nozzle_9Sept2014

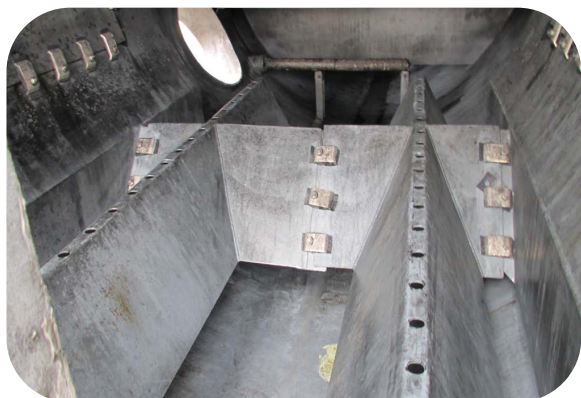
A2710237_Firetube supports
intact_9Sept2014

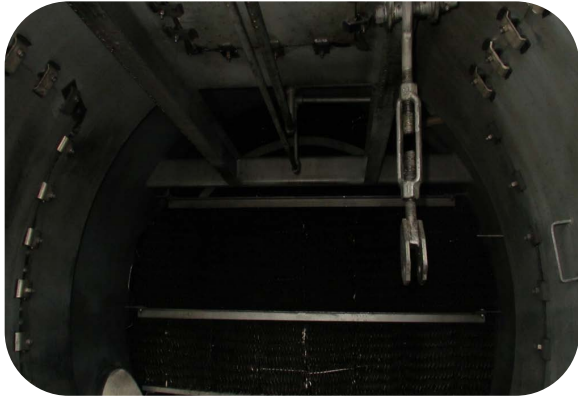
A2710237_Firetube guides and wafer chevron secure_9Sept2014

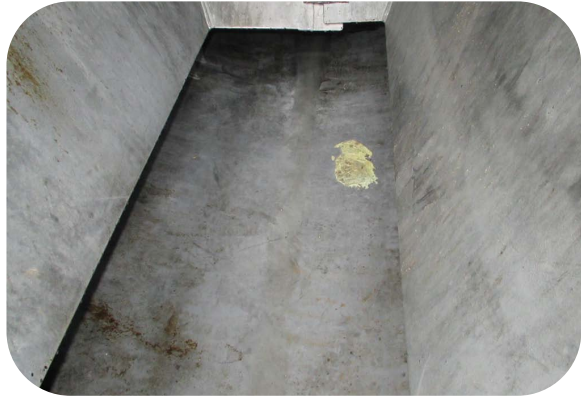
A2710237_East bottom shell coating intact_9Sept2014

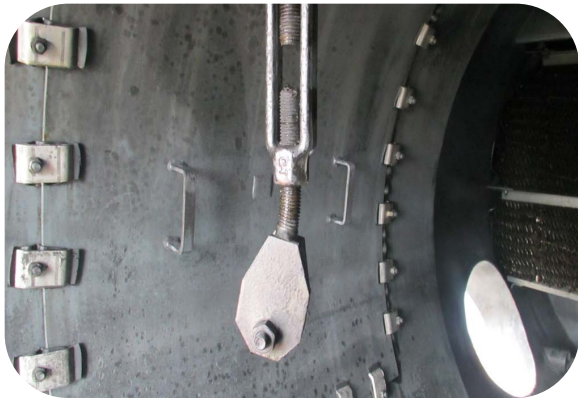
A2710237_Horse shoe doors intact_9Sept2014

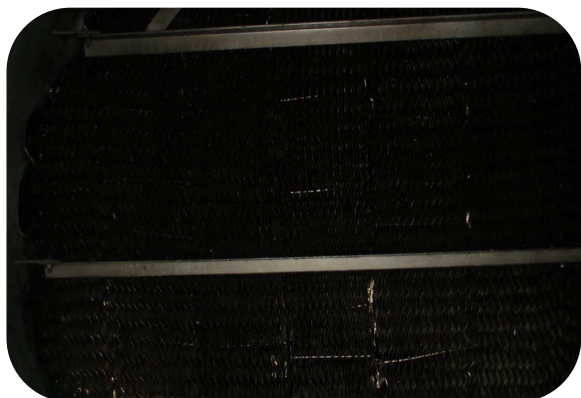
A2710237_Wafer Chevron supports secure_9Sept2014

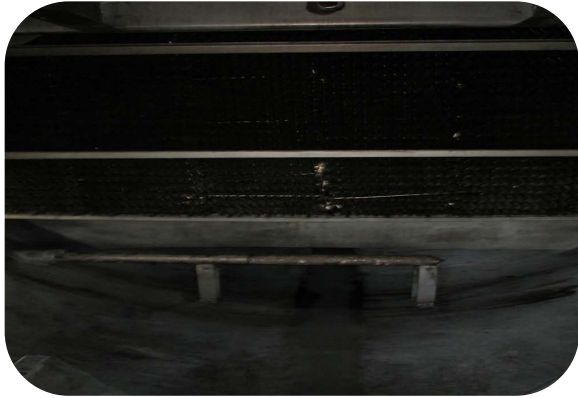
A2710237_Internal Anode, holder and rollers
in good shape_9Sept2014

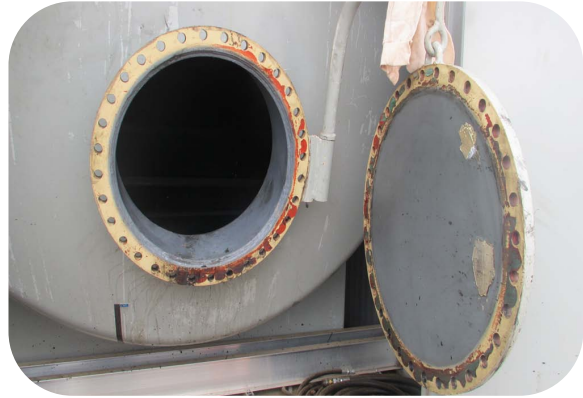
A2710237_West head manway
cover_9Sept2014

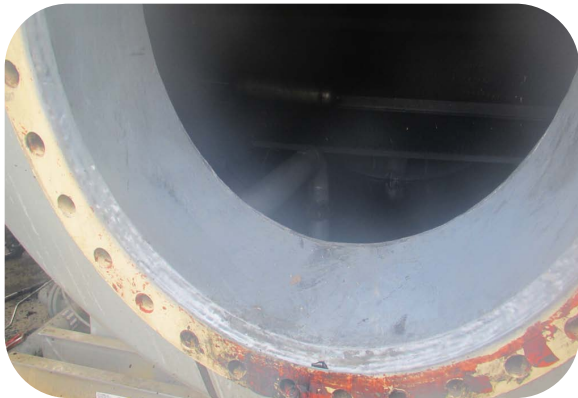
A2710237_West head manway
nozzle_9Sept2014

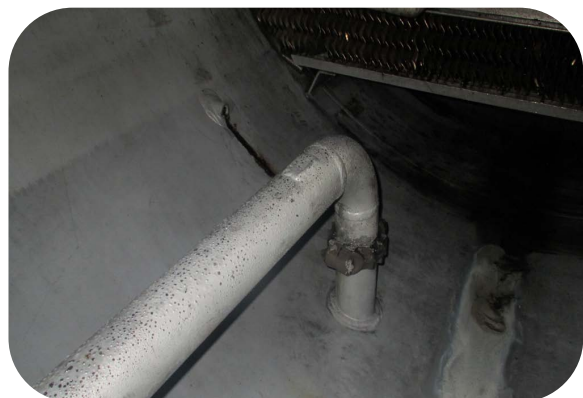
A2710237_Internal piping secure_9Sept2014

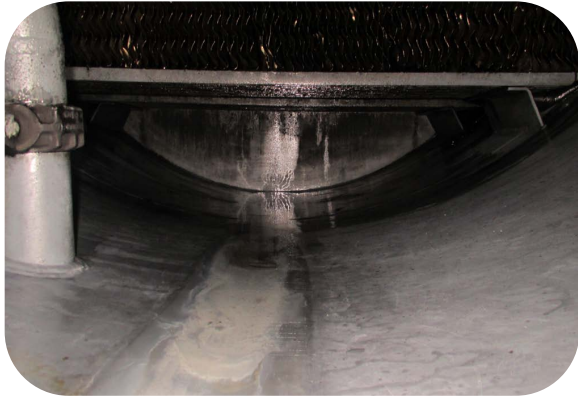
A2710237_West end bottom shell coating_9Sept2014

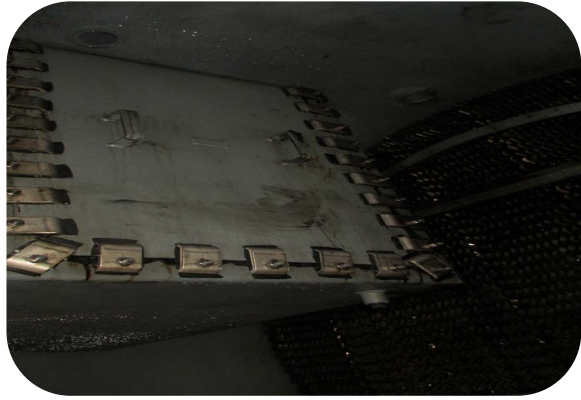
A2710237_Oil collection box_9Sept2014

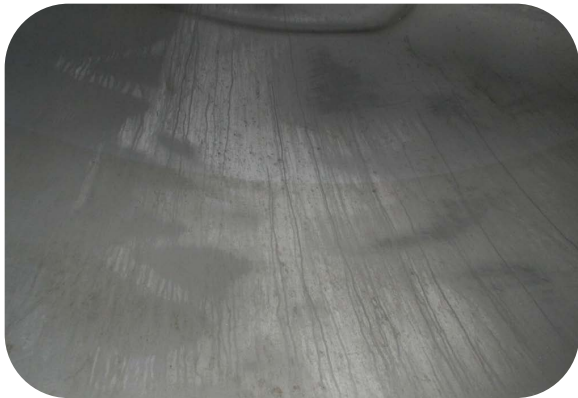
A2710237_West head nuckle_9Sept2014

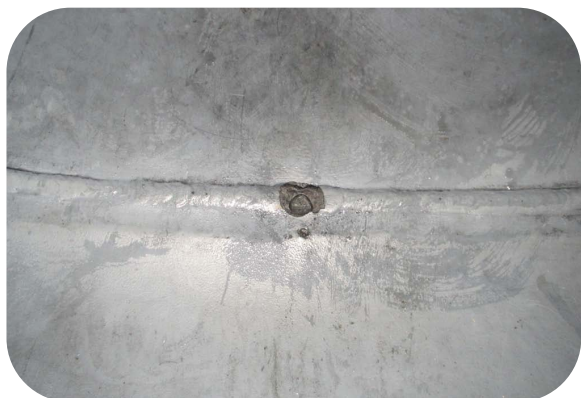
- Wafer Chevron supports secure all bolting in place.
- Oil collection box was in good shape.
- West shell internal was in good shape.
- One deep pit identified on the head the shell circ seam, coating repair was carried out at the time of inspection.

A2710237_West head to shell weld pitt 0.100" deep_9Sept2014

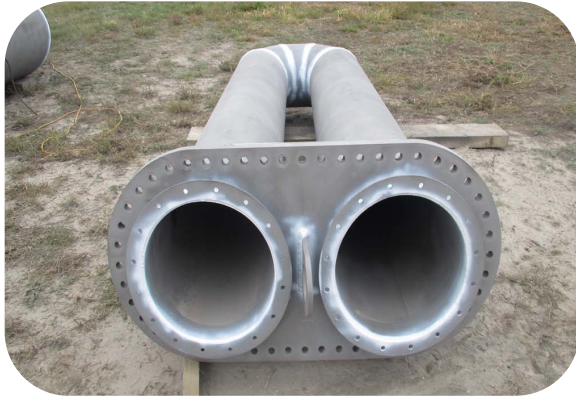
A2710237_MPI of the burner and stack flanges_9Sept2014

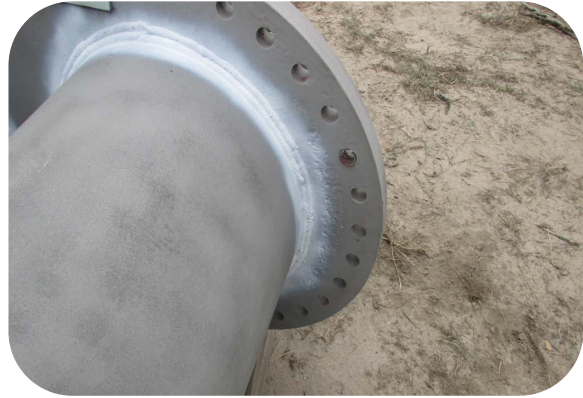
- **No bulging or deformation of the tubes or tube sheet.**
- **Tube legs were free from pitting internally and externally.**
- **Pitting on the tube sheet 0.060" deep 1" wide and 20" long, to be monitored at next inspection.**
- **UT Survey was carried out in October 2013. No changes in the readings were found; all readings were acceptable; see attached UT Report.**
- **MPI was carried out on all miter joint welds and fillet welds, no areas of concern; see attached MPI Report.**

A2710237_Tube sheet corrosion 0.060" deep 1" wide 20" long_9Sept2014

Monitor the corrosion on the tube sheet at next inspection and if needed send out for weld repairs.

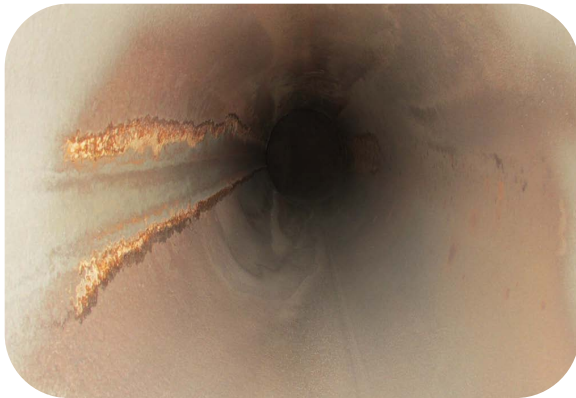
A2710237_Burner tube leg internal_9Sept2014

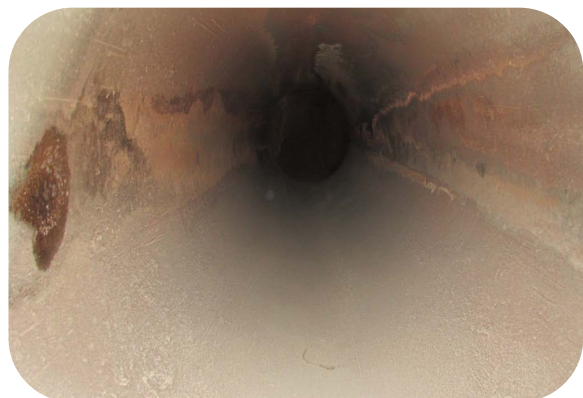
A2710237_Stack tube leg internal_9Sept2014

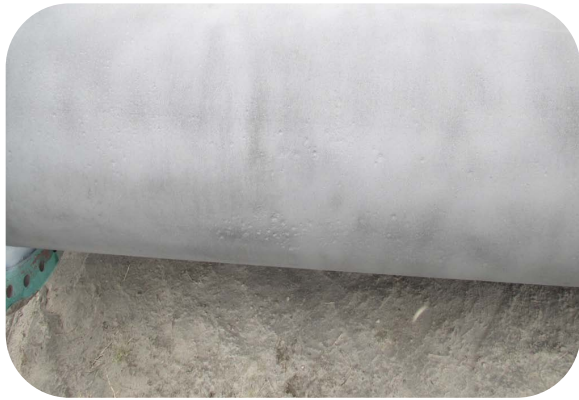
A2710237_External pitting 0.030" on tube legs_9Sept2014

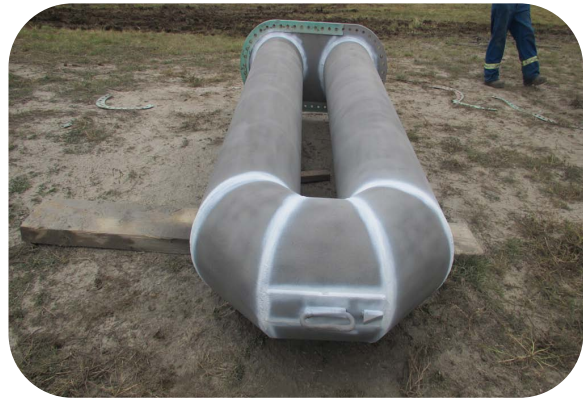
A2710237_MPI of the miter joint section fillet welds_9Sept2014

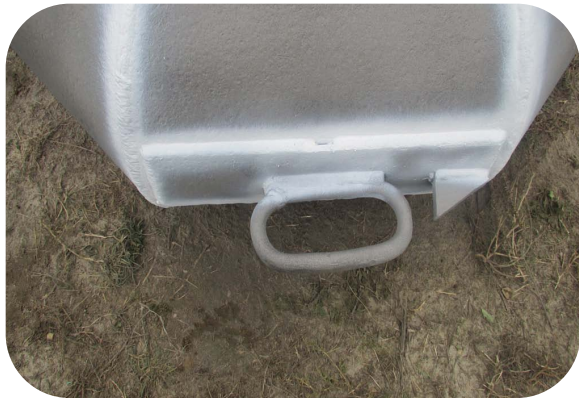
A2710237_MPI of the lifting lug to repad and repad to miter section shell_9Sept2014
