VI VE MT VESSEL INSPECTION REPORT

CLIENT	CNRL 2500, 855 - 2nd Street SW Calgary, Ab T2P 4J8	A Number	A2710237
CLIENT REP	Kyle Huculak RALSTON 5-14 (1339)	Ser Number	L-8-325
		Equipment	GROUP TREATER
		Inspec Date m/d/y	09/08/2015
		Facility	RALSTON 5-14 BATTERY
		LSD	05-14-018-10W4 BATTERY

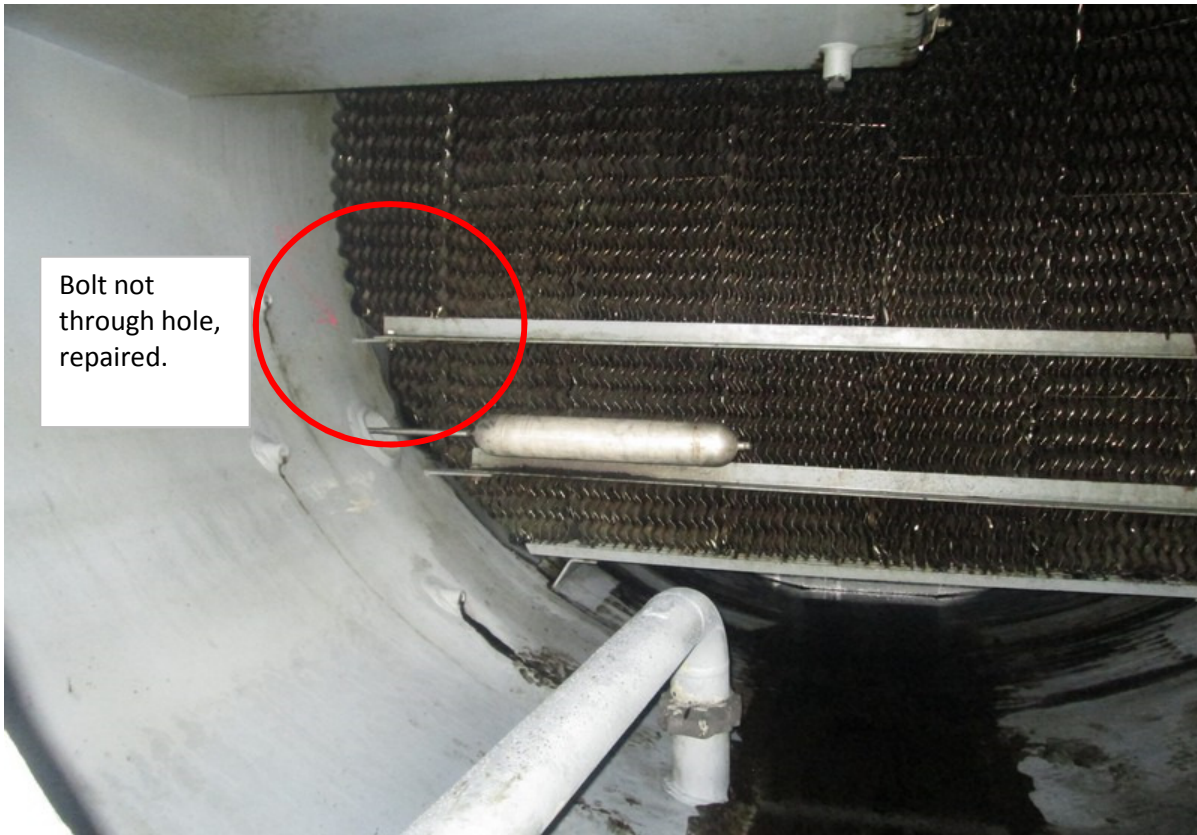
G	F	P	NA	Comments
Coating - Assess coating. Describe area coated, general condition of coating. Look at nozzles, coupling, and areas of most severe corrosion to ensure coating is intact. If coating is in poor condition make decision now if re-coating necessary? If so, when?	X				A few holidays along 6:00 shell, cleaned and Devoe 142 applied.
Anodes - How many, type, condition. % consumed. Are they being replaced?	X				Anodes 70% remaining.
Internal Piping - Is there any? If so, carbon or stainless steel. Describe condition, dents, corrosion, erosion, etc. Ensure supports are secure and any bolts are suitable for future use.	X				Internal piping straight, no corrosion.
Trays - How many? Type of material. Are valves in place. Check for erosion/corrosion; wear on tray, valve legs. Cleanliness?				X	
Baffles, deflector plates, etc. - If present, describe condition. Look closely at welds attached to vessel wall.	X				Internal baffle separating vessel sections is fairly clean. One bolt on west end inlet baffle was out of place, another corroded. Both were repaired.

Bolt not through hole, repaired.

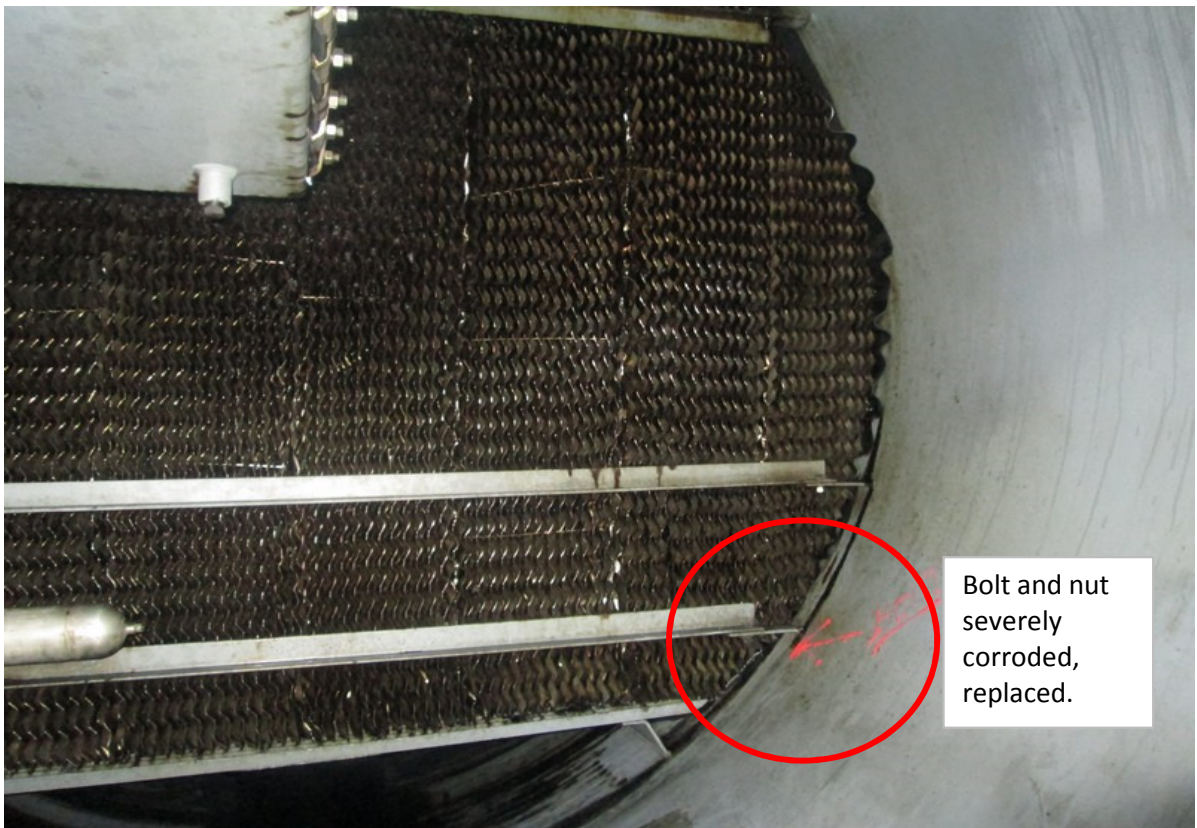
Bolt and nut severely corroded, replaced.

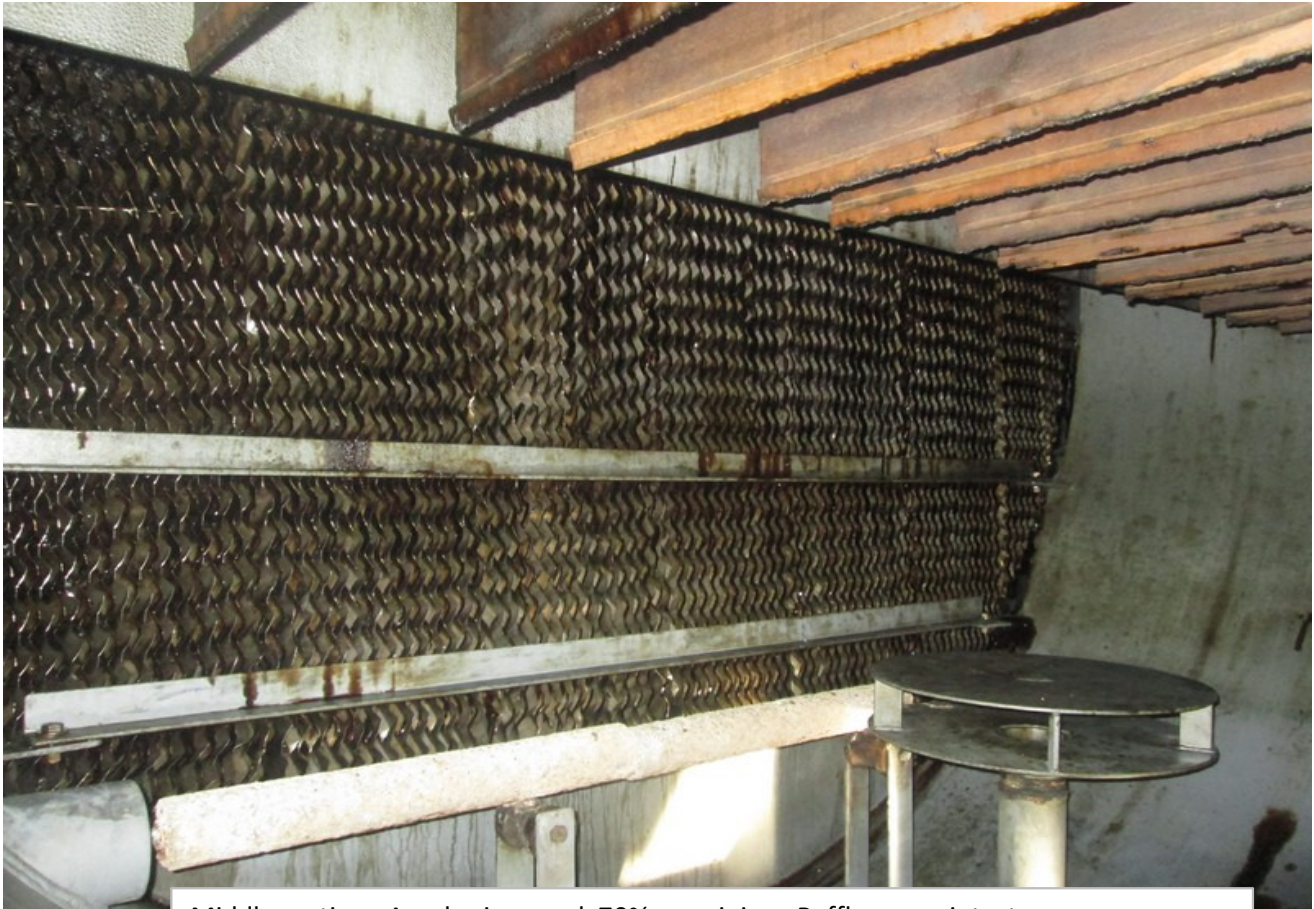
Middle section. Anodes in vessel, 70% remaining. Baffle group intact.

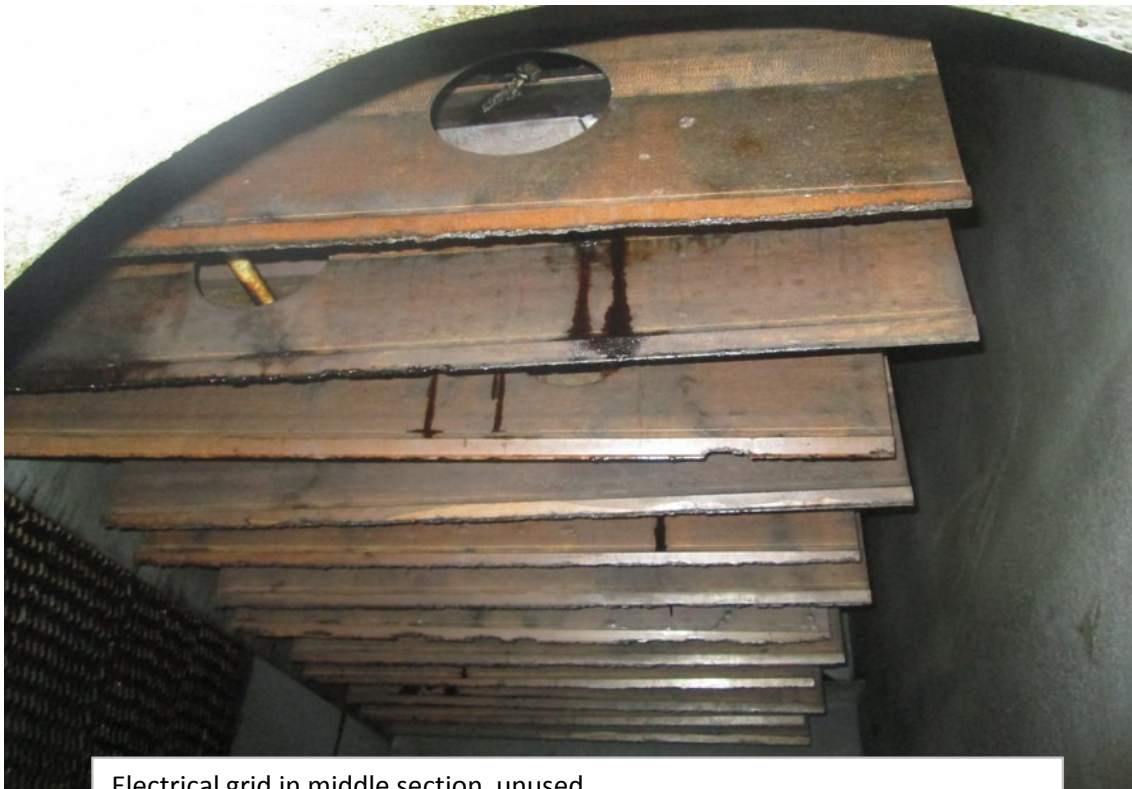
Electrical grid in middle section, unused.

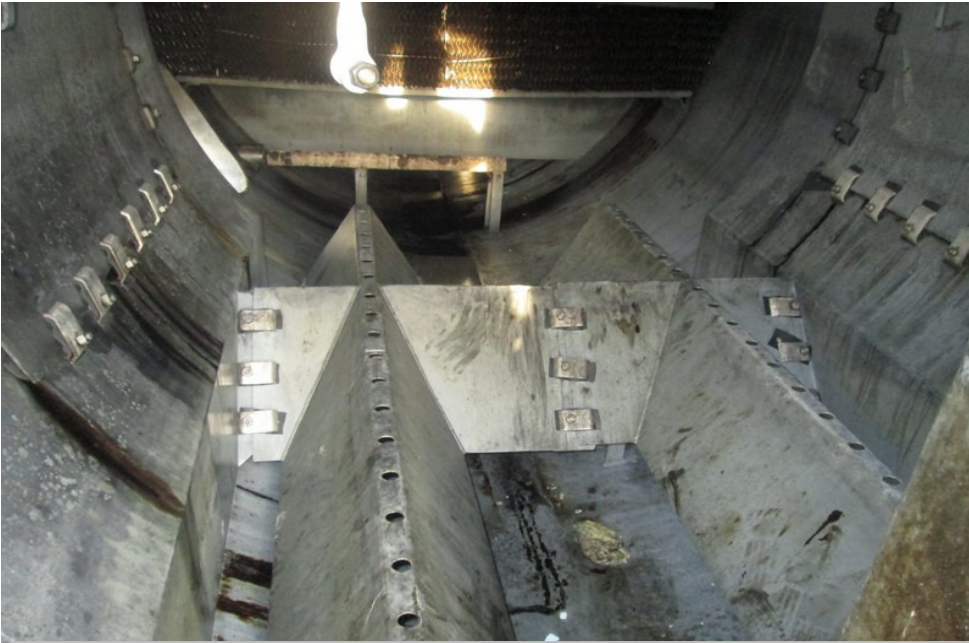
V-shrouds below firetubes are in good condition.

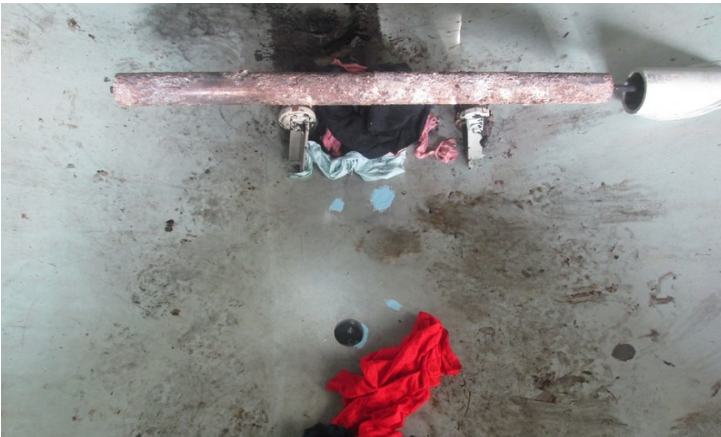
INTERNAL OBSERBATIONS Shell had some 6:00 holidays, cleaned and Devoe 142 applied. Firetube MT examination showed no cracks.
EXTERNAL OBSERVATIONS 2 west anchor bolts loose. MT firetube, no cracks.

Coating holidays at 6:00 in shell and on manway cleaned and Devco 142 applied.
