A2710237_Name plate_10Oct2012

Field Inspection Report

| Client | CNRL | | Date of Inspection | October 10, 2012 | | | | | |
| Equipment | Group Treater & Firetube | | Location | Ralston Battery | | | | | |

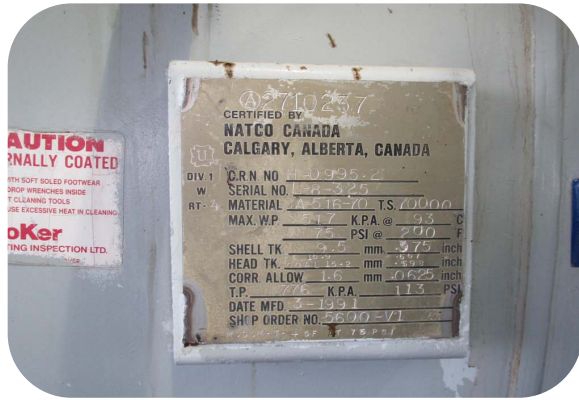
- Name plate was attached and readable.
- External paint was in good condition.
- External insulation needs to be replaced on the South East Middle section.

A2710237_Name plate_10Oct2012

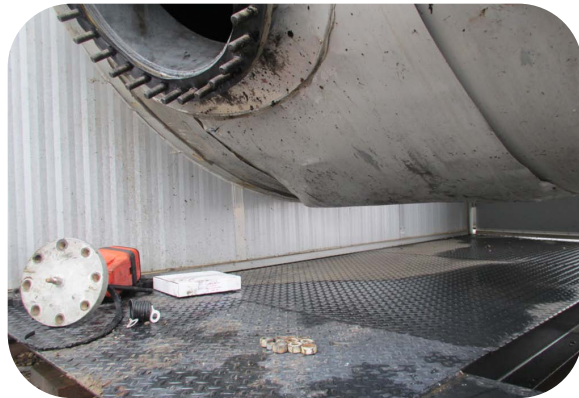
A2710237_Damaged insulation_10Oct2012

Repair/Replace damaged section of insulation.

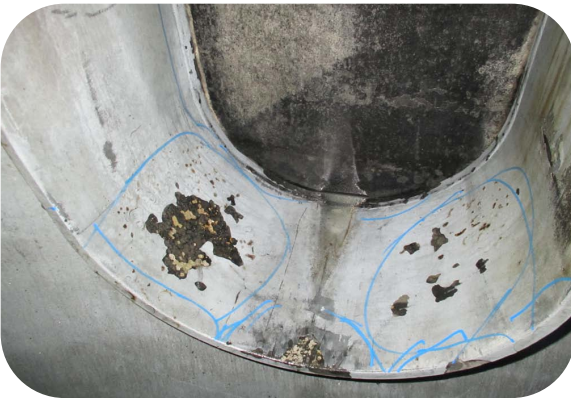
- East Firetube manway was in good shape
- Manway nozzle, cover and gasket surfaces were in good shape.
- Blind flange manway has coating holidays with corrosion present 0.050" on manway nozzle NE section 6" X 6" in size.
- Firetube supports were intact and in good condition.
- Anode rollers were in good shape. Anode supports in good condition and hangers had all bolting in place.
- Anodes were replaced at the time of inspection.
- Internal nozzles were in good shape with no corrosion present.
- Chevron wafer supports were intact and secure.
- Horse shoe diffuser was secure and all bolting hardware intact.
- Thermocouple was intact and secure.
- South East manway cover in good condition.

A2710237_Sealed manway nozzle pitting_10Oct2012

Carry out all required coating repairs.

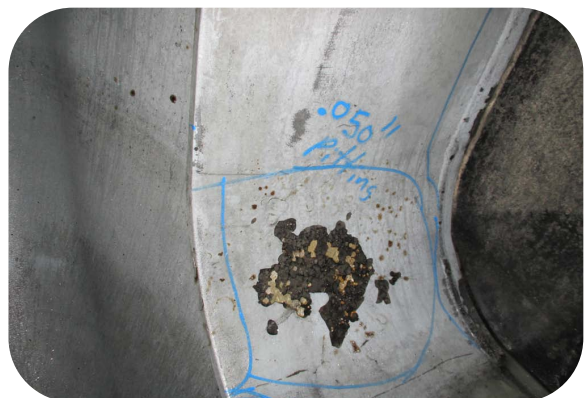
A2710237_Pitting 0.050" deep_10Oct2012

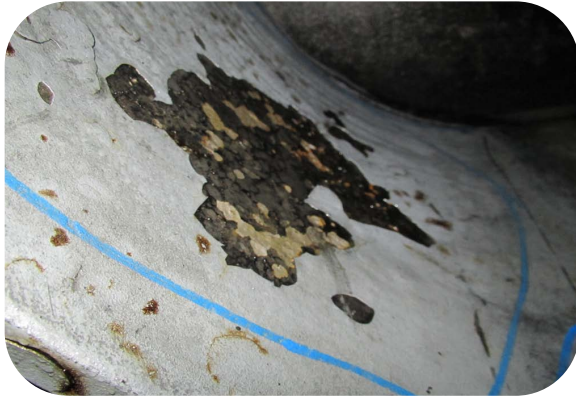
A2710237_Close up of the nozzle pitting_10Oct2012

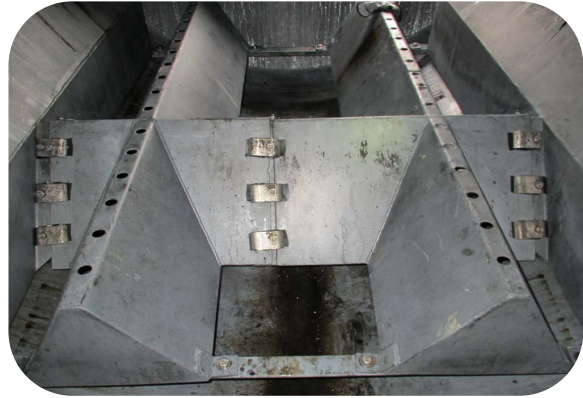
A2710237_Firetube supports_10Oct2012

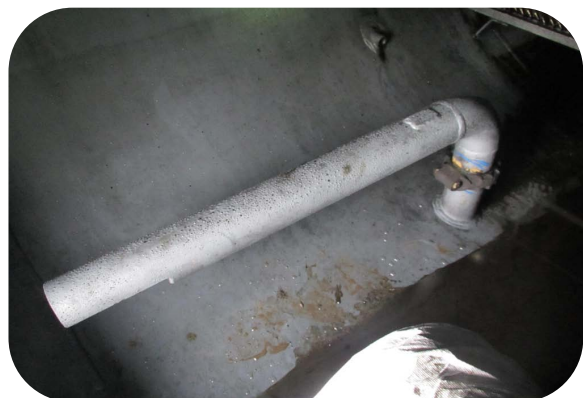
- Manway davit arm was in good working order.
- Manway nozzle, cover and gasket surfaces were in good shape.
- Head and shell coating was in good shape with no pitting.
- No internal corrosion or erosion found.
- Oil collection box was in good shape, all bolting in place and secure.
- Internal nozzles were in good shape.
- Minor coating repair on manway which was carried out at the time of inspection.
- Level float gauge was intact and the nozzles in good shape.
- Chevron wafer supports were intact and secure. Screens were clean.
- 3" Outlet water dump has severe corrosion at the vik clamp.

A2710237_3" Water dump_10Oct2012

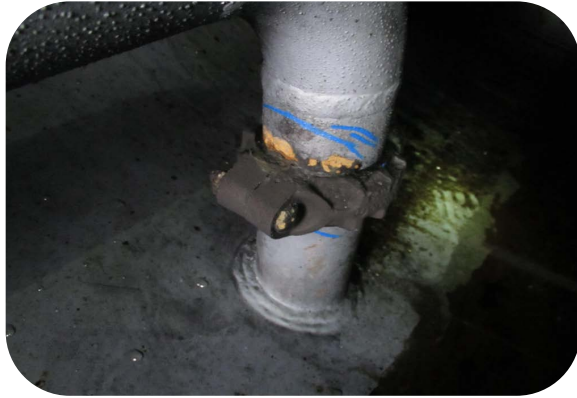
A2710237_Severe corrosion of the vic clamp_10Oct2012

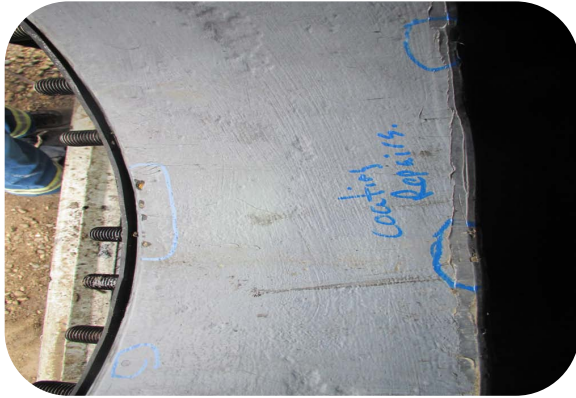
A2710237_Coating repairs on the manway nozzle_10Oct2012

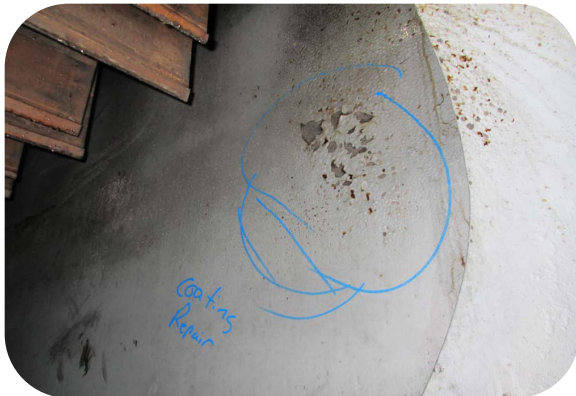
- Manway nozzle, cover and gasket surfaces were in good shape.
- Davit arm was in good working order.
- Coating repair required on the weir plate.
- Inlet diverter plate was intact and secure.
- Level gauge was intact and secure and the nozzle in good shape.

A2710237_Coating repair on weir plate_10Oct2012

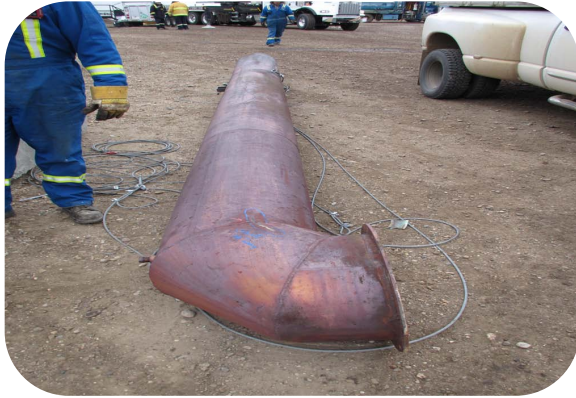
- Visual inspection on stack identified a 10" long crack that will require welding repairs. Also a smaller crack on the saddle weld that also needs welding repairs.

A2710237_Stack_10Oct2012

Carry out welding repairs to the stack.

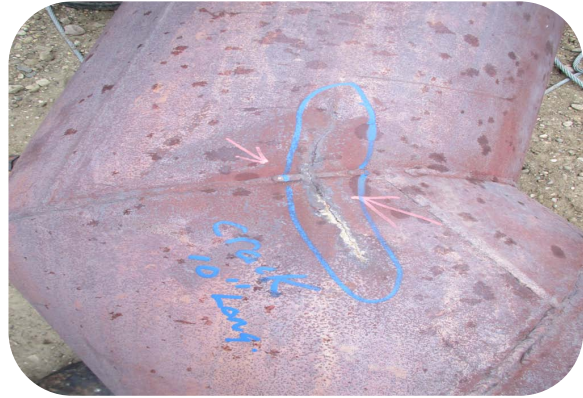
A2710237_10" Crack identified_10Oct2012

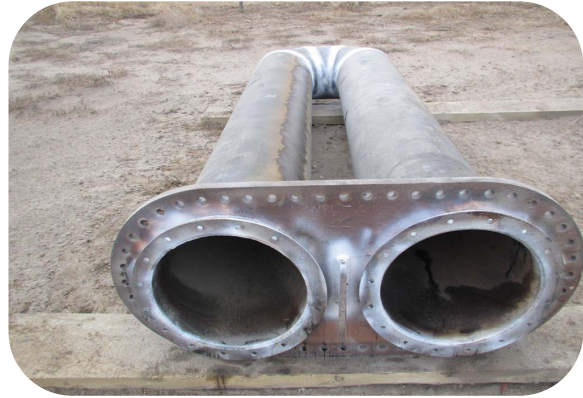
- 18" Internal firetube was pulled and inspected by VI, VE, UT and MT
- 100% MPI revealed no areas of concern; see attached MPI Report.
- No internal/external pitting noted.
- UT inspection found no areas of concern; see attached UT Report.

A2710237_18" Internal firetube_10Oct2012

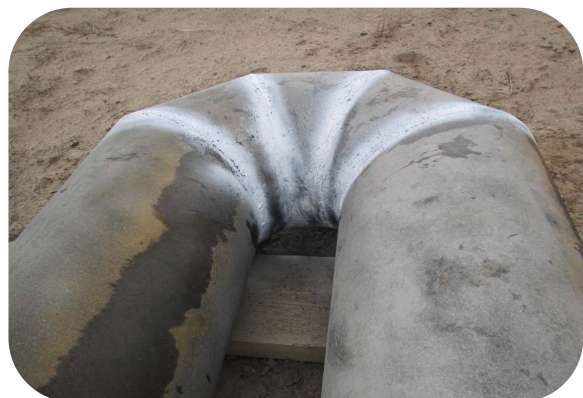
A2710237_MPI of the miter
joints_10Oct2012

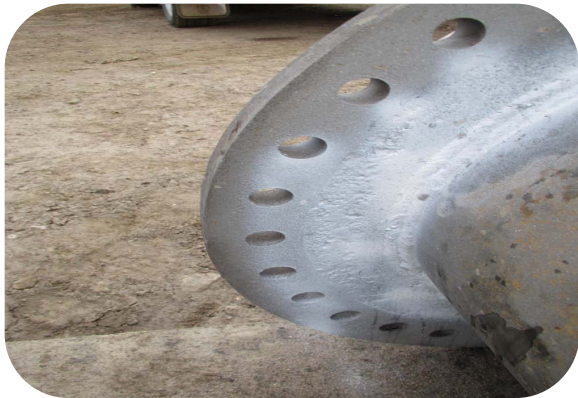
A2710237_No indications found_10Oct2012
