**PRESSURE VESSEL  
VISUAL INSPECTION  
REPORT**

Report #: **156732-MD-50**  
 Inspect Date: 03/20/2012  
 Page: 1 of 14  
 Insp. Co. Job #: 156732

Insp. Comp: Matrix Inspection District: Grande Prairie - North Field: Firebird  
 Location: 14-01-098-08W6 Unit / Skid #: 15330 LSD: 14-01-098-08W6  
 Jurisdiction #: A0516951 Equip Tag #: HS Serial #: HS-12472  
 CRN #: R8469.21 Nat'l Bd #: N/A Year Built: 2004  
 Manufacturer: Larsen & D'Amico Mfg. Ltd Equipment Description: Other: Horizontal Separator  
 Status: In Service - Equip. Type: Vessel: Separator Service: Sweet  
 MAWP Shell: 1440 Psi @ 127 °F Volume: N/A Code Stamp:  Y  N  
 MAWP Tube: @ Height/Length: 184 in. Insulated:  Y  N  
 MDMT: -20 °F RT: RT-1 Size/Diameter.: 48 in. O.D. PWHT:  Y  N  
 Support Saddle Vessel on Original CNRL Inventory List:  Y  N Manway:  Y  N  
 C.A.: 0.125 in. Coated: N/A Clad: N/A J.E.: 1.00 Remote Access:  - Winter Road

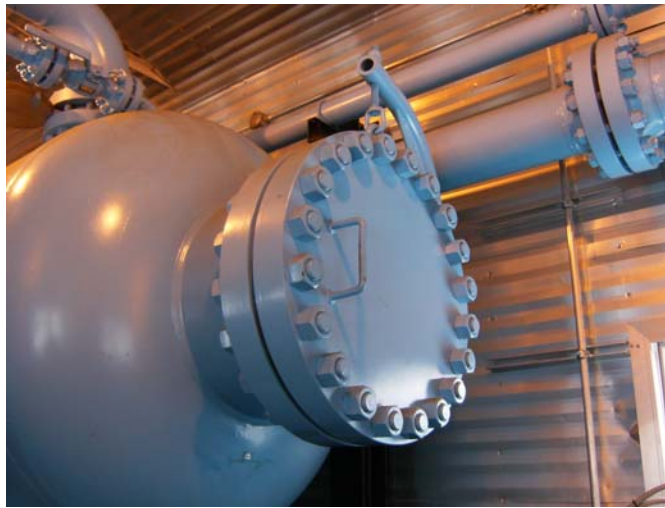
The manway is located on the South head with the davit arm and hardware in acceptable condition

03 manway overview

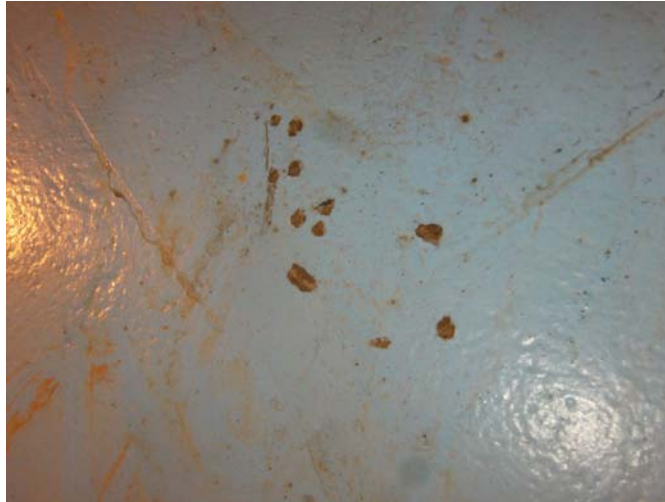
The coating is flaking and chipped on the top shell exposing the base metal with very minor surface corrosion

04 surface corrosion

Clean and touch up the coating to aid in the protection against corrosion  
 Tighten loose bolt on PSV discharge piping blind flange

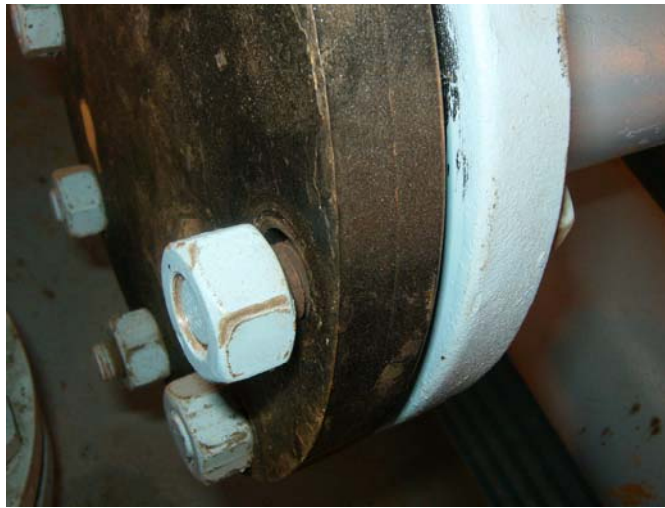
The PSV discharge piping has a blind flange, (that does not obstruct flow) with a loose stud and nut

**05 loose nut**

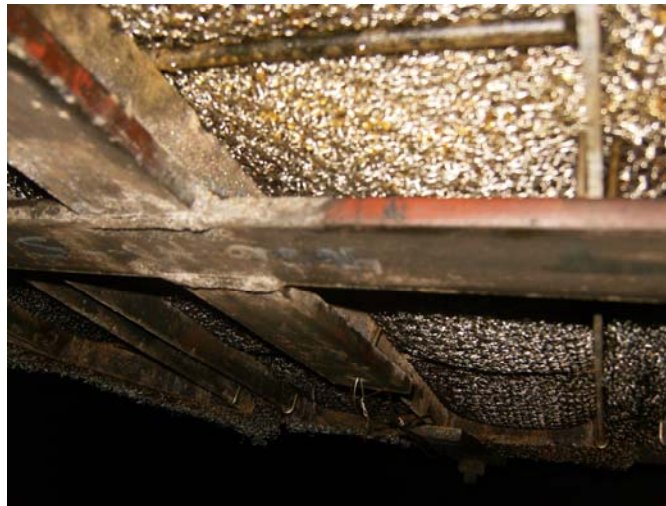
The demister pad is misaligned from the original set position with some minor build-up noted in the demister pad

08 misaligned demister pad

Realign the demister pad to the original rest position

TA 2012 - the demister pad was realigned

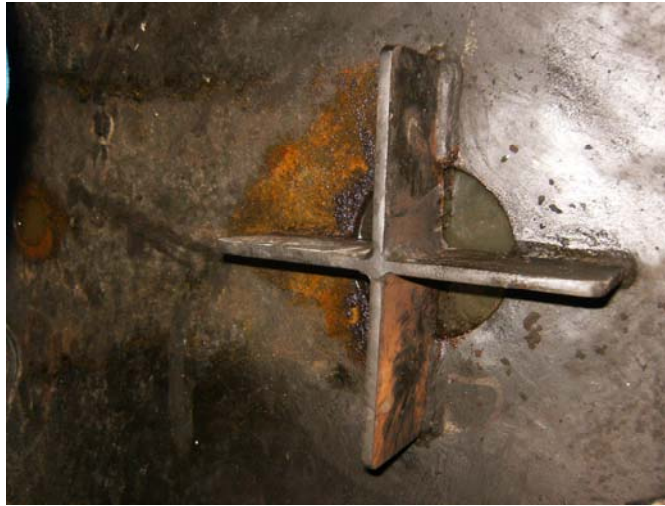
The overall condition of the vessel is good, with minor flash corrosion from wash out and oxidation

09 flash corrosion around drain

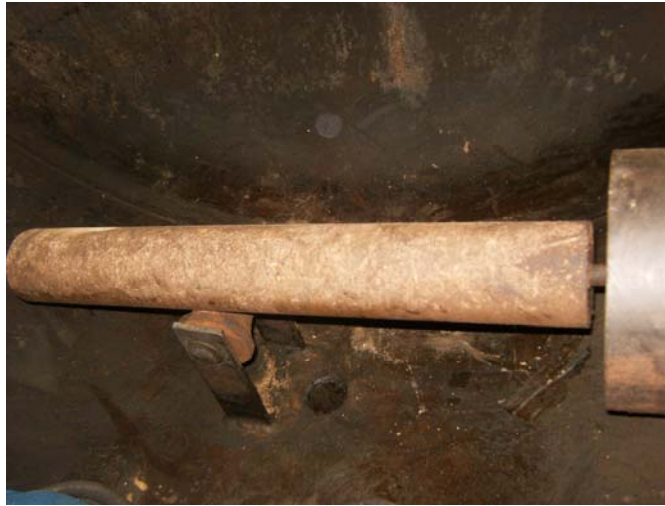
New anodes were installed during the 2012 TA

**11 anode overview**
