**PRESSURE VESSEL
VISUAL INSPECTION
REPORT**

Report #: **156732-MD-52**
 Inspect Date: 06/06/2012
 Page: 1 of 17
 Insp. Co. Job #: 156732

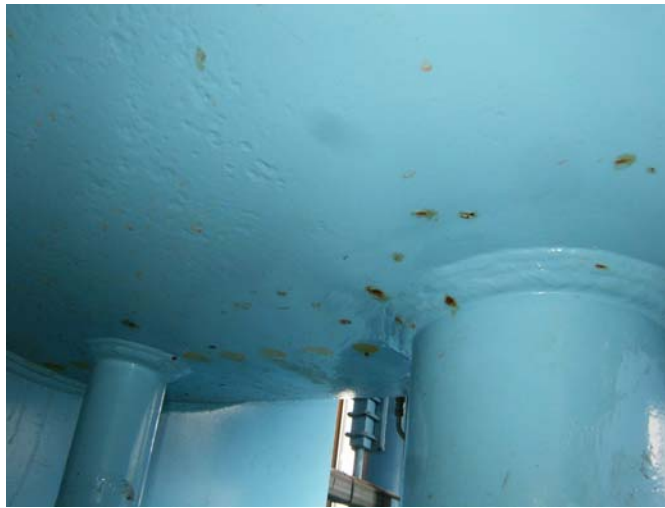
The coating is chipped and flaked exposing the base metal to minor surface corrosion with no evidence of pitting noted.

05 coating deterioration

Clean loose coating and touch-up to aid in corrosion protection
 Confirm with operations that the pressure and temperature do not exceed gauge ratings. Replace as required

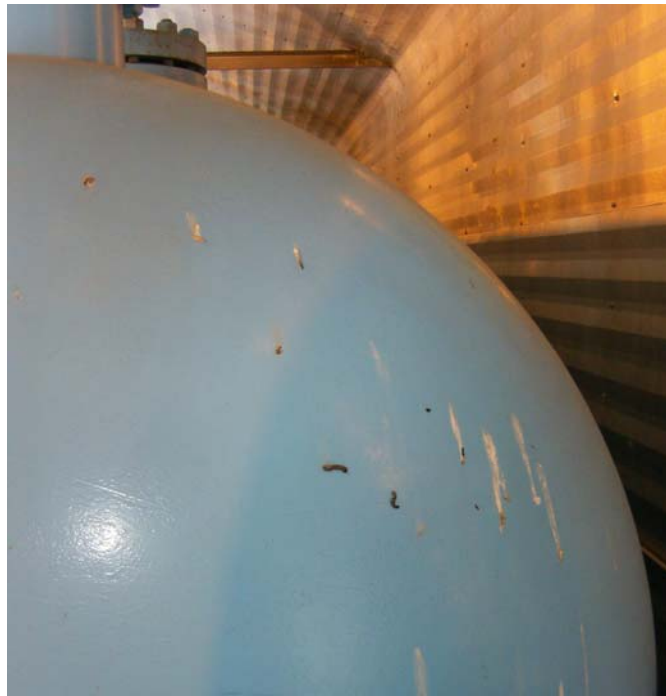
Dust and bird turds on top shell and head sections which may accelerate the corrosion rate

08 bird turds

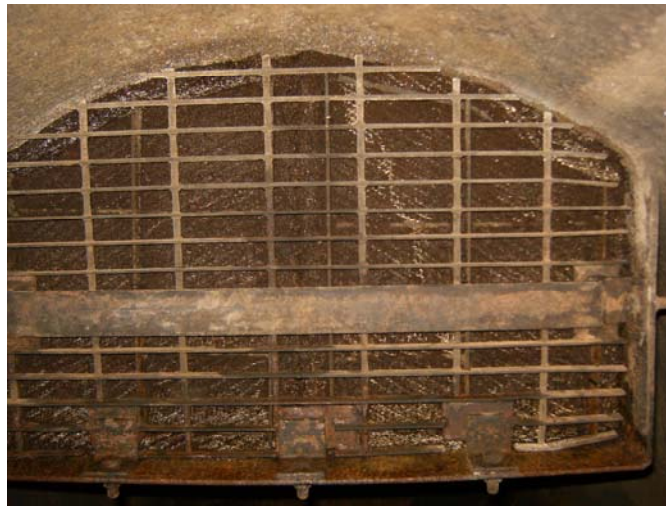
The demister was found to be plugged with solids with mild segregation

11 plugged demister

Remove, clean and reinstall the demister pad or replace the demister pad
 Remove all solids trapped the demister pad on the support plate
 Monitor the pitting during the next TA to determine if it has grown in depth, size or severity

TA 2012 - The demister pad was removed, cleaned and reinstalled after removing all solids

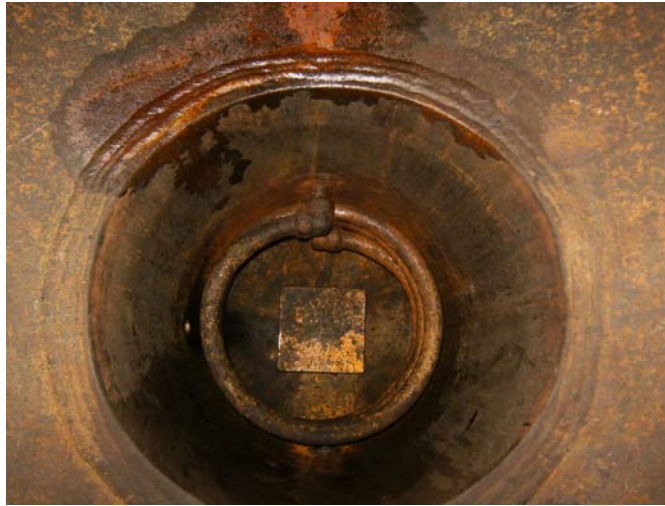
The heating coil in the drain boot is in acceptable condition with no service related issues

12 coil & boot overview

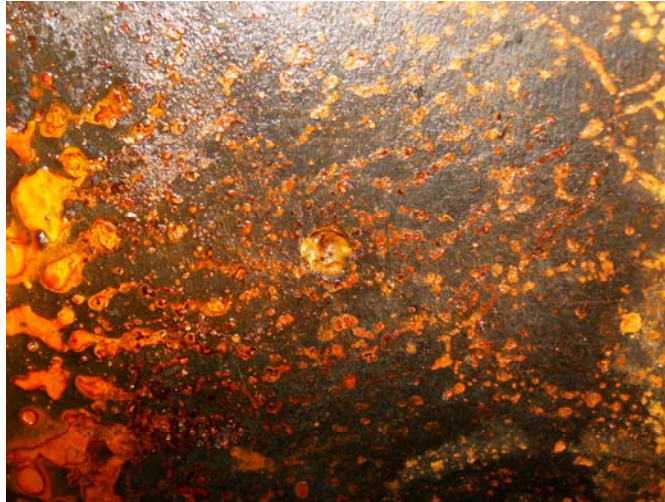
0.062" deep by 0.250" diameter pit recorded on the bottom shell (6 o'clock position) below the inlet diverter plate. Multiple locations below the diverter plate on the shell has near surface pitting

13 pitting in bottom shell

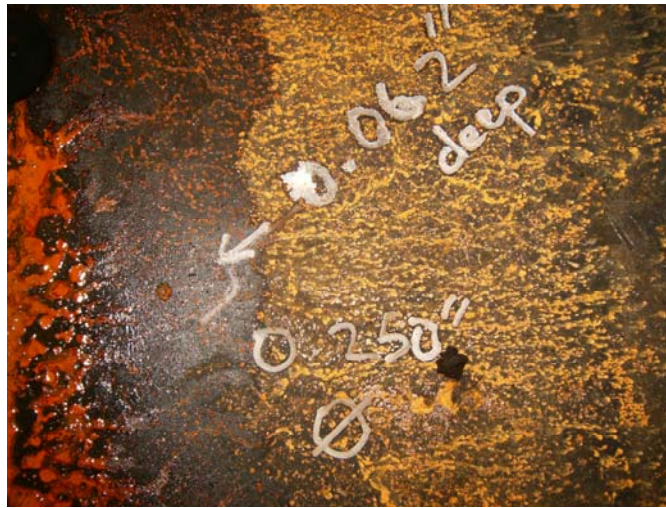
14 largest recorded pit

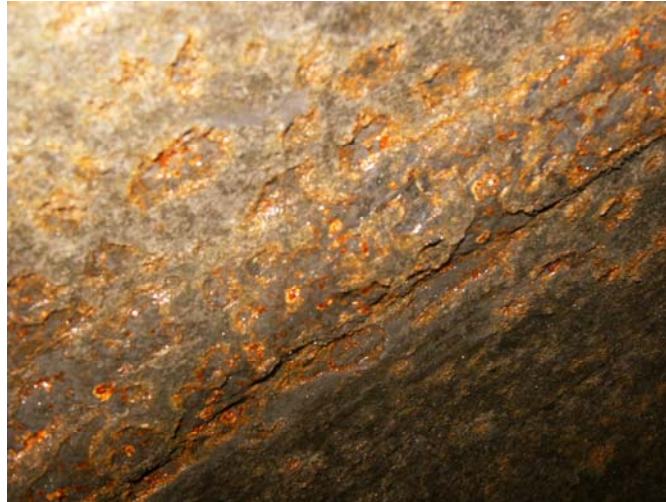
There are multiple locations in the vapour section of the vessel with near surface to ~0.015" pitting due to corrosion on and adjacent to the long seams and circ welds.

15 corrosion on circ seam

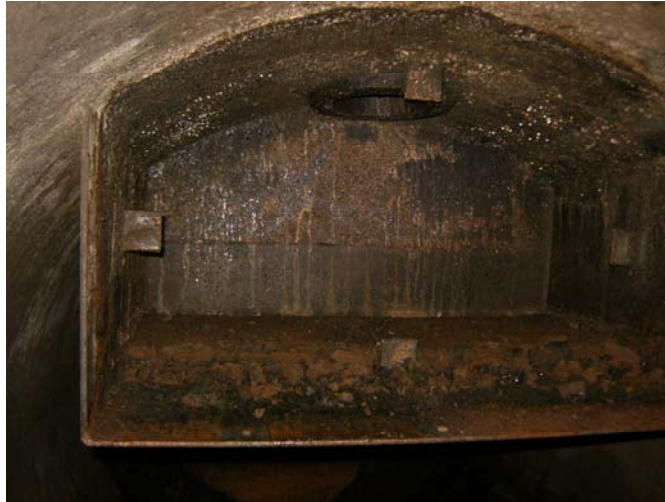
17 demister removed
