**Canadian Natural Resources Limited  
GENERAL PRESSURE VESSEL INFORMATION**

**Job # 10.114022 / 10.115211**

District: <b>Fort St. John BC</b>	Skid No.
Facility: <b>Babcock Mountain Gas Gathering</b>	Location (LSD): <b>a-100-K / 93-I-15</b>
Tank Name / Equipment Number: <b>Produced Water Tank (Double wall / 400 BBL)</b>	
Orientation: <b>Vertical</b>	
Status: <b>In Service</b>	<b>Regulatory Inspection</b>

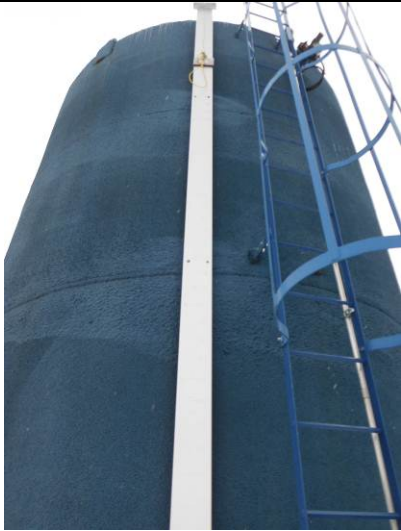
Level board – faded, minimal legibility

<b>Recommendations or corrective actions : Vessel is Fit for Service or describe corrective actions required)</b> (MIC to review corrective actions with Operations, discuss with Chief Inspector where necessary, and get remedial action implemented) <b>Recommendations:</b> 1. Consider replacing level gauge board. <b>Summary:</b> Tank is in overall good condition, visual external inspection carried out. <b>Tank is fit for service</b>

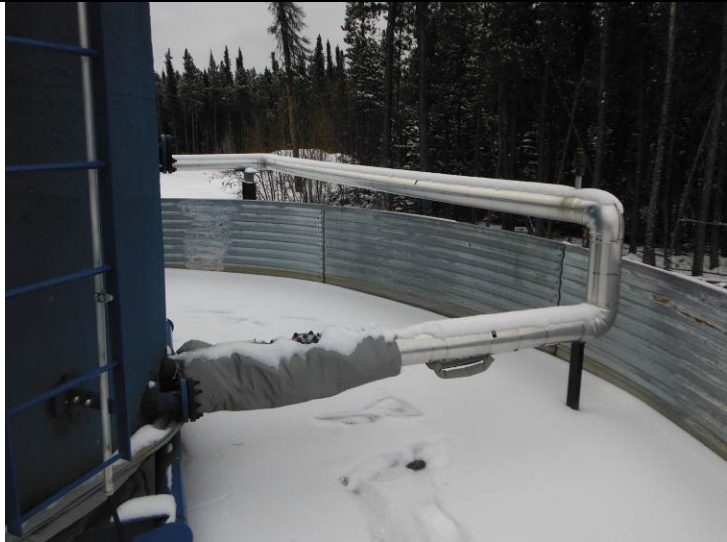
Valves and piping well supported

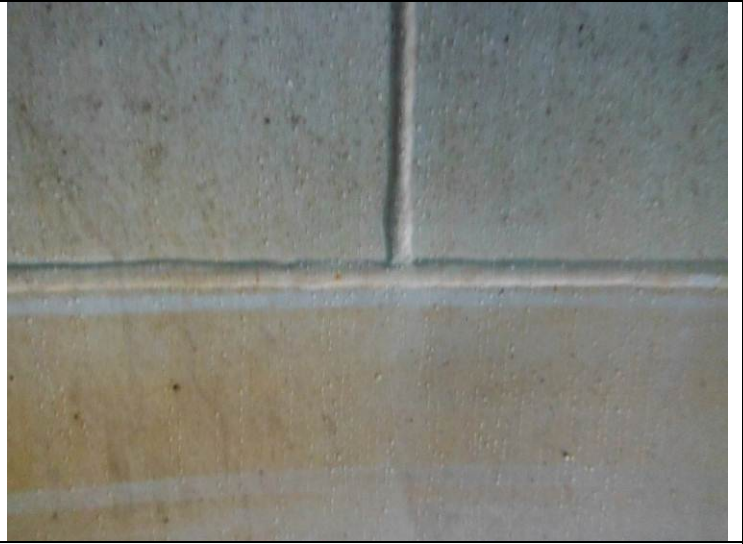
**Shell tee weld - typical condition, no issues**

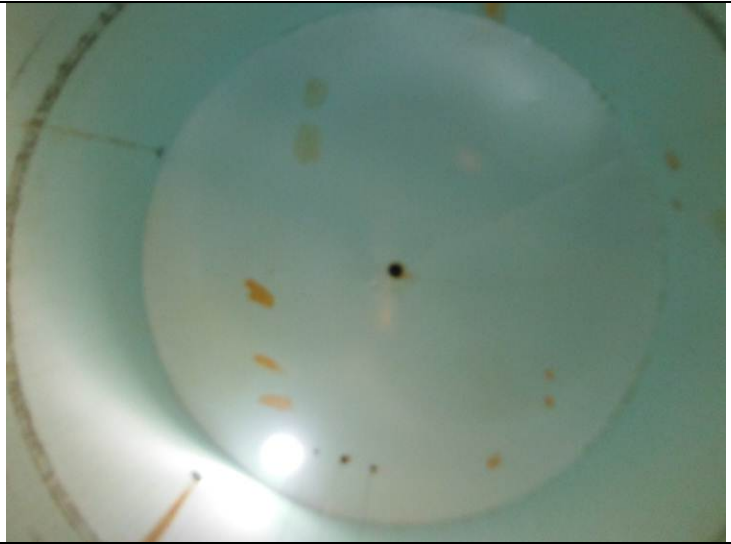
**Deck**

<b>Roof / Deck</b> Record location, size and depth of all erosion, corrosion or mechanical damage. Describe General condition.	X				<b>Good condition. No corrosion. No damage.</b>
<b>Float</b>	X				<b>Float is intact and in place with free movement</b>
<b>Man Way Access</b>	X				<b>One coating chip repaired at time of inspection.</b>
<b>Nozzles</b>	X				<b>Nozzles are coated, unobstructed and in good condition - Stainless steel suction nozzles – no damage.</b>
<b>Thermal Probe</b>	X				<b>Good condition. No damage.</b>
<b>Welds</b> Inspect all welds, including attachment welds. Record all service-related damages and if there is any discuss with Chief Inspector before closing.	X				<b>All welds are in coated and in good condition.</b>
<b>NDE Inspections</b>				X	<b>No internal NDE at this time</b>
<b>Other: Firetube</b>	X				<b>Firetube: MT, VE carried out. MT: No cracking detected VE: No external corrosion, pitting or damaged noted.</b>

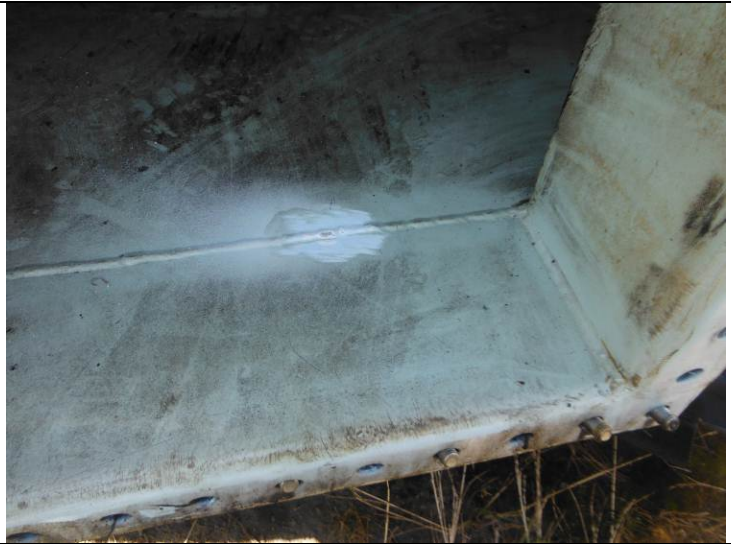
<b>Internal Inspection Items</b>	<b>G</b>	<b>F</b>	<b>P</b>	<b>N/A</b>	<b>Comments</b>
<b>Coating</b> Assess coating. Describe area coated, general condition of coating.	X				<b>Tank is 100% internally coated with epoxy. Good condition. One area of chipped coating at manway repaired at time of inspection.</b>
<b>Anodes.</b> How many, type, condition. % consumed. Are they being replaced?				X	<b>None.</b>
<b>Internal Piping</b> Is there any? If so, carbon or stainless steel. Describe condition, dents, corrosion, erosion, etc. Ensure supports are secure and any bolts are suitable for future use.				X	<b>None.</b>
<b>Bottom</b> Record location, size and depth of all erosion, corrosion or mechanical damage. Describe General condition.	X				<b>Good condition – no areas of failed coating. No damage.</b>
<b>Shell Sections</b> Record number of shell sections. Record location, size and depth of all erosion, corrosion or mechanical damage. Describe General condition.	X				<b>4 shell sections in good condition. No corrosion. No damage.</b>

**Coating chip repaired at time of inspection**

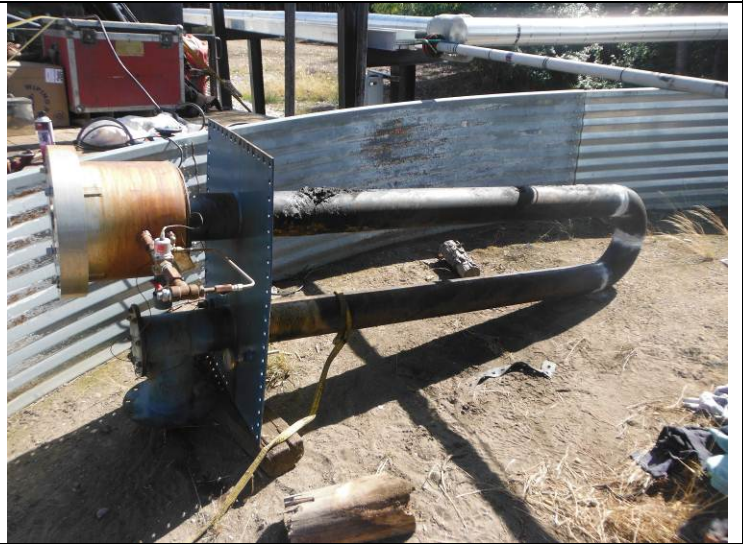
**Fire tube - no cracking detected**
