**Canadian Natural Resources Limited  
GENERAL PRESSURE VESSEL INFORMATION**

**JOB# 10.111880**

District: <b>Grande Prairie, AB</b>	Skid No.
Facility: <b>East Knopcik Gas Gathering</b>	Location (LSD): <b>11-28-74-10-W6M</b>
Vessel Name Equipment Number: <b>Inlet Separator</b>	
Orientation: <b>Horizontal</b>	
Status: <b>In Service</b>	<b>Regulatory Inspection</b>

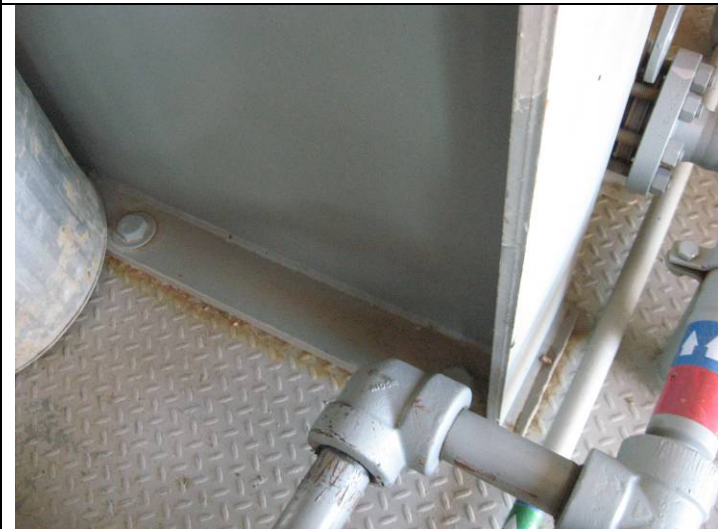
Anchor bolts

<b>Anchor Bolts</b> Hammer tap to ensure secure. Look for cracking in treads or signs of deformation.	X				<b>Firmly bolted to skid deck.</b>
<b>Concrete foundation</b> Check for cracks, spalling, etc.				X	<b>No concrete.</b>
<b>Ladder / Platform</b> Describe general condition, ensure support is secure to vessel, describe any hazards.				X	<b>None</b>
<b>Nozzle</b> Assess paint, look for leakage, and ensure stud threads are fully engaged. Record any damage, deflection, etc. Are nozzles gusseted?	X				<b>All studs are fully engaged to nuts – no short bolts.</b> <b>Nozzles are not gusseted.</b> <b>Paint in good condition – no exposed metal.</b>
<b>Gauges</b> Ensure gauges are visible, working, no leakage, and suitable for range of MAWP/ Temp.	X				<b>Pressure gauge attached.</b> <b>Pressure gauge: 0 to 1000 PSI.</b> <b>Temp gauge: No temp gauge.</b>
<b>External Piping</b> Ensure pipe is well supported. All clamps, supports, shoes, etc. in place. Look for evidence of structural overload, deflection, etc. Paint condition, external corrosion?	X				<b>Piping is well supported, all clamps, supports and shoes are in place.</b> <b>No structural overloads or deflections noted.</b> <b>Most of the immediate piping is attached – to and from skid is not tied in yet.</b>

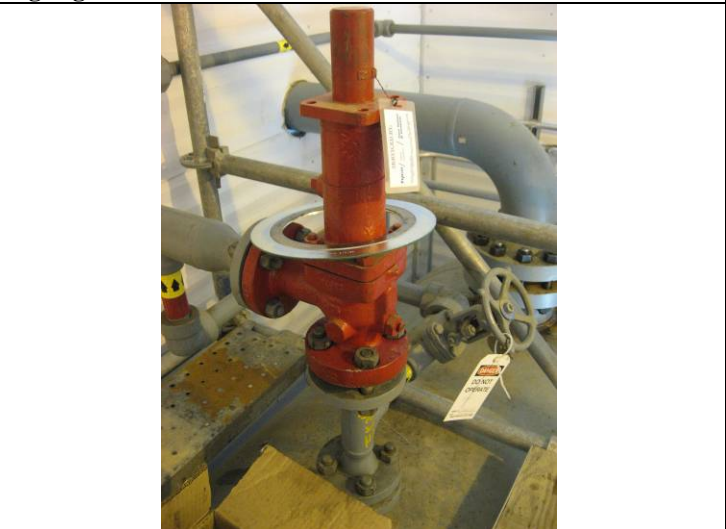
<b>Valving</b> Ensure no leaks are visible. Valves are properly supported and chained if necessary.	X				<b>Valves are well supported – no evidence of leaking.</b>
<b>PSV</b> Ensure PSV is set at pressure at or below that of vessel.	X				<b>Located on top shell – set at MAWP of vessel.</b> <b>Discharge piping is same size as valve outlet.</b> <b>Valve is properly supported and routed. No block valve.</b> <b>PSV seal in place.</b>
<b>NDE methods</b> Was UT/ MPI done on vessel (MI coordinator to review results)	X				<b>Suncor corrosion survey: Ultrasonic thickness inspection carried out, no metal thickness detected below nominal.</b>
<b>Recommendations or corrective actions : Vessel is Fit for Service or describe corrective actions required)</b> (MIC to review corrective actions with Operations, discuss with Chief Inspector where necessary, and get remedial action implemented)					
<b>See internal inspection for summary and recommendations.</b>

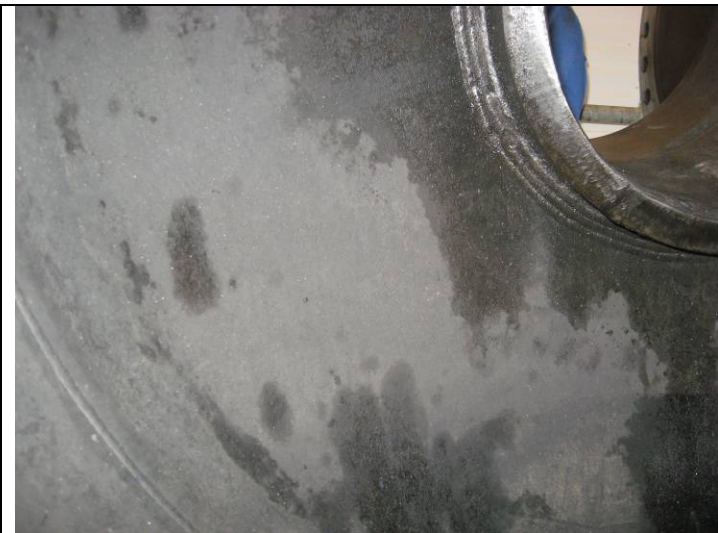
**Man way head**

Internal Inspection Items	G	F	P	N/A	Comments
<b>Coating</b> Assess coating. Describe area coated, general condition of coating.				X	<b>Vessel is not coated internally.</b>
<b>Anodes.</b> How many, type, condition. % consumed. Are they being replaced?				X	<b>No anodes.</b>
<b>Internal Piping</b> Is there any?	X				<b>No internal piping.</b>
<b>Trays</b> How many? Type of material. Are valves in place. Check for erosion/ corrosion; wear on tray valve legs. Cleanliness?				X	<b>No trays.</b>
<b>Baffles, deflector plates, etc.</b> If present, describe condition. Look closely at welds attached to vessel wall.	X				<b>Inlet diffuser is in place and intact. Oil weir intact and in place – is 8 inches in height – located just aft of the water boot.</b>
<b>North Head</b> Note all corrosion, erosion or mechanical damage. (If vessel is horizontal identify direction of this head)	X				<b>Good condition – no corrosion or pitting detected. Man way is located on North head – no corrosion or pitting detected.</b>
