**Canadian Natural Resources Limited  
GENERAL PRESSURE VESSEL INFORMATION**

**Job# 10.118768**

District: <b>Grande Prairie, AB</b>	Skid No.
Facility: <b>Knopcik Compressor Station</b>	Location (LSD): <b>11-28-74-10-W6M</b>
Vessel Name Equipment Number: <b>Inlet Separator</b>	
Orientation: <b>Horizontal</b>	
Status: <b>In Service</b>	<b>Regulatory Inspection</b>

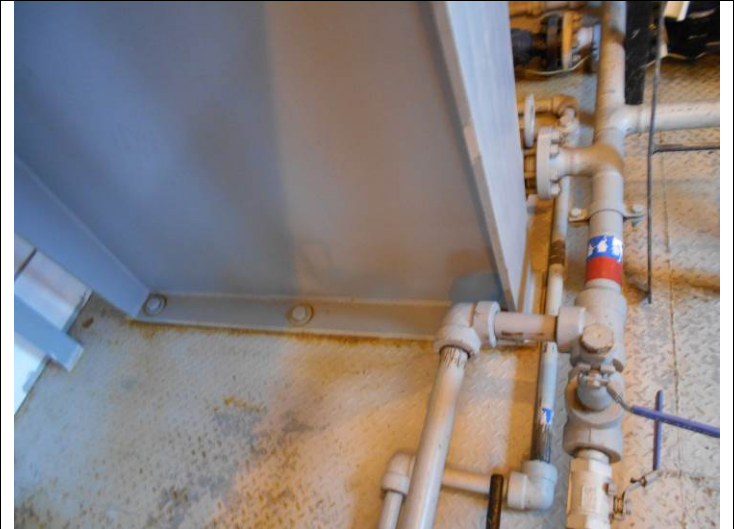
Anchor bolts

<b>Anchor Bolts</b> Hammer tap to ensure secure. Look for cracking in treads or signs of deformation.	X				<b>Firmly bolted to skid deck.</b>
<b>Concrete foundation</b> Check for cracks, spalling, etc.				X	<b>No concrete.</b>
<b>Ladder / Platform</b> Describe general condition, ensure support is secure to vessel, describe any hazards.				X	<b>None</b>
<b>Nozzle</b> Assess paint, look for leakage, and ensure stud threads are fully engaged. Record any damage, deflection, etc. Are nozzles gusseted?	X				<b>All studs are fully engaged to nuts – no short bolts.</b> <b>Nozzles are not gusseted.</b> <b>Paint in good condition – no exposed metal.</b>
<b>Gauges</b> Ensure gauges are visible, working, no leakage, and suitable for range of MAWP/ Temp.	X				<b>Pressure gauge attached.</b> <b>Pressure gauge: 0 to 1000 PSI.</b> <b>Temp gauge: 0 to 250 deg F.</b>
<b>External Piping</b> Ensure pipe is well supported. All clamps, supports, shoes, etc. in place. Look for evidence of structural overload, deflection, etc. Paint condition, external corrosion?	X				<b>Piping is well supported, all clamps, supports and shoes are in place.</b> <b>No structural overloads or deflections noted.</b> <b>Most of the immediate piping is attached – to and from skid is not tied in yet.</b>

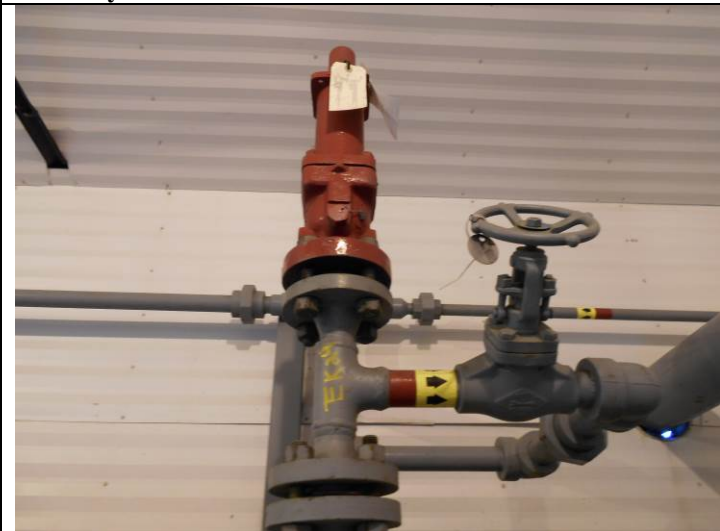
<b>Valving</b> Ensure no leaks are visible. Valves are properly supported and chained if necessary.	X				<b>Valves are well supported – no evidence of leaking.</b>
<b>PSV</b> Ensure PSV is set at pressure at or below that of vessel.	X				<b>Located on top shell – set at MAWP of vessel.</b> <b>Discharge piping is same size as valve outlet.</b> <b>Valve is properly supported and routed. No block valve.</b> <b>PSV seal in place.</b>
<b>NDE methods</b> Was UT/ MPI done on vessel (MI coordinator to review results)	X				<b>Ultrasonic corrosion survey carried out – pipe metal thickness detected below nominal minus corrosion allowance. Thickness calculations carried out:</b> <b>UT point 190 (6” Elbow) – nominal thickness is 11.0mm / min thickness is 9.2mm / T min thickness is 5.9mm.</b>
<p><b>Recommendations or corrective actions: (Vessel is Fit for Service or describe corrective actions required)</b> (MIC to review corrective actions with Operations, discuss with Chief Inspector where necessary, and get remedial action implemented)</p> <p><b>Recommendations:</b> 1. No Recommendation at this time.</p> <p><b>Summary:</b> Vessel is in overall good condition, visual external inspection and ultrasonic corrosion survey carried out – pipe metal thickness detected below nominal minus corrosion allowance. Thickness calculations carried out to ensure sufficient metal exists for safe operation.</p> <p><b>Corrosion rate based on greatest thickness loss (nozzle) 0.025mm per year. Retirement Date to “T”min is year 2245.</b></p> <p><b>Vessel is Fit for Service</b></p>
