**Canadian Natural Resources Limited
GENERAL PRESSURE VESSEL INFORMATION**

Job # 105.00642

District: Grand Prairie	Skid No. Nil
Facility: Clear Hills Gas Plant	Location (LSD): 16-11-88-13 W6M
Vessel Name Equipment Number: Stabilizer Feed Heater	
Orientation: Horizontal	
Status: In service	Regulatory Inspection

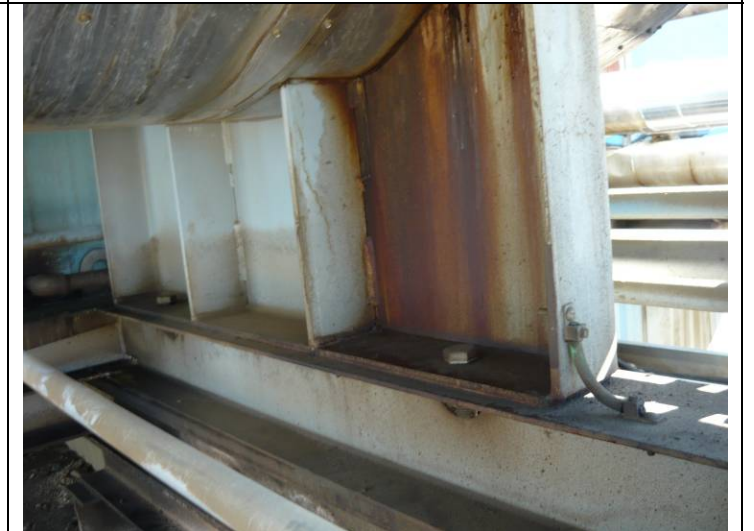
Anchor Bolts Hammer tap to ensure secure. Look for cracking in treads or signs of deformation.	X				Saddle is bolted to skid floor and support structure, No deformation or cracking present.
Concrete foundation Check for cracks, spalling, etc.				X	
Ladder / Platform Describe general condition, ensure support is secure to vessel, describe any hazards.				X	
Nozzle Assess paint, look for leakage, and ensure stud threads are fully engaged. Record any damage, deflection, etc. Are nozzles gusseted?	X				Nozzle paint is in good condition no leaks present. No Stud threads present, no damage or deflection present. One Gusset present on piping off boot.
Gauges Ensure gauges are visible, working, no leakage, and suitable for range of MAWP/Temp.	X				Temperature Gauge is (50-550°C) Suitable for range. Gauge is clear and visible.
External Piping Ensure pipe is well supported. All clamps, supports, shoes, etc. in place. Look for evidence of structural overload, deflection, etc. Paint condition, external corrosion?	X				Piping is well supported and in place. No loose clamps or supports present. No evidence of structural overload or deflection. Paint is in good condition, no exposed metal.
