**Canadian Natural Resources Limited  
GENERAL PRESSURE VESSEL INFORMATION**

**Job # 10.113190**

<b>District: GP South</b>		<b>Skid No.</b>				
<b>Facility: Hamburg Water Injection</b>		<b>Location (LSD): 13-20-96-09 W6M</b>				
<b>Vessel Name &amp; Equipment Number: Line Heater</b>						
<b>Orientation: Horizontal</b>						
<b>Status: In Service</b>		<b>Regulatory Inspection</b>				
<b>PRESSURE VESSEL NAMEPLATE DATA</b>						
"A" or "G" or "S" (Sask.) or BC Registration Number. <b>A0504891</b>		CRN Number <b>D 4268.213</b>				
Vessel serial number: CB-13260		Size: 48 in x 16 ft				
Shell thickness: 6.4 mm		Shell material: SA-36				
Head thickness:		Head material: SA-36				
Tube wall thickness: S80 / S160		Tube material:				
Tube diameter: 3.5 OD		Tube length:				
Channel thickness:		Channel material:				
Design pressure	Shell: Atmos	Operating pressure	Shell:			
	Tubes: 21622 kPa (3136 psi) 11183 kPa (1622 psi)		Tubes:			
Design Temp.	Shell: 93°C	Operating temperature	Shell:			
	Tubes: 93°C		Tubes:

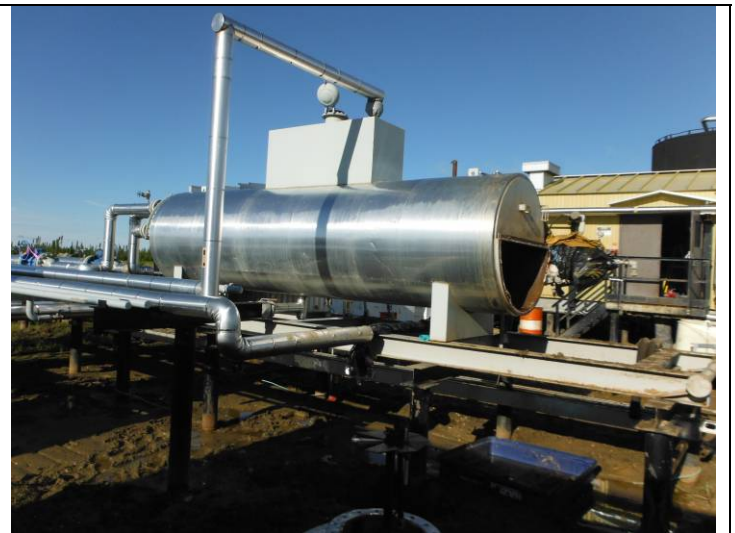
Overview -Vessel

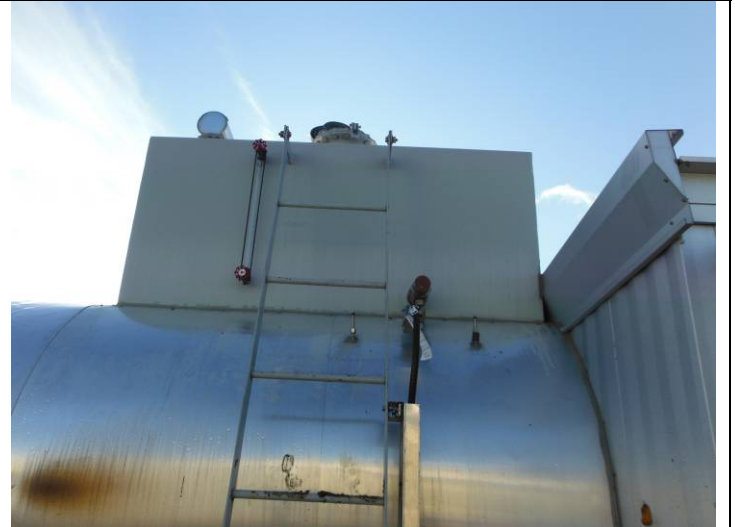
Expansion tank and liquid level

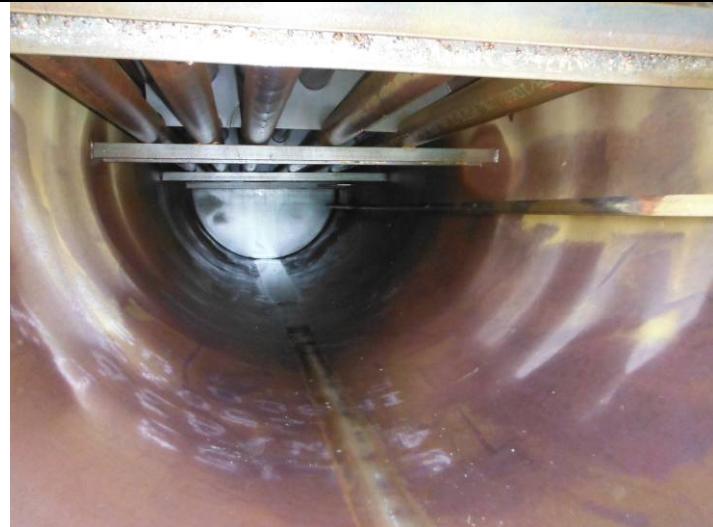
Overview - Shell internal

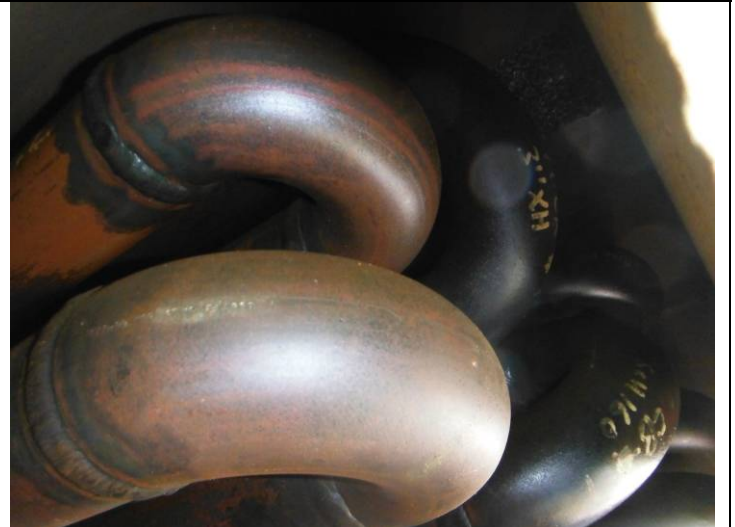
<b>NDE methods</b> Was UT/ MPI done on vessel (MI coordinator to review results)	X				<b>Ultrasonic thickness survey carried out on coil 3 inch return bends and inlet elbows – no metal thickness detected below nominal minus corrosion allowance.</b>
<b>Recommendations or corrective actions (indicate if fit for service)</b> <b>Recommendations:</b> No recommendations at this time. <b>Summary:</b> Vessel is in overall good condition, visual external, visual internal inspection and ultrasonic corrosion survey performed – no metal thickness detected below nominal minus corrosion allowance. <b>Vessel is fit for service.</b>

Coil 3 inch return bends

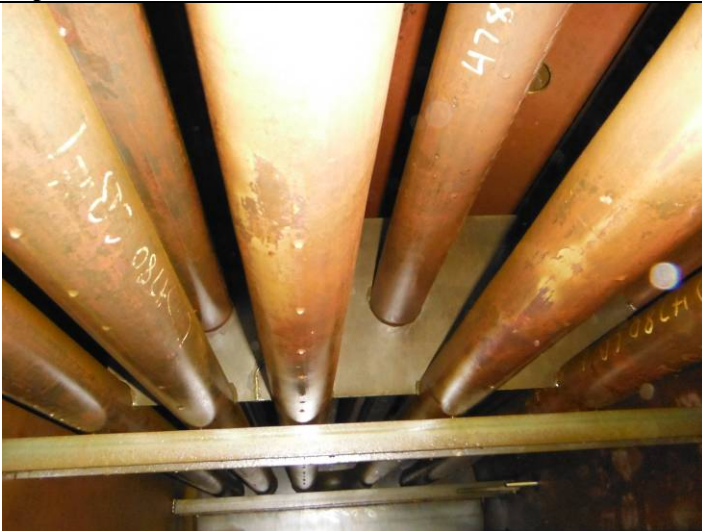
**Overview - Tubes**

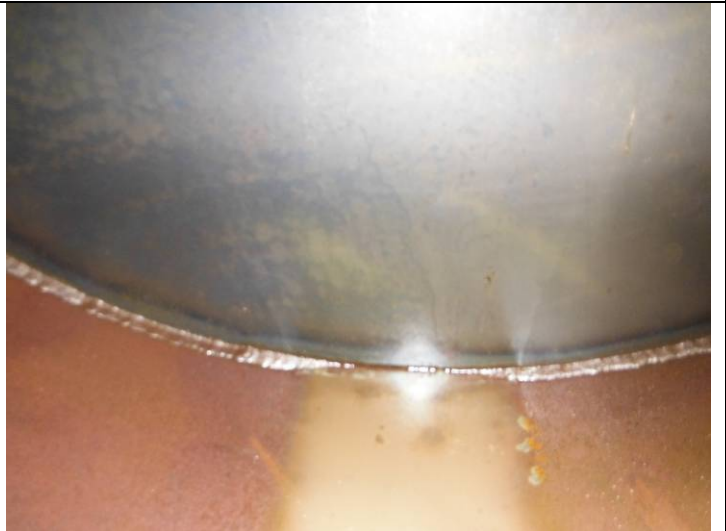
**South end plate**

<b>South Head</b> Note all corrosion, erosion or mechanical damage. (If vessel is horizontal identify direction of this head)	X				<b>Good condition – No damage, no corrosion.</b>
<b>Shell Sections</b> Record number of shell sections. Record location, size and depth of all erosion, corrosion or mechanical damage. Describe general condition	X				<b>Two shell section in good condition. No pitting. No damage. No corrosion. Loose product deposits at 12:00 shell.</b>
<b>Demister pad</b> Is it in place? Is it clean? If any corrosion is apparent in vessel, lift pad and check top head for corrosion.				X	<b>None.</b>
<b>Welds</b> Inspect all welds, including attachment welds. Record all service-related damages and if there is any discuss with Chief Inspector before closing.				X	<b>All welds are in good condition – no pitting, no corrosion.</b>
<b>Coil</b>	X				<b>Coil tubes are in good condition. No pitting. No corrosion.</b>
