**Canadian Natural Resources Limited
GENERAL PRESSURE VESSEL INFORMATION**

Job# 10.113336

District: Grande Prairie AB.	Skid No.
Facility: Clear Hills Gas Gathering	Location (LSD): 7-12-87-13W6M
Vessel Name Equipment Number: Separator	
Orientation: Vertical	
Status: Out of Service	Regulatory Inspection

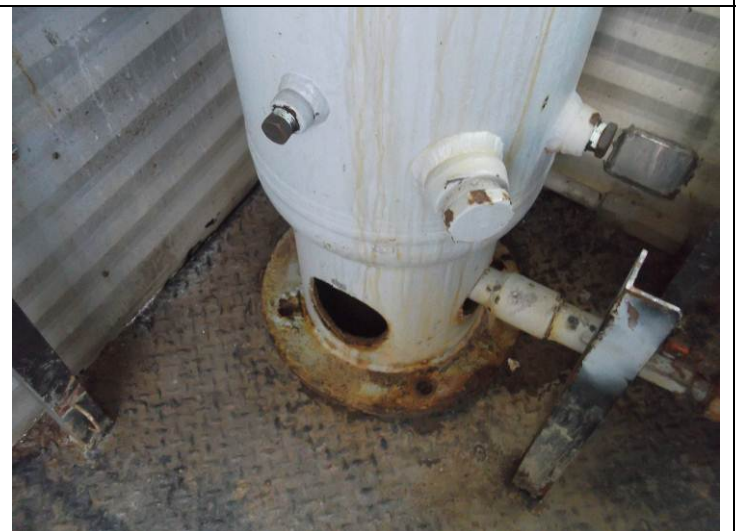
Base

Anchor Bolts Hammer tap to ensure secure. Look for cracking in treads or signs of deformation.	X				Vessel skirt welded to support base. No deformation.
Concrete foundation Check for cracks, spalling, etc.				X	
Ladder / Platform Describe general condition, ensure support is secure to vessel, describe any hazards.				X	
Nozzle Assess paint, look for leakage, and ensure stud threads are fully engaged. Record any damage, deflection, etc. Are nozzles gusseted?				X	Piping is disconnected
Gauges Ensure gauges are visible, working, no leakage, and suitable for range of MAWP/ Temp.				X	Gauges removed
External Piping Ensure pipe is well supported. All clamps, supports, shoes, etc. in place. Look for evidence of structural overload, deflection, etc. Paint condition, external corrosion?				X	Piping is removed
Valve: Ensure no leaks are visible. Valves are properly supported and chained if necessary.				X	No valves
