**Canadian Natural Resources Limited
GENERAL PRESSURE VESSEL INFORMATION**

Job # 105.00642

District: Grand Prairie	Skid No. Nil
Facility: Clear Hills Gas Plant	Location (LSD): 16-11-88-13 W6M
Vessel Name Equipment Number: High Pressure Inlet Separator	
Orientation: Horizontal	
Status: In service	Regulatory Inspection

A3141304

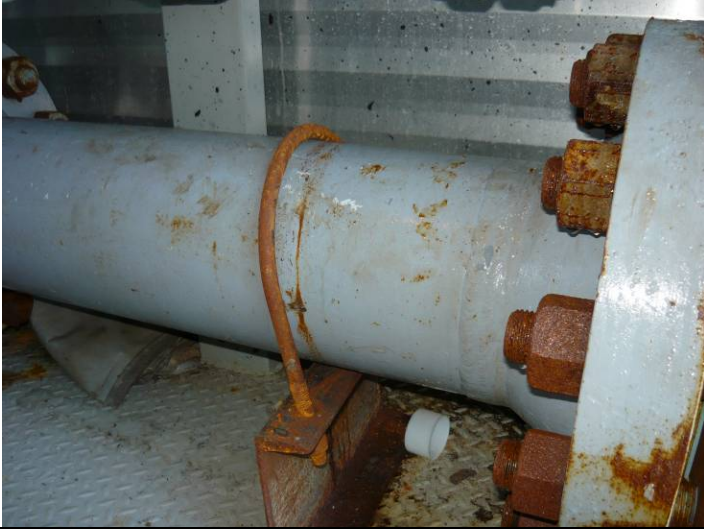
Anchor Bolts Hammer tap to ensure secure. Look for cracking in treads or signs of deformation.	X				Saddle is bolted to skid floor, No deformation or cracking present.
Concrete foundation Check for cracks, spalling, etc.				X	
Ladder / Platform Describe general condition, ensure support is secure to vessel, describe any hazards.				X	
Nozzle Assess paint, look for leakage, and ensure stud threads are fully engaged. Record any damage, deflection, etc. Are nozzles gusseted?	X				Nozzle paint is in good condition no leaks present. No Stud threads present, no damage or deflection present. No gussets present.
Gauges Ensure gauges are visible, working, no leakage, and suitable for range of MAWP/ Temp.	X				Pressure gauge (0-10300 kPa) Suitable for MAWP Gauge is clear and visible.
External Piping Ensure pipe is well supported. All clamps, supports, shoes, etc. in place. Look for evidence of structural overload, deflection, etc. Paint condition, external corrosion?	X				Piping is well supported and in place. Three loose pipe clamps on outlet line noted. No evidence of structural overload or deflection. Paint is in good condition but with areas of scattered failure, staining from these areas of corrosion present.
