**Canadian Natural Resources Limited
GENERAL PRESSURE VESSEL INFORMATION**

Job # 10.113190

| Facility: Hamburg Battery | | Location (LSD): 15-21-96-10 W6M | | | | |
| Vessel Name & Equipment Number: Fuel Gas Scrubber | | | | | | |

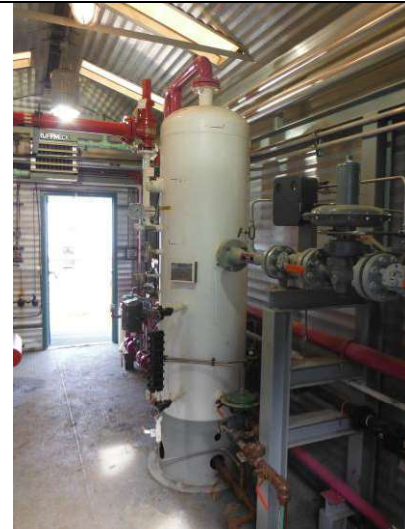
Overview -Vessel

| External Inspection Items | G | F | P | N/A | Comments |
|---|---|---|---|---|--|
| External Condition Assess paint condition, areas peeling, record any corrosion, damage, etc (record location, size and depth of corrosion or damage) | X | | | | Paint is in good condition, no exposed metal. No damage. |

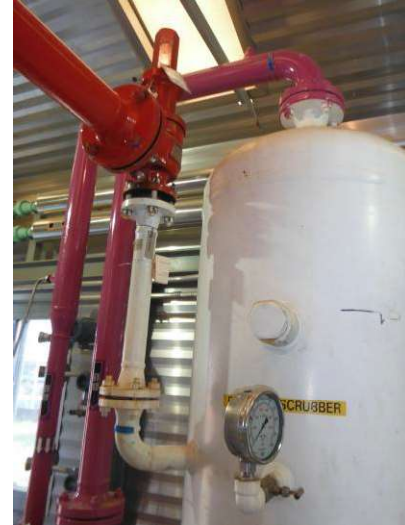
| External Inspection Items | G | F | P | N/A | Comments |
|---|---|---|---|---|--|
| PSV Ensure PSV is set at pressure at or below that of vessel. Discharge piping is same size as inlet to valve and is properly supported and routed. Ensure no block valves between psv and vessel or if there are they are locked open. | X | | | | Located on upper shell– set at MAWP of vessel. PSV seal in place. Discharge piping is same size as valve outlet. No block valve between vessel and PSV |

PSV location – Upper shell

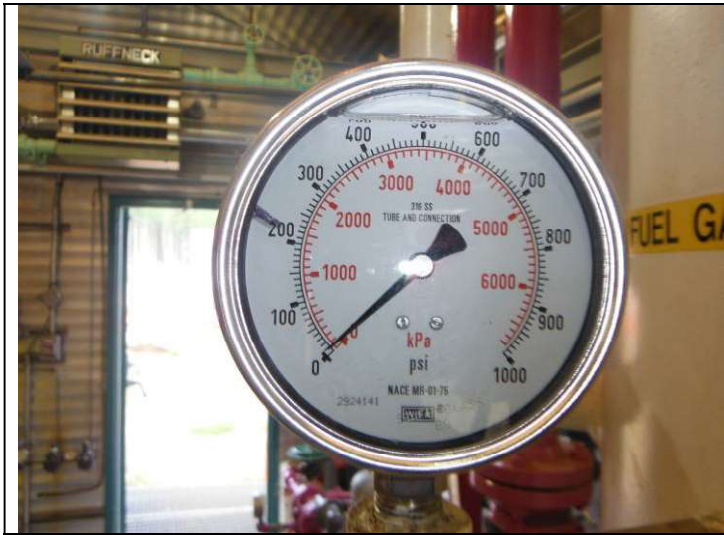
Pressure gauge

| External Inspection Items | G | F | P | N/A | Comments |
|---|---|---|---|---|--|
| Gauges Ensure gauges are visible, working, no leakage, and suitable for range of MAWP/ Temp. | X | | | | Gauges are visible and working. No signs of leaks. Suitable for range of MAWP and temperature |
