**Canadian Natural Resources Limited
GENERAL PRESSURE VESSEL INFORMATION**

Job # 10.113190

District: Hamburg Oil – GP South	Skid No. 15136
Facility: Hamburg Battery	Location (LSD): 15-21-96-10 W6M
Vessel Name & Equipment Number: Test Separator	
Orientation: Vertical	
Status: In Service	Regulatory Inspection

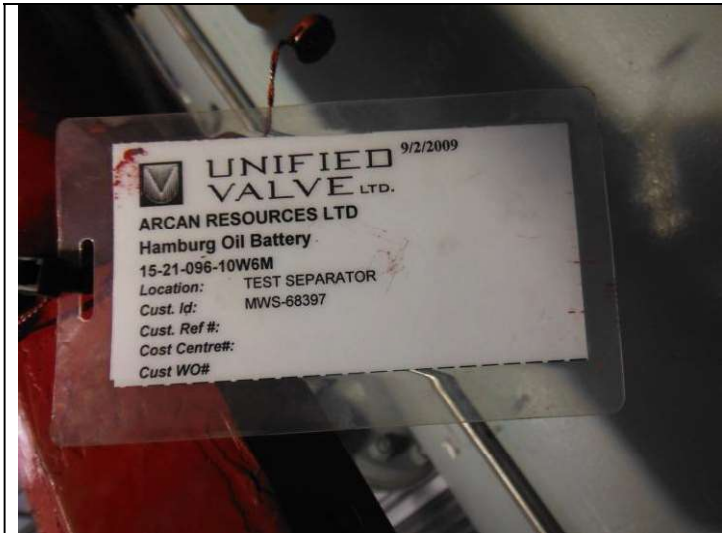
PSV service tag

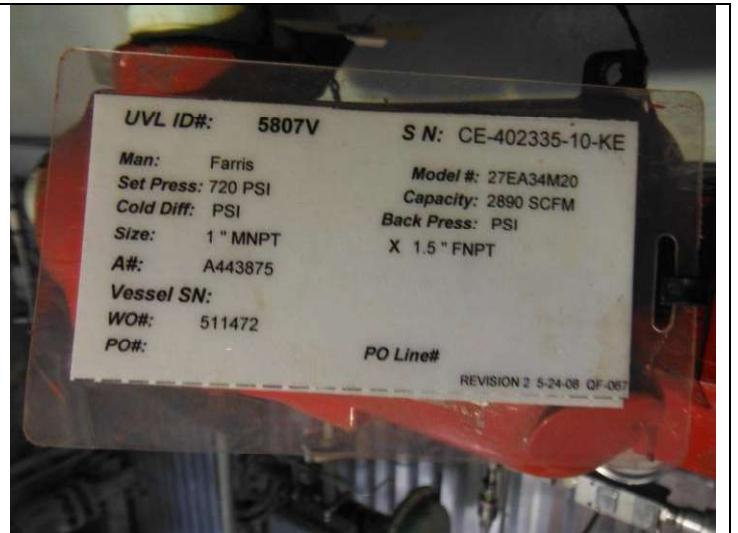
PSV service tag
