**Canadian Natural Resources Limited
GENERAL PRESSURE VESSEL INFORMATION**

Job # 10.113190

District: Hamburg Oil – GP South		Skid No. 15138				
Facility: Hamburg Battery		Location (LSD): 15-21-96-10 W6M				
Vessel Name & Equipment Number: Glycol Contactor						
Orientation: Vertical						
Status: In Service		Regulatory Inspection				
PRESSURE VESSEL NAMEPLATE DATA						
"A" or "G" or "S" (Sask.) or BC Registration Number. A0238179		CRN Number H 1668.2				
Vessel serial number: 1813-V100		Size: 20in x 20ft				
Shell thickness: 22.2mm		Shell material: SA 516 70N				
Head thickness: 24.6mm		Head material: SA 516 70N				
Tube wall thickness:		Tube material:				
Tube diameter:		Tube length:				
Channel thickness:		Channel material:				
Design pressure	Shell: 9756 kPa (1415 psi)	Operating pressure	Shell:			
	Tubes:		Tubes:			
Design Temp.	Shell: 66°C	Operating temperature	Shell:			
	Tubes:		Tubes:			
X-ray: RT-1		Heat treatment: Nil				
Code parameters: ASME VIII DIV 1		Joint efficiency (if on nameplate):

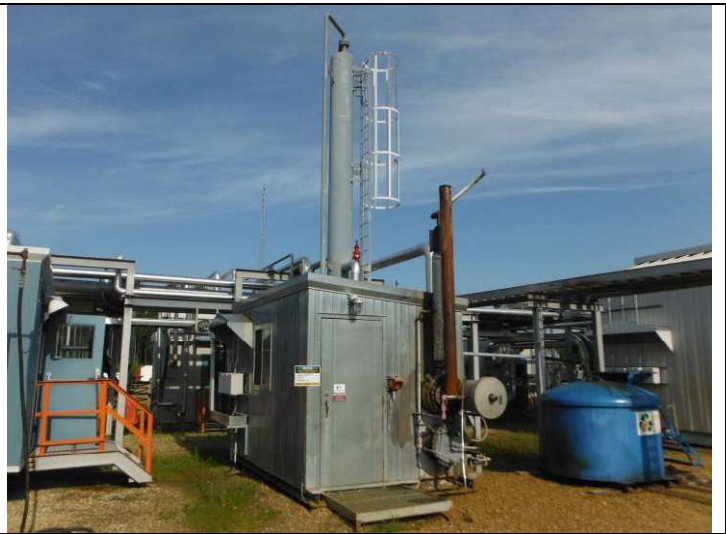
Overview - Skid

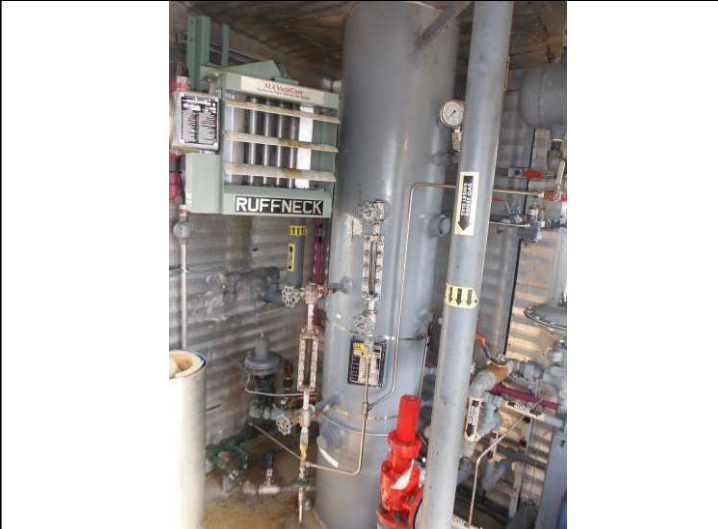
Overview - Lower shell

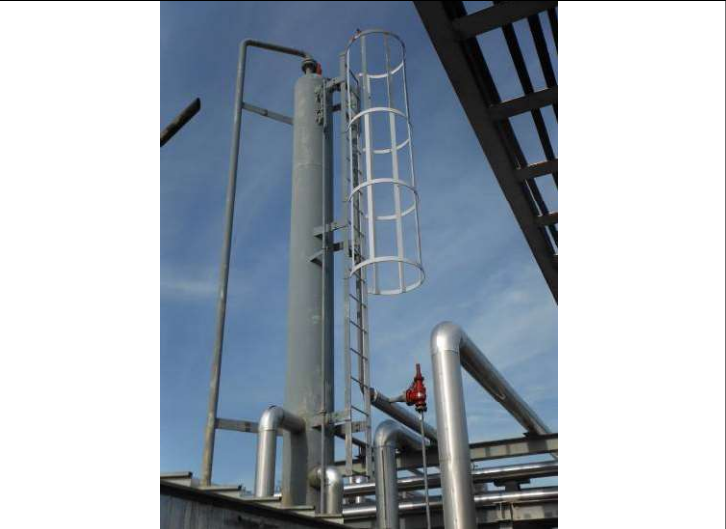
Overview - Upper shell

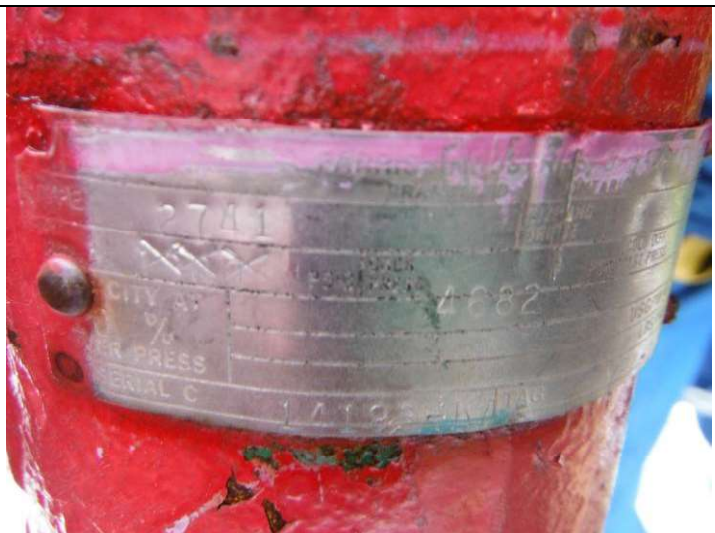
PSV data plate – 2006 service tag is not attached.
