**Canadian Natural Resources Limited
GENERAL PRESSURE VESSEL INFORMATION**

Job # 10.110421

District: Ft. St. John B.C.	Skid No.
Facility: Rigel Compressor Station	Location (LSD): d-75-A/94-A-15 W6M
Vessel Name Equipment Number: Glycol Dehy	
Orientation: Vertical	
Status: In Service	Regulatory Inspection

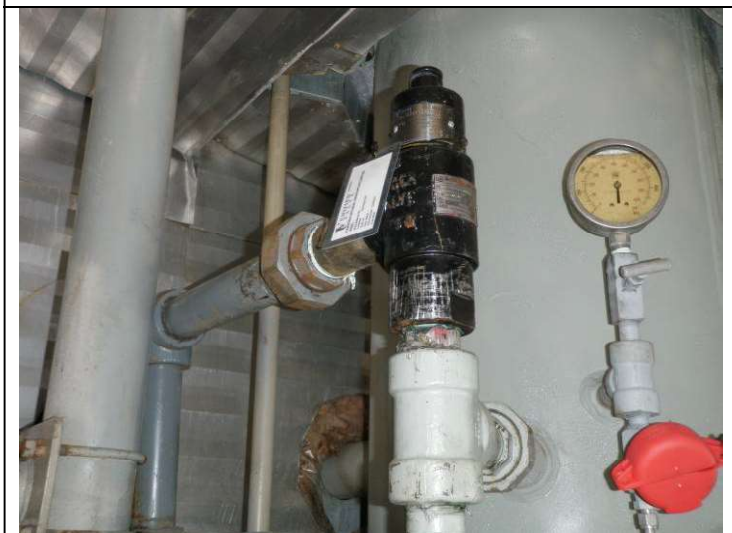
PSV Ensure PSV is set at pressure at or below that of vessel. Discharge piping is same size as inlet to valve and is properly supported and routed. Ensure no block valves between PSV and vessel or if there are they are locked open.	X				Located on lower shell. Set pressure is below MAWP. Seal intact. No block valve.
NDE methods Was UT/ MPI done on vessel (MI coordinator to review results)	X				Ultrasonic corrosion survey carried out – no metal thickness detected below nominal minus corrosion allowance.
<p>Recommendations or corrective actions : Vessel is Fit for Service or describe corrective actions required) (MIC to review corrective actions with Operations, discuss with Chief Inspector where necessary, and get remedial action implemented)</p> <p>Recommendations: 1. None at this time.</p> <p>Summary: This vessel is in good condition, visual external and ultrasonic thickness inspection carried out – no metal thickness detected below nominal minus corrosion allowance.</p> <p>Long term corrosion rate based on greatest thickness loss – no corrosion rate to assess.</p> <p>Vessel is fit for service.</p>

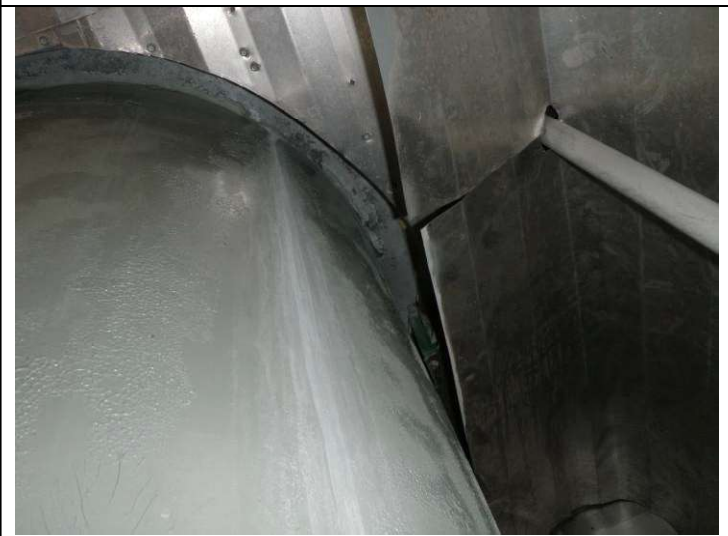
Roof Seal leaking

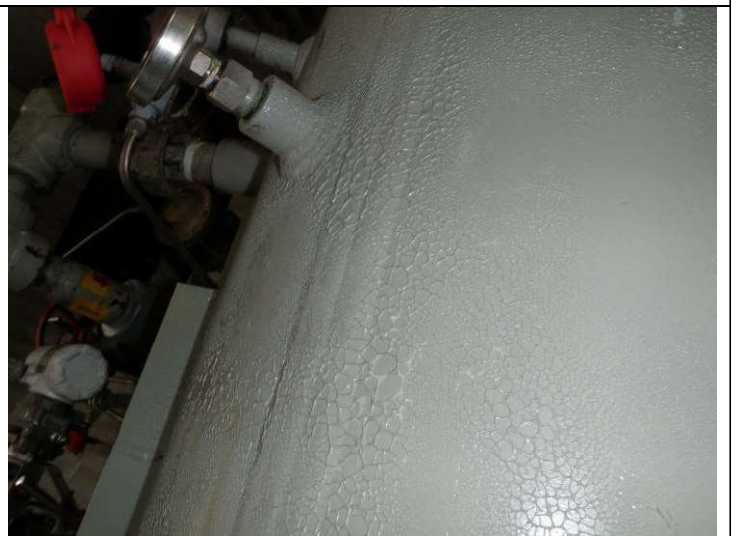
Paint blistered
