**Canadian Natural Resources Limited  
GENERAL PRESSURE VESSEL INFORMATION**

**Job # 10.110421**

<b>District:</b> Ft. St. John B.C.	Skid No.
<b>Facility:</b> Rigel Compressor Station	<b>Location (LSD):</b> d-75-A/94-A-15 W6M
<b>Vessel Name Equipment Number:</b> Inlet Separator	
<b>Orientation:</b> Vertical	
<b>Status:</b> In Service	<b>Regulatory Inspection</b>

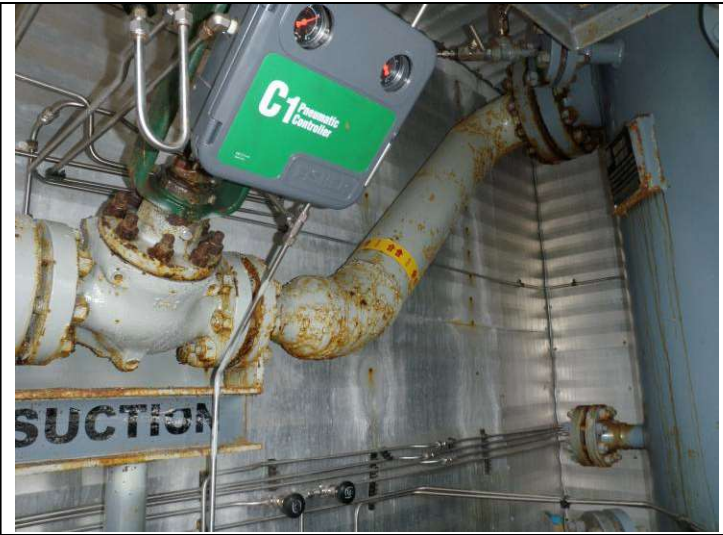
<b>Anchor Bolts</b> Hammer tap to ensure secure. Look for cracking in treads or signs of deformation.	X				Secured.
<b>Concrete foundation</b> Check for cracks, spalling, etc.				X	None.
<b>Ladder / Platform</b> Describe general condition, ensure support is secure to vessel, and describe any hazards.				X	None.
<b>Nozzle</b> Assess paint, look for leakage, and ensure stud threads are fully engaged. Record any damage, deflection, etc. Are nozzles gusseted?		X			Studs are fully engaged. Threaded fittings are secure. Paint is blistered with surface corrosion.
<b>Gauges</b> Ensure gauges are visible, working, no leakage, and suitable for range of MAWP/Temp.	X				Liquid level gauge is clear and working.
<b>External Piping</b> Ensure pipe is well supported. All clamps, supports, shoes, etc. in place. Look for evidence of structural overload, deflection, etc. Paint condition, external corrosion?		X			Paint is blistered with surface corrosion. Well supported. No signs of deflection. No leaks.

Inlet piping – Surface corrosion

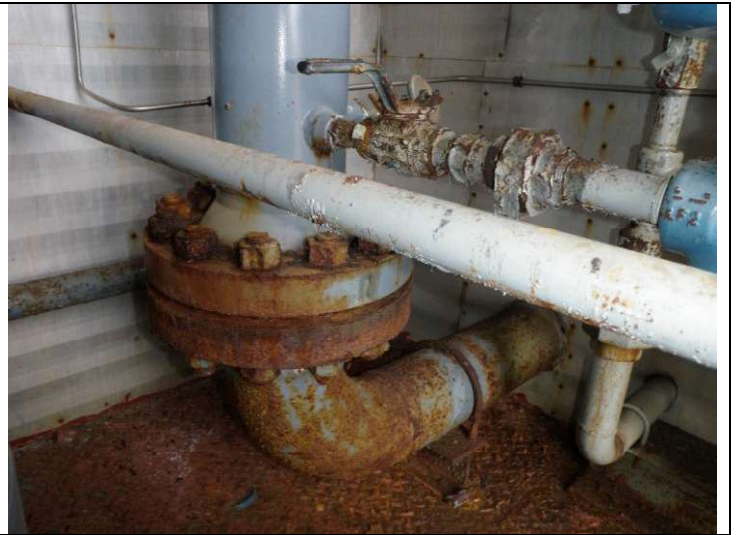
Outlet piping – Surface corrosion

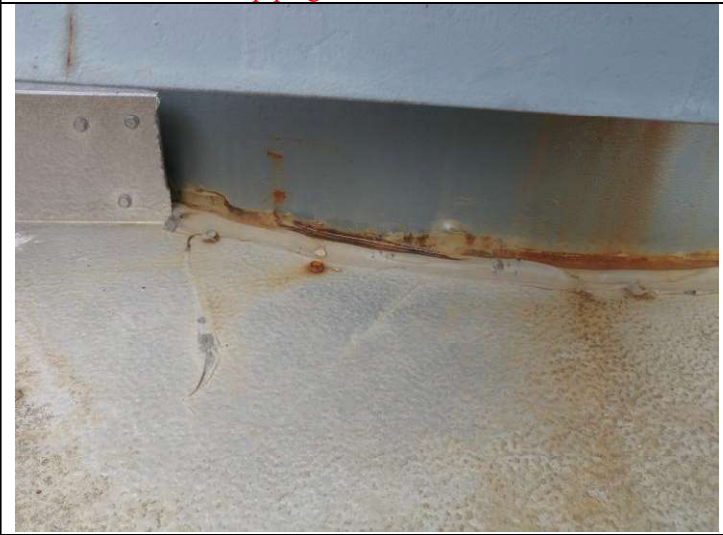
Roof seal broken

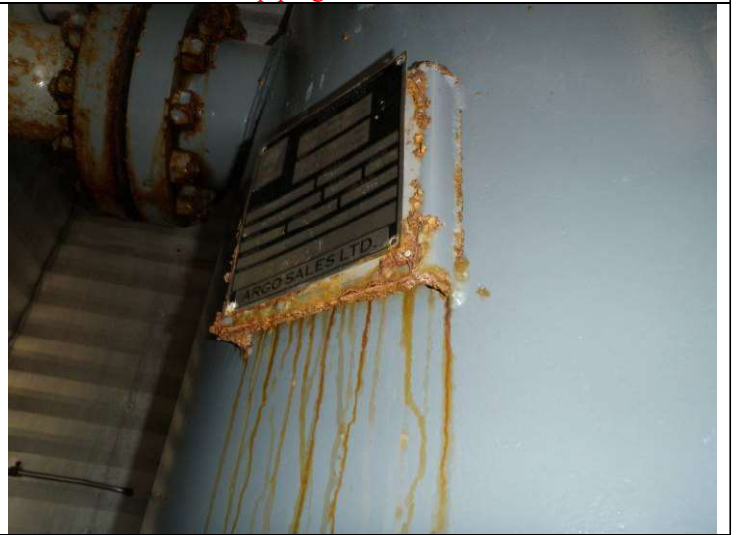
Shell surface corrosion
