**Canadian Natural Resources Limited
GENERAL PRESSURE VESSEL INFORMATION**

District: Fort St John, B.C.	Skid No.
Facility: Osprey Field	Location (LSD): d-08-I / 94-A-15
Vessel Name Equipment Number: 2 Phase Separator	
Note: Currently vessel is located in lay down yard.	
Orientation: Vertical	
Status: Out of Service	Regulatory Inspection

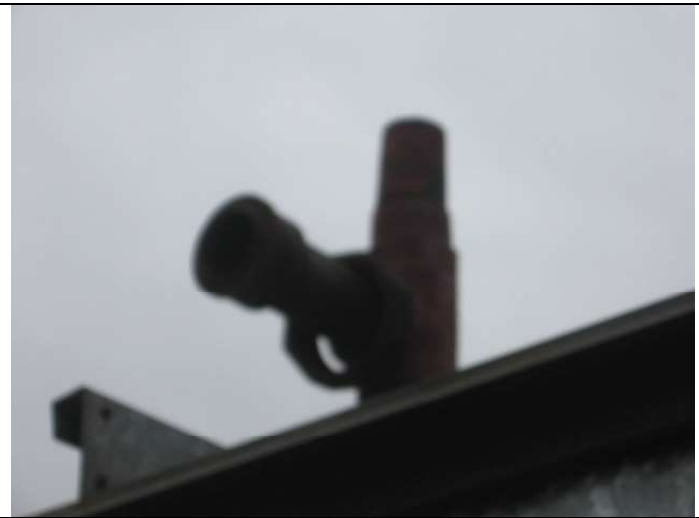
PSV – no access at this time.

Recommendations: 1. Flush out vessel prior to use – there is still some product in the bottom. 2. Service PSV prior to putting into service. 3. Clean up skirt, and dump piping and paint.

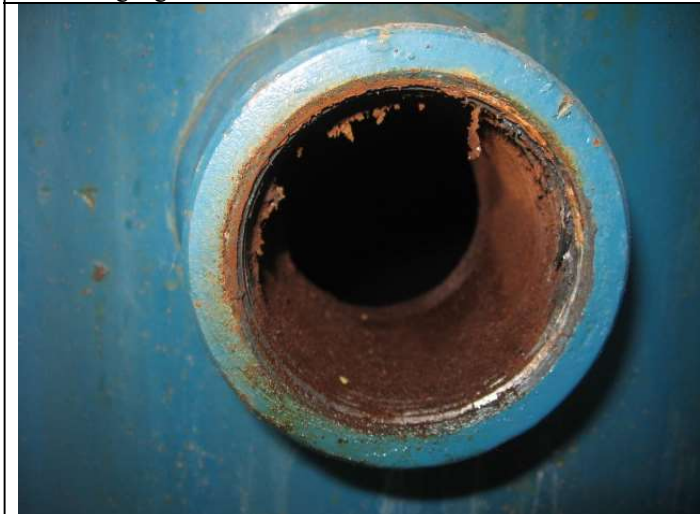
Water dump control opening – general oxidization and surface corrosion – no pitting.

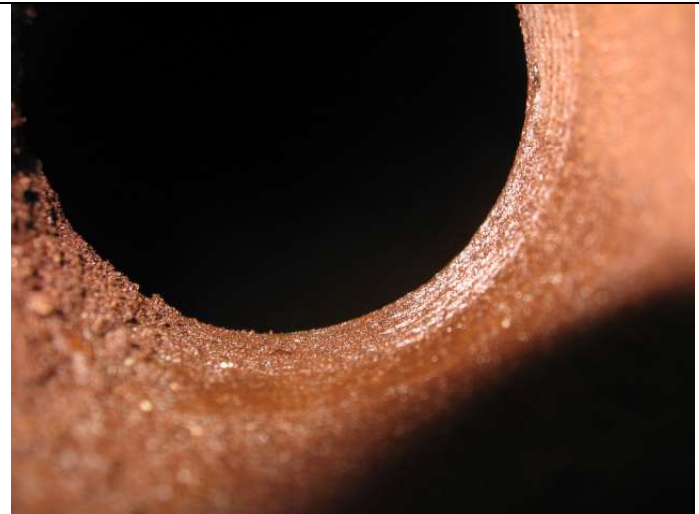
Water dump control nozzle – surface corrosion – no pitting.
