Report #: 156850-MD-02
Inspect Date: 07/04/2012
Page: 1 of 15
Insp. Co. Job #: 156850

National and control in the distribution and						
		nspection	LSD:10-10-096-12W6 Jurisdic	tion #:	A04	92612
External Inspection Results – VE External Inspection Performed

Cariadi	CHILL	aturai			шър. С	.O. JOD #.	100000
Insp. Company: Matrix_Inspection LSD: 10-10-096-12W6 Jurisdiction #: A0492612					92612		
Internal Inspection Results – VI Internal Inspection Performed

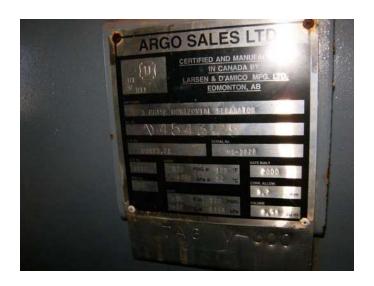
01 nameplate

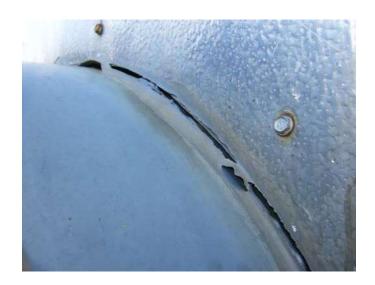
04 deteriorated caulking seal

Recommendations:						
Service the PSV						
Reseal the thru wall caulking to prevent moisture ingress						
Clean and touch up the coating to aid in the protection against corrosion.

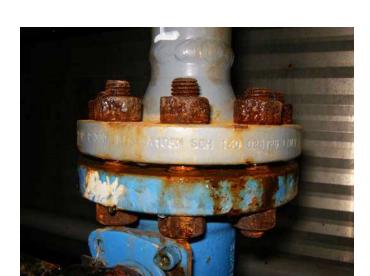
Insp. Company:	Matrix_Inspection	LSD: 10-10-096-	12W6	Jurisdiction #:	A0492612		
Vessel NDE and Final	Summary:						
NDE Performe	UT ⊠ Report#:		ET RT Other	Report#: Report#:			
Maxi-Trak Observation	s Summary (Summarize i	nspection results Max 255	Characters):				
PSV due for service Corrosion between the flanges, on the piping & hardware on the bottom of the vessel The manway thru wall caulking deteriorated TA 2012 - Demister pad is out of position with build-up and segregation							
Maxi-Trak Recommend	dations Summary (Summa	arize Recommendations M	ax 255 Charact	ers):			
Clean and touch up t	caulking to prevent moistu the coating to aid in the proclean and reinstall demiste	otection against corrosion					
Actions Corrected at T	ime of Inspection: (If action	s were corrected at the time of Ins	spection – note the o	orrected actions here.)			
The demister pad wa	s removed, cleaned and	reinstalled

05 corrosion between flanges

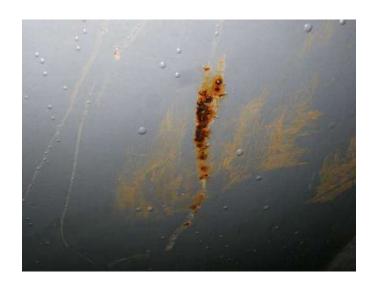
Ladder / Platform		•	No ladders or platforms	一		
Leaks		No	No leaks noted at the time of inspection	一百		
Piping from Vessel	Ħ	Accept	Adequately supported and secure			
Previous UT Survey		Yes		ompan	y: N/A	
External Visual Observations						<u> </u>
External visual Observations	<u> </u>					
The coating is weathered, scratched and chipped exposing the base metal to minor surface corrosion throughout the vessel No pitting evident at the time of inspection						
There is condensation noted throughout the vessel which is accelerating corrosion between the flanges, on the piping and hardware on the bottom of the vessel.						
The manway thru wall cau	lking	is deteriorat	ed allowing for moisture ingress.			
The manway is in accepta	ble co	ondition as w	vell as the davit arm and hardware.			
The PSV is due for service	9					
A UT corrosion survey wa	s perf	ormed with i	no significant metal losses recorded at the time of ins	pection	١.

06 surface corrosion

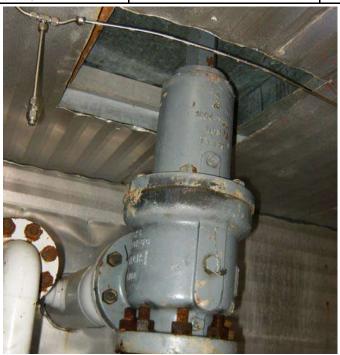
Carseal Intact:		_			Code St	tamp:		
Shell Side / Tube Side: Out for Service During Insp.: Location of PSV:								
PSV Comments								
Due for service								
_ 10 .0. 001 1100

07 PSV overview

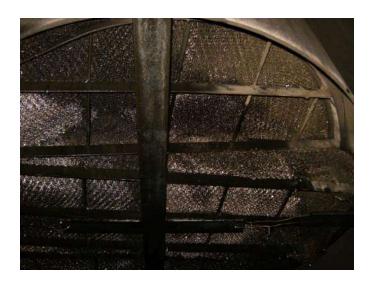
It should be noted that th	ere is i	oroduct build	1-un on the he	ads, shell, baffles and demiste	r		
The demister is sagged and segregated with mild product build-up on the mesh. The sagging of the demister pad has resulting in the support harness out of position and partially in the outlet nozzle							
The baffles are in acceptable condition with no evidence of mechanical or service related damage. There is no evidence of "knife-edging" but it should be noted that there is mild product build-up adhered to the baffle surface							
There is minor flash corrosion on the exposed shell and head surfaces from washing and oxidation							
Recommendations:							
Remove and clean the demister pad and reinstall

08 demister pad overview

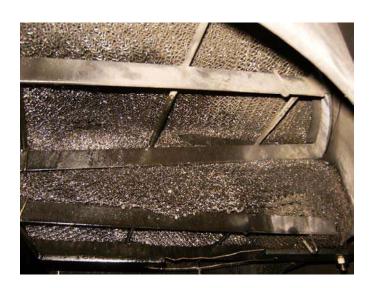
09 out of position

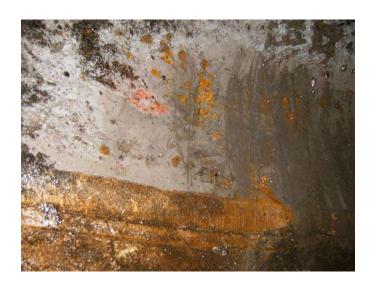
11 flash corrosion on welds

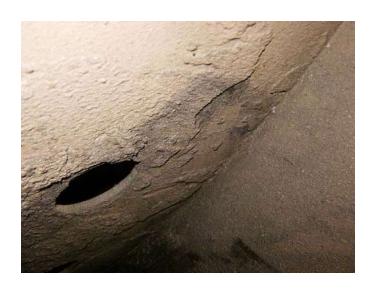
12 build-up on baffle
