Report #: 156960-MD-04
Inspect Date: 10/15/2012
Page: 1 of 12
nsp. Co. Job #: 156960

Insp. Company: Matrix_Inspection LSD: 12-29-096-11W6 Jurisdiction #: A0218888						
External Inspection Results – VE External Inspection Performed

Equipment Photographs:

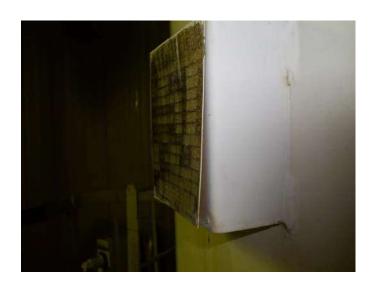
Item	N/A	Condition	Comment (Check Status Bar or Press F1 for Help)	NCR	Action Item Integrity	Action Item Maintenance
Nameplate		Accept	Legible with one broken rivet			
Foundation and Supports		Accept	Welded skirt anchored to skid			
Anchor Bolts		Accept	Secure with minor surface corrosion			
Grounding		Accept	Grounded directly to South East side of skirt			
Insulation Condition			No insulation			
PSV		Reject	Overdue service & discharge piping disconnected			\boxtimes
Shell Heads & Nozzles		Accept	Minor surface corrosion through out			
Metal Surfaces (Paint)		Accept	Chipped and flaking exposing base metal			\boxtimes
Aux Equipment			Not applicable			
Cathodic Protection			No external anode			
Alignment		Accept	Vertical and upright			
Flange Connections		Accept	Adequate thread engagement and hardware			
Pressure Gauge			No pressure gauge			
Temperature Gauge			No temperature gauge			
Sight Glass			No sight glass

02 broken nameplate rivet

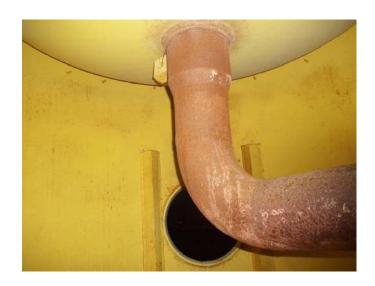
04 surface corrosion

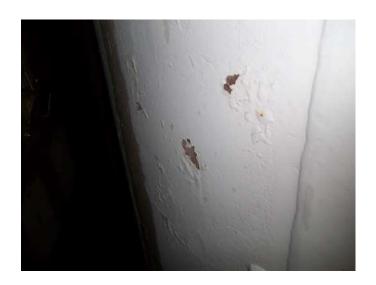
05 paint deterioration

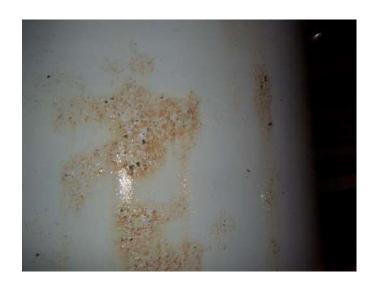
06 surface corrosion

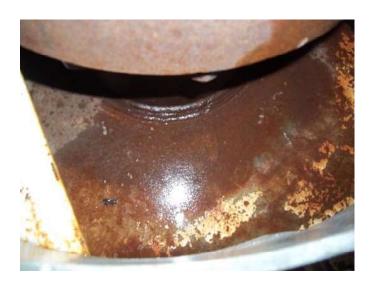
•						
The PSV is overdue for s	ervice	and the disc	charge to piping flange connection is disconnected			
There is mechanical damage noted thru out the surfaces on the middle shell, (it appears as a tooling marks from erection) There is also mechanical damage on the top head below the paint						
A UT corrosion survey was performed at the time of inspection with no significant wall losses recorded.						
Recommendations:						
Secure PSV piping Service, replace PSV Secure the nameplate Clean and touch up the coating to aid in the protection against corrosion						
If this vessel is to be moved and/or placed into service the lifting lugs and top nozzle should be MT examined as well as ABSA document AB-10 completed

07 surface corrosion top head

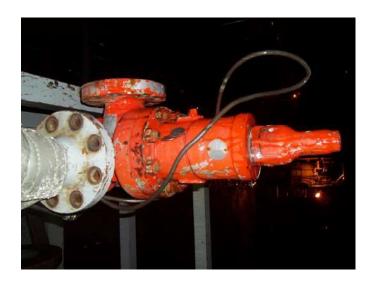
Ladder / Platform		Accept	All 4 platforms are secure with cages for ladders			
Leaks		No	No evidence of leaks			
Piping from Vessel		Reject	PSV discharge to header piping is disconnected			
Previous UT Survey						
External Visual Observations						
At the time of inspection the dehydrator was not in service and the 6" inlet was blinded						
The coating is flaking and chipped throughout exposing the base metal to minor surface corrosion with no evidence of pitting.						
There are two 24" manways on the vessel with adequate hardware and thread engagement						
The nameplate has one broken rivet						
All platforms and ladders are secure with well supported cages on the ladders

08 disconnected PSV
