Report #: 155741-MD-46
Inspect Date: 02/19/2012
Page: 1 of 10
Insp. Co. Job #: 155741

Insp. Comp: Matrix_Inspection District Grande Praisire - North Field: South Hamburg Useralism 12-29-086-1196 Unit's fold # Glocal Reboller Scrial #: 95-1677 Scrial #: 95-1677 Year Built 1995 Wart Bid #: N-2400 Scrial #: 95-1677 Year Built 1995 Wart Bid #: N-2400 Scrial #: 95-1677 Year Built 1995 Wart Bid #: N-2400 Scrial #: 95-1677 Year Built 1995 Wart Bid #: N-2400 Scrial #: 95-1677 Year Built 1995 Wart Bid #: N-2400 Scrial #: 95-1677 Year Built 1995 Wart Bid #: N-2400 Scrial #: 95-1677 Year Built 1995 Wart Bid #: N-2400 Scrial #: 95-1677 Year Built 1995 Wart Bid #: N-2400 Scribe S	С	riticality Designation:				Vellow					
Jurisdiction #: A3106404	I	nsp. Comp:Matrix_Insp	ection	District:	Grande Prai	rie - North		Fiel	d: South	Hamburg	
CRN #: M8555.2		Location: 12-29-096-	11W6 U	nit / Skid #:	Glycol R	eboiler	_	LSI	D: 12-29-0)96-11W6	
Manufacturer: P. Constructors Equipment Description: Other: Rich Glycol Flash Drum	Ju	risdiction #: A31064	.04 E				-				_

Equipment Photographs:

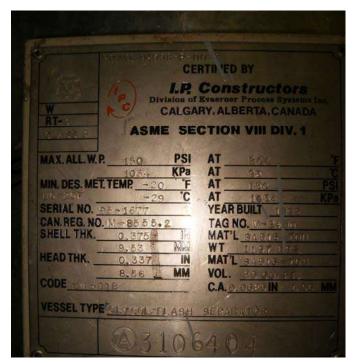
01 nameplate

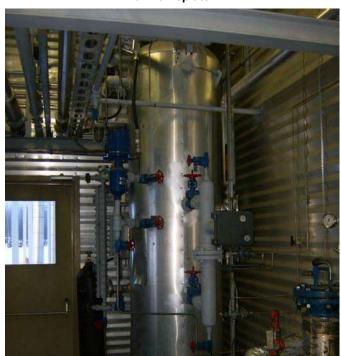
02 overview

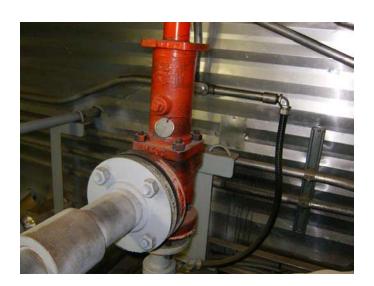
Carseal Intact: Code Stamp: Location of PSV: PSV Comments PSV is due for service		Outlet Size & Type:	-	_		Bloc	k Valve: -	-			
Shell Side / Tube Side: Out for Service During Insp.: Location of PSV: PSV Comments PSV is due for service				_			Code St	amp:			
PSV is due for service		Shell Side / Tube Side:		Out for Se	ervice During	Insp.:	Location of I	PSV: _			
	PSV	Comments									
Service tag is missing	De										
Service tag is missing	73	V is due for service

03 PSV overview

Service the PSV	aurig	on the botto	on nead
