GENERAL NDE REPORT Chinchaga 2011-29

Client: Canadian Natural Resources Ltd.
 Address: Grande Prairie, AB
 P.O.#:
 Client Rep.: Craig Liba / Deston Reber

Lot #: Chinchaga Gas Plant
 Location: LSD 01-24-96-05 W6M
 Procedure: (RTD) MT-001
 Code: ASME VIII Div 1

Ref: Heater Coil
A170474

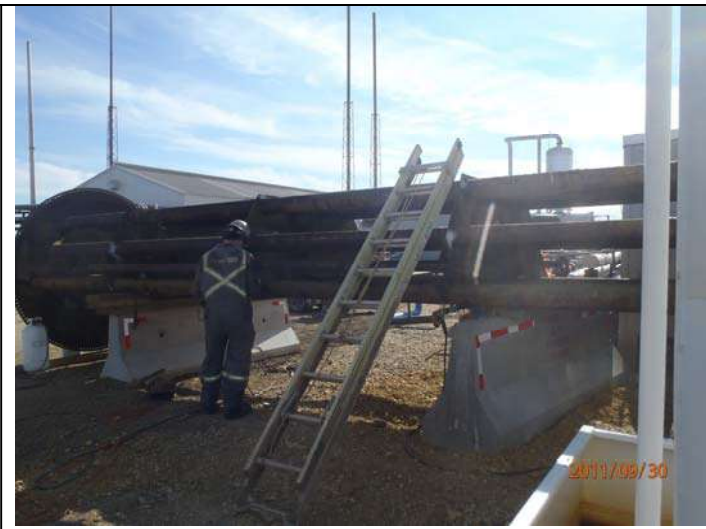
Overview of Brascan Heater Coil

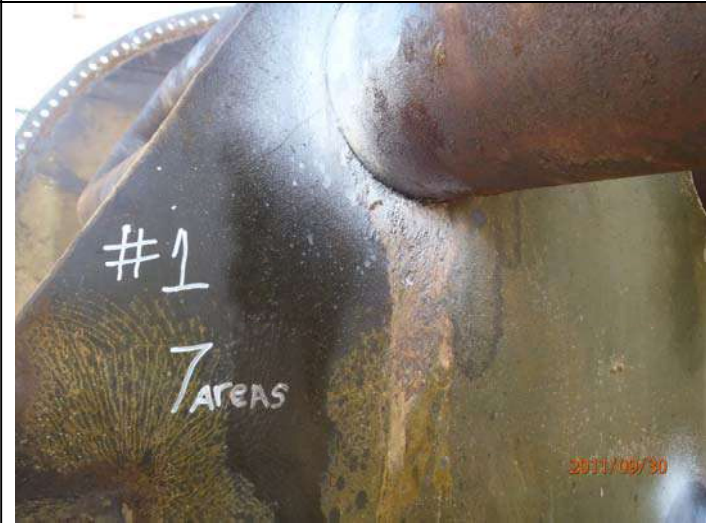
7 Tack Weld Locations on each Divider

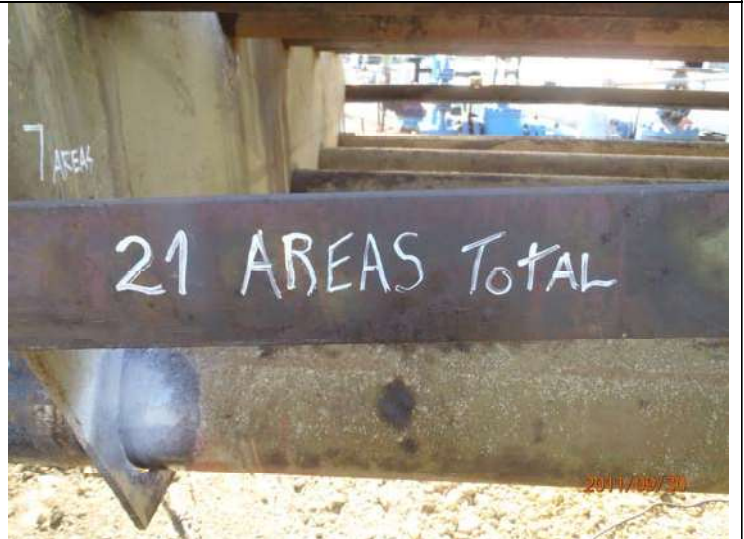
21 Total Tack Weld Locations

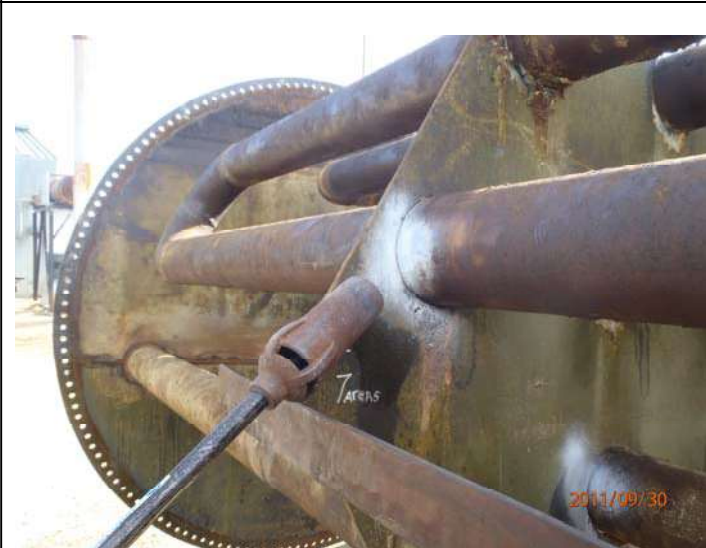
Preheat and MPI on locations before welding

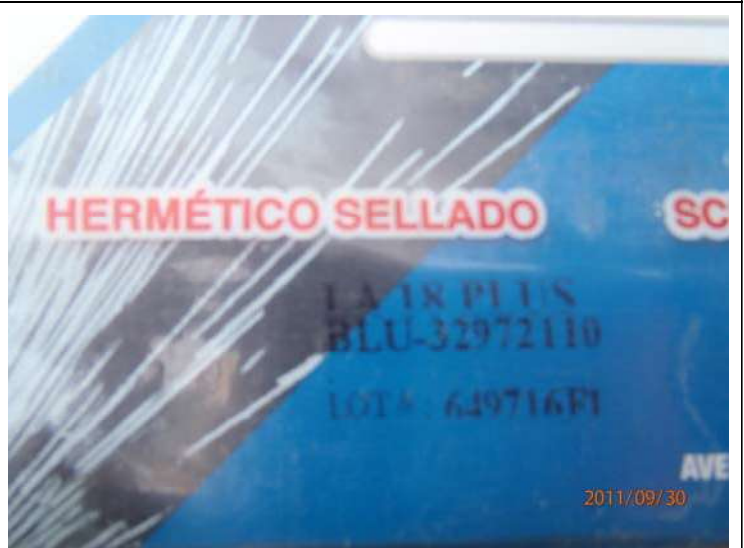
New unopened rods

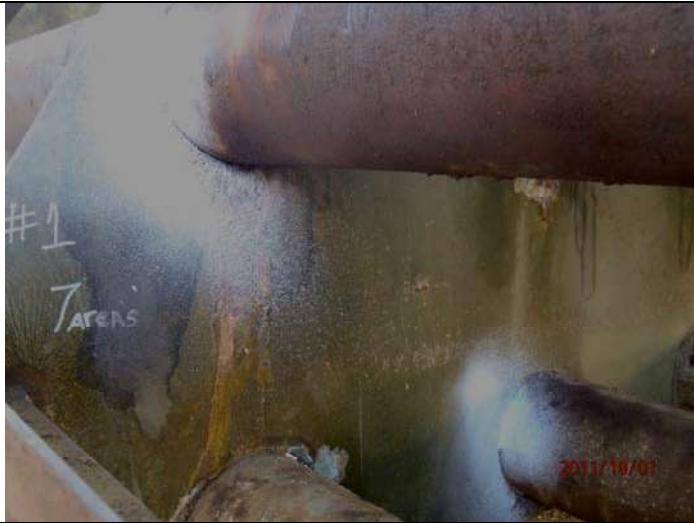
Results: Magnetic Particle inspection was performed on 21 tack weld locations before welding and on the same weld locations 12 hours after the welds were completed, no cracking was found at the time of the inspection.

21 Locations were inspected with MPI 12 hours after welding
