**Canadian Natural Resources Limited
GENERAL PRESSURE VESSEL INFORMATION**

Job #10.110763

Facility: Chinchaga Gas Plant	Location (LSD): 01-24-96-05 W6M
--------------------------------------	--

Vessel Name Equipment Number: **Line Heater (Braescan)**

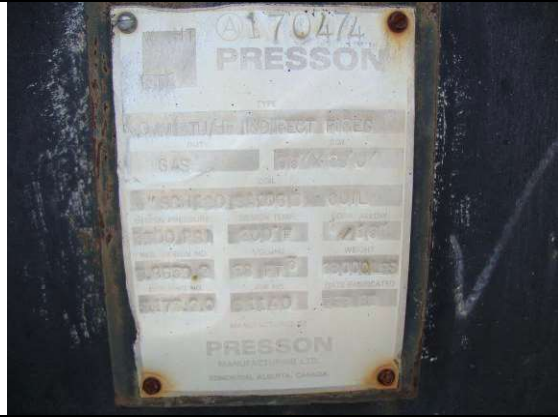
Vessel data plate

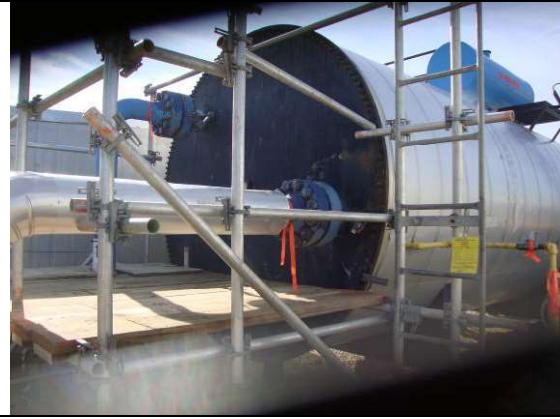
East Head Note all corrosion, erosion or mechanical damage. (If vessel is horizontal identify direction of this head)	X				Minor microbe damage.
West Head Note all corrosion, erosion or mechanical damage. (If vessel is horizontal identify direction of this head)	X				Minor microbe damage.
Shell Sections Record number of shell sections. Record location, size and depth of all erosion, corrosion or mechanical damage. Describe general condition. If any corrosion greater than corrosion allowance is observed in either shell or head, discuss with Chief Inspector before closing vessel.	X				The shell had general pitting corrosion in the 4 to 8 o'clock positions for the full length. Pit depth is estimated at an average of 0.030" with one 1" diameter isolated pit measured at 0.100". Shell nominal is 0.25". The shell is in non-pressure service. There is also extensive microbe attack along the top of the shell.

Vessel head

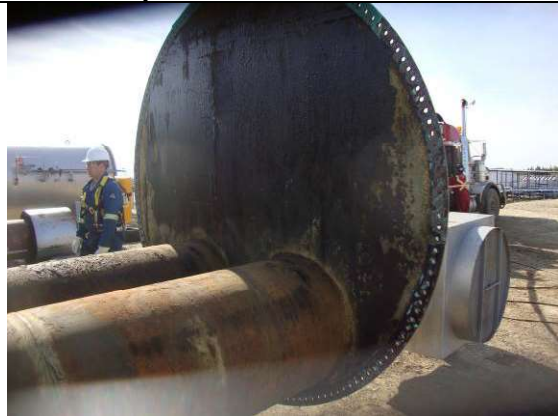
Vessel fire tube bolting flange

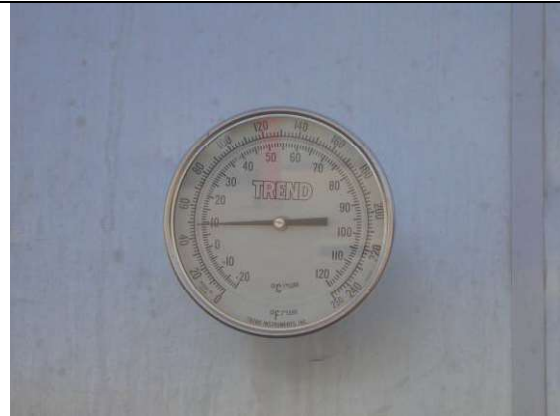
Vessel temperature gauge

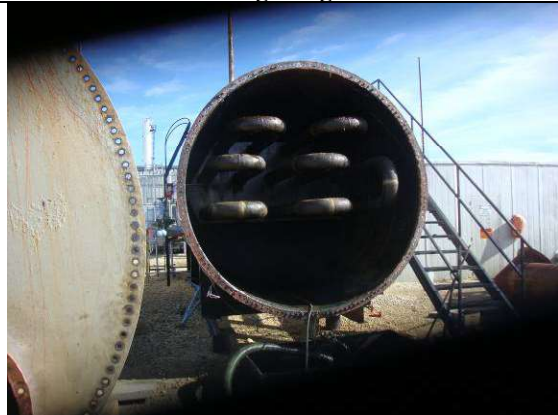
Vessel tube coil

<p>Recommendations or corrective actions : Vessel is Fit for Service or describe corrective actions required) (MIC to review corrective actions with Operations, discuss with Chief Inspector where necessary, and get remedial action implemented)</p> <p>Recommendations: 1. Conduct a full assessment of the amount of damage to the gas tube OD at the baffles by removing the gas coil, shifting the support plates approximately 2 inches, cleaning the tube areas under the plates and mapping all pitting. Then conduct a fitness for service evaluation. 2. Use biocides to control the microbes</p> <p>Summary: This line heater is in fair condition, visual inspection carried out – corrosion detected on gas coil at baffle supports – weld repairs carried out and line heater was returned to service.</p> <p>Vessel is fit for service for one year. Conduct a full assessment of the condition of the gas coil before further service.</p>

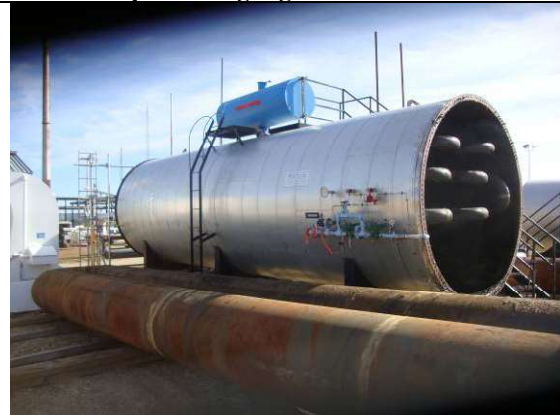
Vessel overview

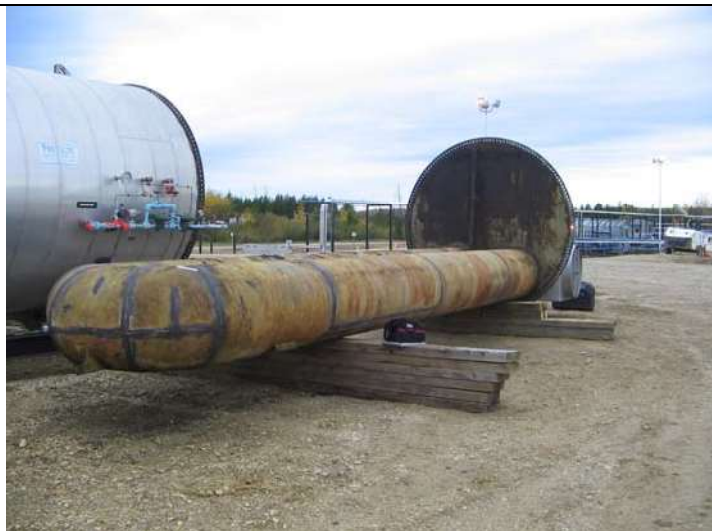
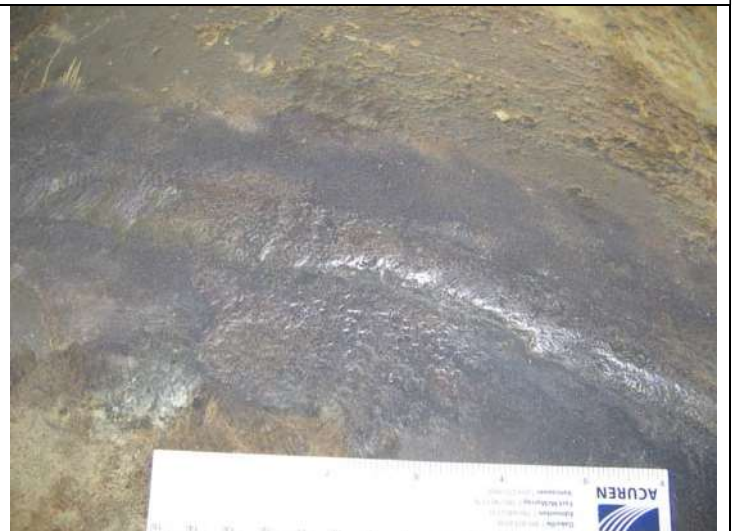
Fire tube: Pitting / corrosion?		X			The fire tube is in generally good condition although there are some areas of pitting near the return bend in the tube, welds and HAZ. The deepest were measured at 0.025" deep. The fire tube does not have any flat spots indicative of overheating. The stack end of the tube has general corrosion on the inside extending about 3' along the tube.
Welds Inspect all welds, including attachment welds. Record all service-related damages and if there is any discuss with Chief Inspector before closing.	X				Welds are in good condition – no evidence of corrosion or erosion.
Repairs Required. If yes, ensure procedure and copy of AB 40 is on file, and one sent to local ABSA, and Chief Inspector	X				1. Weld pitting on gas coil.
NDE Was any NDE done. (MI coordinator to review results)	X				Magnetic particle inspection carried out on fire tube welds – no cracking detected.

Firetube

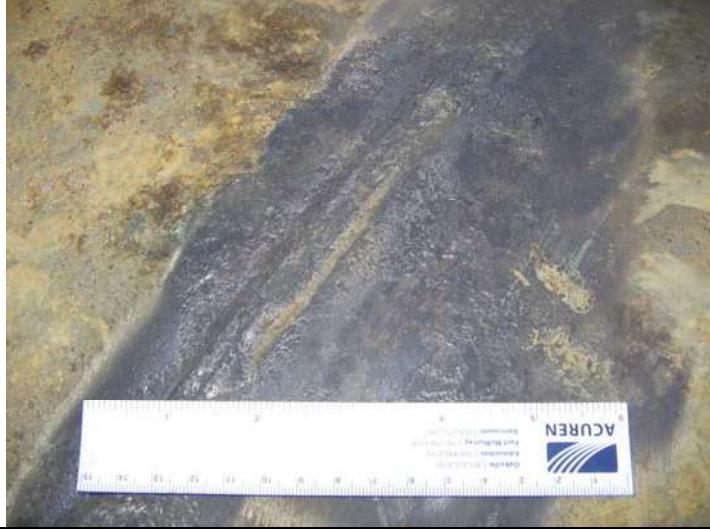
Corrosion along top of firetube in tube, weld and HAZ.

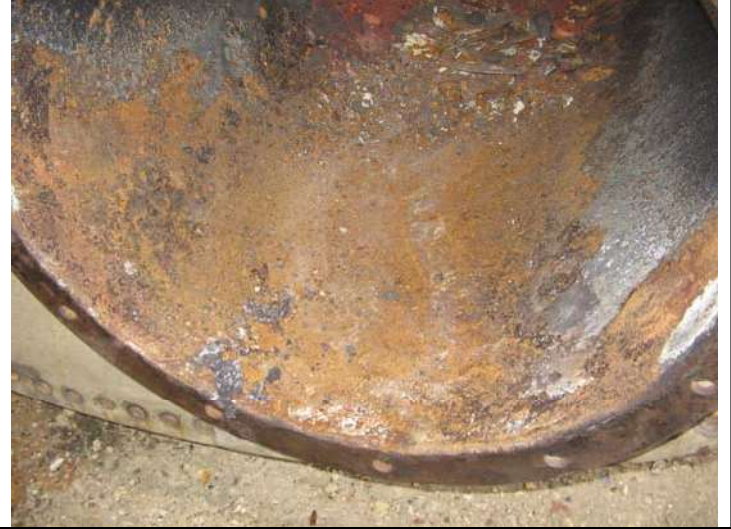
Corrosion along top of firetube.

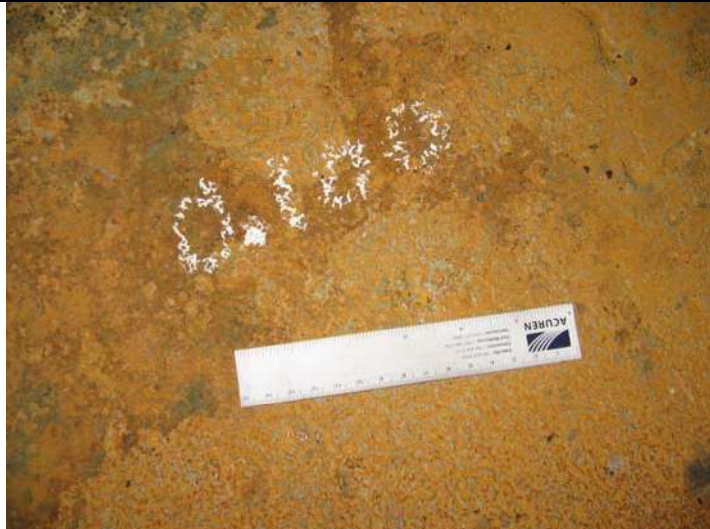
Corrosion along bottom ID of exhaust end of firetube.

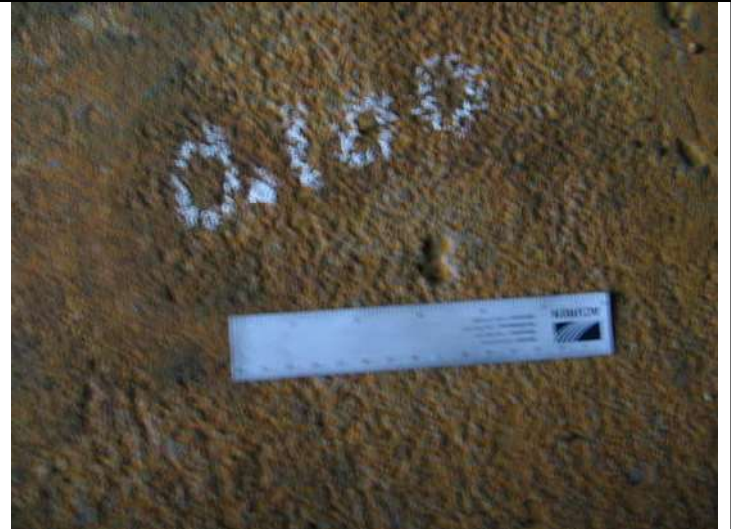
Internal Inspection Items	G	F	P	N/A	Comments
Coating Assess coating. Describe area coated, general condition of coating.				X	Vessel not coated.
Anodes. How many, type, condition. % consumed. Are they being replaced?				X	None.
Internal Piping Is there any? If so, carbon or stainless steel. Describe condition, dents, corrosion, erosion, etc. Ensure supports are secure and any bolts are suitable for future use.	X				Gas Coil: The tubes have been subject to microbe attack. There is minor pitting throughout with deep pits at the baffle plates. Several locations were scraped and the largest pit was approximately 0.100" deep and 0.25" diameter. It was not possible to visually examine the areas directly under the baffle plates.
Trays How many? Type of material. Are valves in place. Check for erosion/ corrosion; wear on tray valve legs. Cleanliness?				X	No trays.
Baffles, deflector plates, etc. If present, describe condition. Look closely at welds attached to vessel wall.	X				Baffle plates are straight. They are subject to microbe attack especially in the areas next to the tubes. Metal loss at this time is not critical.

Pitting along the bottom of the shell (glycol side.)

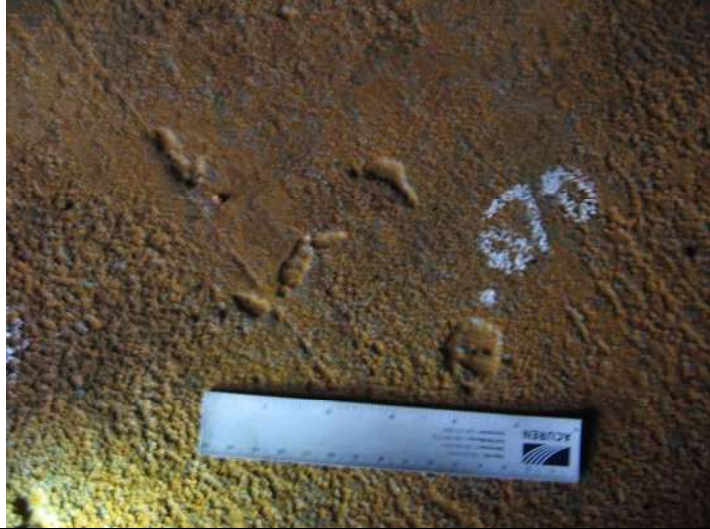
Same pitting with oblique lighting.

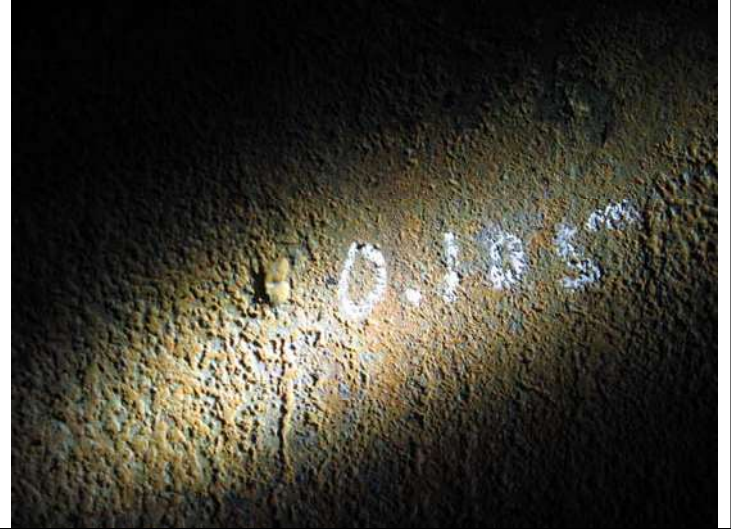
Pits at bottom of shell.

Pitting at bottom of shell.

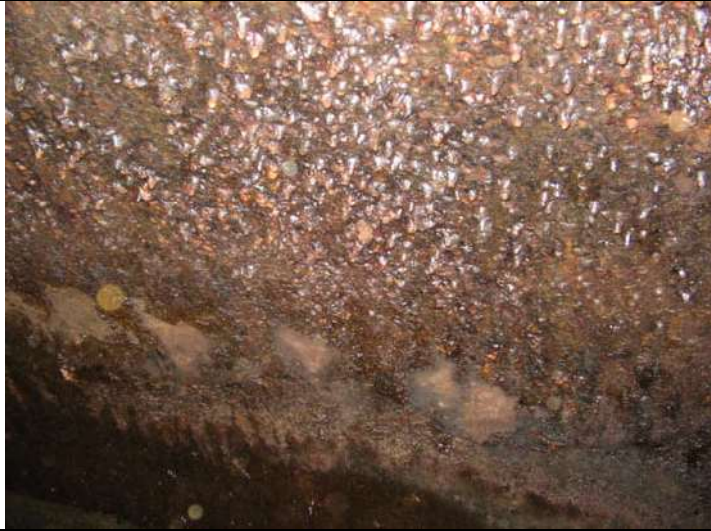
“Carbuncles” (???) along top of shell.

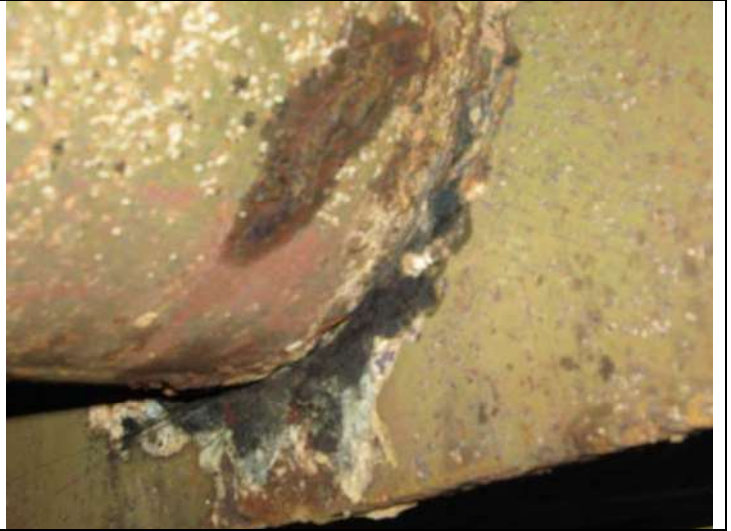
Corrosion of the gas tube OD at the support plates.
