**Canadian Natural Resources Limited  
GENERAL PRESSURE VESSEL INFORMATION**

**Job 10.112902**

District: <b>Grande Prairie AB.</b>	Skid No.
Facility: <b>Clear Hills Gas Plant</b>	Location (LSD): <b>16-11-88-13W6M</b>
Vessel Name Equipment Number: <b>Stabilizer Feed Drum</b>	
Orientation: <b>Horizontal</b>	
Status: <b>In Service</b>	<b>Regulatory Inspection</b>

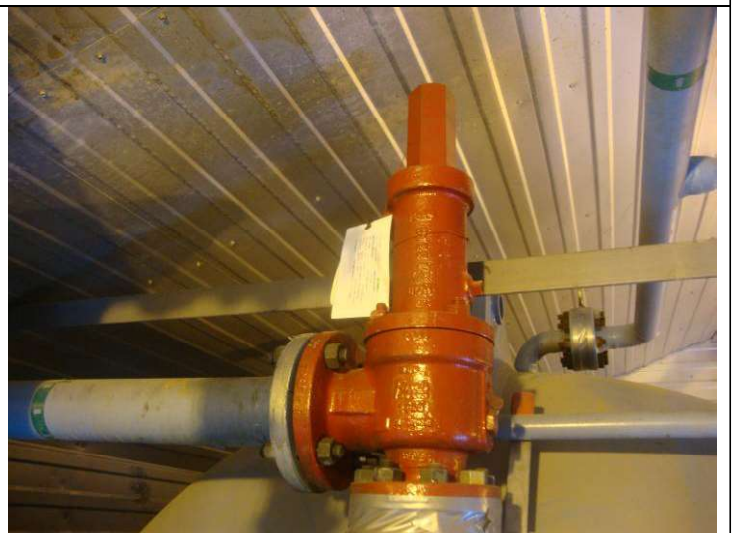
<b>Valving</b> Ensure no leaks are visible. Valves are properly supported and chained if necessary.	X				<b>Valves are supported properly – no leaks.</b>
<b>PSV</b> Ensure PSV is set at pressure at or below that of vessel.	X				<b>Location: Vessel head - Set at MAWP of vessel. No block valve between vessel and PSV. Discharge piping is same size as valve out let. Seal in place.</b>
<b>NDE methods</b> Was UT/ MPI done on vessel (MI coordinator to review results)	X				<b>Ultrasonic corrosion survey carried out – pipe metal thickness detected below nominal minus corrosion allowance. Thickness calculations carried out: 2” Elbow – nominal thickness is 3.9mm / min thickness is 3.2mm / T min thickness is 1.6mm.</b>
<p><b>Recommendations or corrective actions : Vessel is Fit for Service or describe corrective actions required)</b> (MIC to review corrective actions with Operations, discuss with Chief Inspector where necessary, and get remedial action implemented)</p> <p><b>Recommendations:</b> No recommendations.</p> <p><b>Summary: This vessel is in good condition, visual external and ultrasonic thickness inspection carried out – pipe metal thickness detected below nominal minus corrosion allowance. Thickness calculations carried out to ensure sufficient metal exists for safe operation.</b></p> <p>Long term corrosion rate based on greatest thickness loss – no corrosion rate to assess.</p> <p><b>Vessel is fit for service.</b></p>
