**Canadian Natural Resources Limited
GENERAL PRESSURE VESSEL INFORMATION**

Job 10.112902

District: Grande Prairie AB.	Skid No.
Facility: Clear Hills Gas Plant	Location (LSD): 16-11-88-13W6M
Vessel Name Equipment Number: Inlet Separator	
Orientation: Horizontal	
Status: In Service	Regulatory Inspection

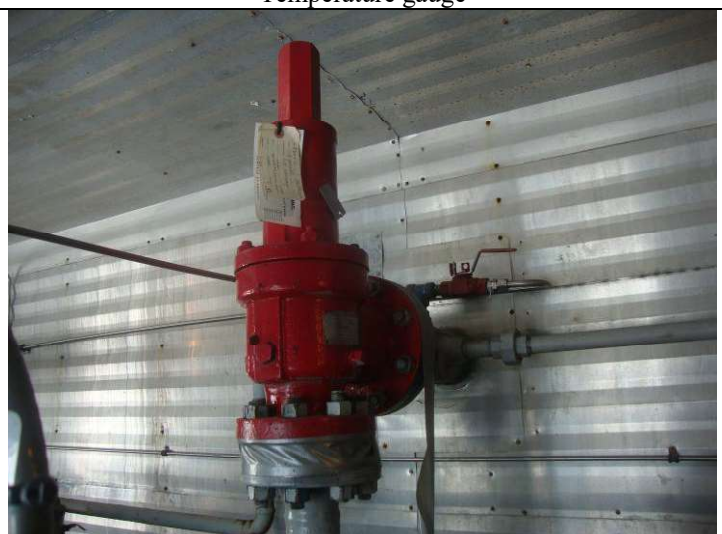
Valving Ensure no leaks are visible. Valves are properly supported and chained if necessary.	X				Valves are supported properly – no leaks.
PSV Ensure PSV is set at pressure at or below that of vessel.	X				Location: Top shell - Set at MAWP of vessel. No block valve between vessel and PSV. Discharge piping is same size as valve out let. Seal in place.

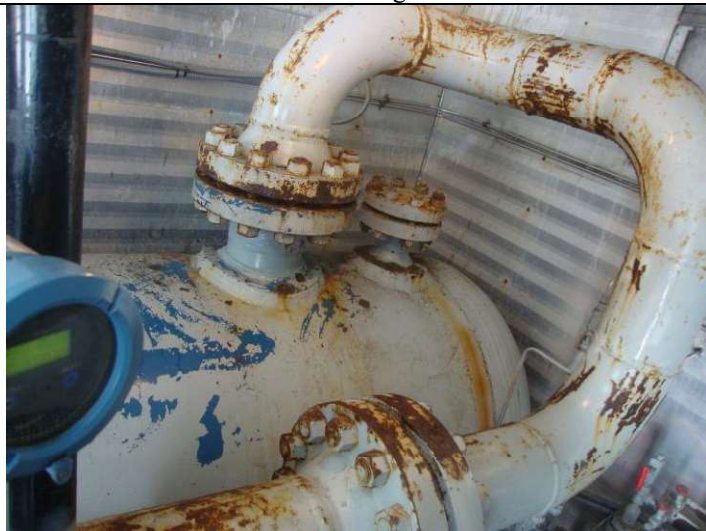
Anchor Bolts Hammer tap to ensure secure. Look for cracking in treads or signs of deformation.	X				Vessel saddles welded firmly to skid floor – no deformation.
Concrete foundation Check for cracks, spalling, etc.				X	
Ladder / Platform Describe general condition, ensure support is secure to vessel, and describe any hazards.				X	
Nozzle Assess paint, look for leakage, and ensure stud threads are fully engaged. Record any damage, deflection, etc. Are nozzles gusseted?	X				Flanged and threaded nozzle joints are fully engaged. No damage or deflections – no leaks. Nozzles are not gusseted.
Gauges Ensure gauges are visible, working, no leakage, and suitable for range of MAWP/ Temp.	X				Clear and clean – no leakage. Within operational range for service. Pressure gauge 0 – 1500 PSI Temperature gauge 0 – 250 Deg F.
External Piping Ensure pipe is well supported. All clamps, supports, shoes, etc. in place. Look for evidence of structural overload, deflection, etc. Paint condition, external corrosion?	X				Piping is well supported, no deflection, all clamps and supports are in place. Paint peeling corrosion on all exposed metal, pitting and corrosion.

<p>NDE methods Was UT/ MPI done on vessel (MI coordinator to review results)</p>	X			<p>Ultrasonic corrosion survey carried out – head, shell and pipe metal thickness detected below nominal minus corrosion allowance. Thickness calculations carried out: Shell – nominal thickness is 41.3mm / min thickness is 37.5mm / T min thickness is 36.3mm. UT point 420 (Lower Head) – nominal thickness is 43.0mm / min thickness is 38.5mm / T min thickness is 34.6mm. UT point 465 (2" Elbow) – nominal thickness is 8.7mm / min thickness is 5.3mm / T min thickness is 2.8mm.</p>
<p>Recommendations or corrective actions : Vessel is Fit for Service or describe corrective actions required) (MIC to review corrective actions with Operations, discuss with Chief Inspector where necessary, and get remedial action implemented) Recommendations: Re- paint vessel and piping. Summary: This vessel is in good condition, visual external and ultrasonic thickness inspection carried out – head, shell and metal thickness detected below nominal minus corrosion allowance. Thickness calculations carried out to ensure sufficient metal exists for safe operation. Short term corrosion rate based on greatest thickness loss (shell) 0.500mm per year. Retirement Date to “T”min is year 2015. Vessel is fit for service.</p>

Corrosion on piping and top shell
