**Canadian Natural Resources Limited  
GENERAL PRESSURE VESSEL INFORMATION**

**Job # 105.00642**

District: <b>Grand Prairie</b>	Skid No. <b>Nil</b>
Facility: <b>Clear Hills Gas Plant</b>	Location (LSD): <b>16-11-88-13 W6M</b>
Vessel Name Equipment Number: <b>Inlet Separator</b>	
Orientation: <b>Horizontal</b>	
Status: <b>In service</b>	<b>Regulatory Inspection</b>

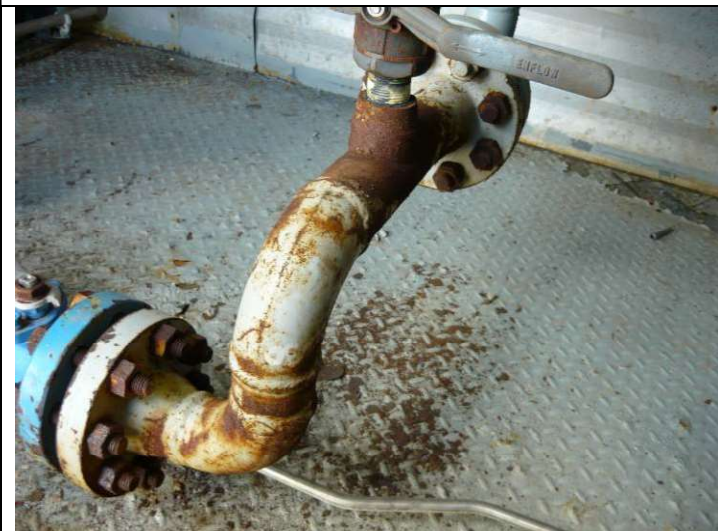
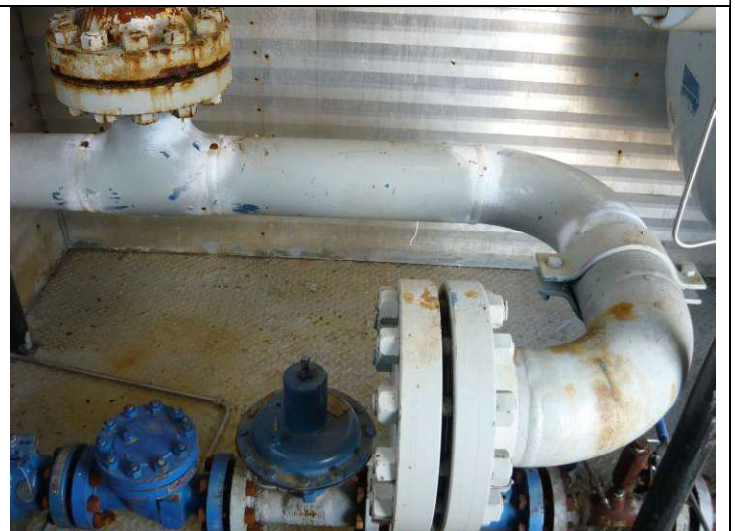
Dump line piping

<b>Anchor Bolts</b> Hammer tap to ensure secure. Look for cracking in treads or signs of deformation.	X				Saddle is welded to skid floor, No deformation or cracking present.
<b>Concrete foundation</b> Check for cracks, spalling, etc.				X	
<b>Ladder / Platform</b> Describe general condition, ensure support is secure to vessel, describe any hazards.				X	
<b>Nozzle</b> Assess paint, look for leakage, and ensure stud threads are fully engaged. Record any damage, deflection, etc. Are nozzles gusseted?	X				Nozzle paint is in good condition no leaks present. No Stud threads present, no damage or deflection present. No gussets present.
<b>Gauges</b> Ensure gauges are visible, working, no leakage, and suitable for range of MAWP/ Temp.	X				Pressure gauge (0-10300 kPa) Suitable for MAWP Gauge is clear and visible.
<b>External Piping</b> Ensure pipe is well supported. All clamps, supports, shoes, etc. in place. Look for evidence of structural overload, deflection, etc. Paint condition, external corrosion?	X				Piping is well supported and in place. No loose clamps or supports. No evidence of structural overload or deflection. Inlet. <b>Dump line piping has corrosion and paint failure to 20% in areas.</b>

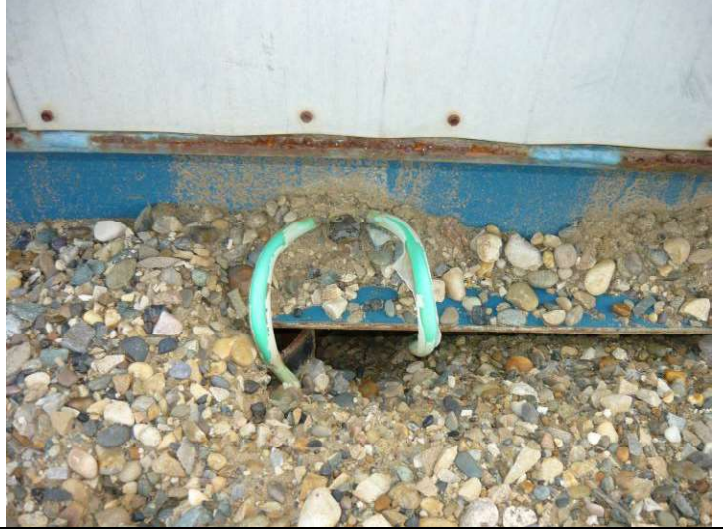
External Inspection Items	G	F	P	N/A	Comments
<b>Insulation</b> Verify sealed around manways, nozzles, no damage present, and there is no egress of moisture.				X	No insulation present.
<b>External Condition</b> Assess paint condition, areas peeling, record any corrosion, damage, etc (record location, size and depth of corrosion or damage)	X				Paint is in good condition, No damage or deflection present.
<b>Leakage</b> Record any leakage at flanges, threaded joints, weep holes on repads, etc.	X				No leaks present.
<b>Saddle/Skirt</b> Assess condition of paint, fire protection, concrete. Look for corrosion, buckling, dents, etc. Look at vessel surface area near supports. Verify no signs of leakage at attachment to vessel and attachment welds are acceptable. Ground wire attached?	X				Saddle is firmly bolted to skid <b>corrosion and paint failure present around saddle to 5%</b> , no buckling or dents present. No leakage present at attachment welds to vessel. Attachment welds are acceptable.  Skid is grounded.
