HORIZONTAL VESSEL - GENERAL INSPECTION FORM						
District: Fort Saint John			Skid No. Area 1			
Facility: Clear Hills Gas Plant			Location (LSD): 16-11-088-13 W6M			
Vessel Name & Equipment Number: LP Inlet Separator						
Orientation: Horizontal						
Status: In Service			Regulatory Inspection			
PRESSURE VESSEL NAMEPLATE DATA						
"A" or "G" or "S" (Sask.) or BC Registration Number.  A# 2955267			CRN Number  V-3213.2			
Vessel serial number: 93-C2697-3000			Size: 72 in x 30 ft			
Shell thickness: 38.1 mm (1.50")			Shell material: SA-516-70			
Head thickness: 43.6 mm (1.717")			Head material: SA-516-70			
Tube wall thickness:			Tube material:			
Tube diameter:			Tube length:			
Channel thickness:			Channel material:			
MAWP	Shell: 700 PSI (4826 kPa)		Operating pressure	Shell: 50 Psi		
	Tubes:			Tubes:		
Design Temp.	Shell: 100 Deg. F (49 C)		Operating temperature	Shell: 25 Deg. C		
	Tubes:			Tubes:		
X-ray: RT-1			Heat treatment: HT

Canadian Natural Resources Limited

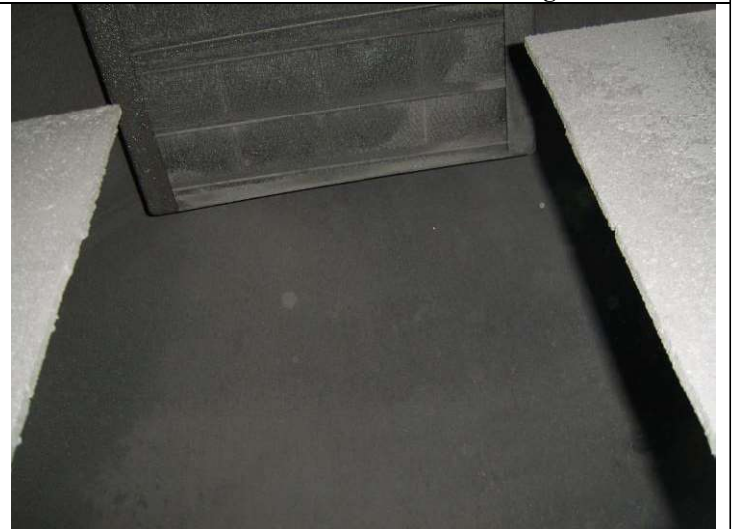
**Summary: This vessel was taken out of service to inspect the weir plate an interface could not be obtained. Results show that the weir plate was previously cut out. Vessel will be properly cleaned so the weir can be repaired.**

Weir Plate Removed

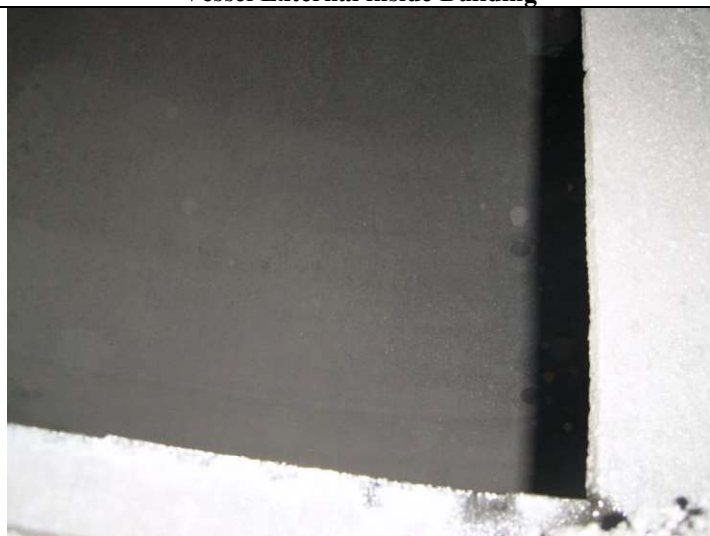
Weir plate removed 2" attachment remaining on shell for bolt on new weir plate

<b>Internal Inspection Items</b>	<b>G</b>	<b>F</b>	<b>P</b>	<b>N/A</b>	<b>Comments</b>
<b>Coating</b> Assess coating. Describe area coated, general condition of coating.				X	<b>Vessel is not internally coated.</b>
<b>Anodes.</b> How many, type, condition. % consumed. Are they being replaced?				X	<b>Vessel is not equipped with any internal anodes.</b>
<b>Internal Piping</b> Is there any? If so, carbon or stainless steel. Describe condition, dents, corrosion, erosion, etc. Ensure supports are secure and any bolts are suitable for future use.				X	<b>Complete internal access not possible as per LEL's and sludge. Vessel is being cleaned so internal access can be obtained.</b>
<b>Trays</b> How many? Type of material. Are valves in place. Check for erosion/ corrosion; wear on tray valve legs. Cleanliness?				X	N/A
<b>Baffles, deflector plates, etc.</b> If present, describe condition. Look closely at welds attached to vessel wall.			X		<b>Weir plate was suspected to have had a problem as this was the result of the vessel cleaning and opening. Quick observation noted that the weir plate had been cut out. Vessel will be cleaned so the weir plate can be repaired via a bolt in place weir to the existing plate material or via a weld repair.</b>

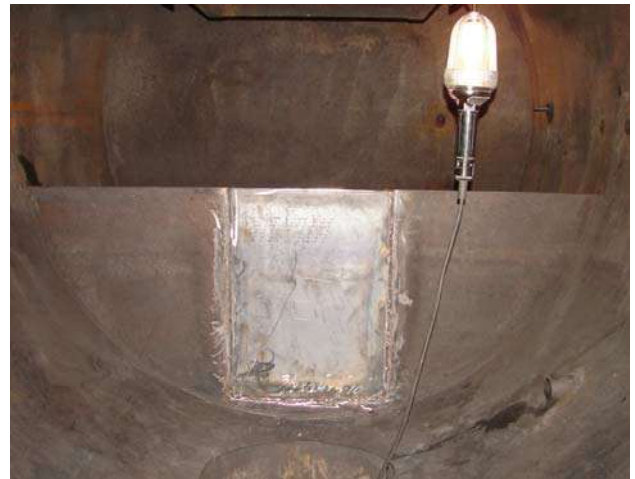
Cut-out section with new welded plating

**June 04, 2009 the weir was repaired by Bring-It Welding by replacing the cut-out section with new welded plating. The welding performed was on a non-pressure component on the vessel.**
