**Canadian Natural Resources Limited
GENERAL PRESSURE VESSEL INFORMATION**

Job # 105.00642

District: Grand Prairie	Skid No. Nil
Facility: Clear Hills Gas Plant	Location (LSD): 16-11-88-13 W6M
Vessel Name Equipment Number: Low Pressure Inlet Separator	
Orientation: Horizontal	
Status: In service	Regulatory Inspection

Photo Table for A2955267

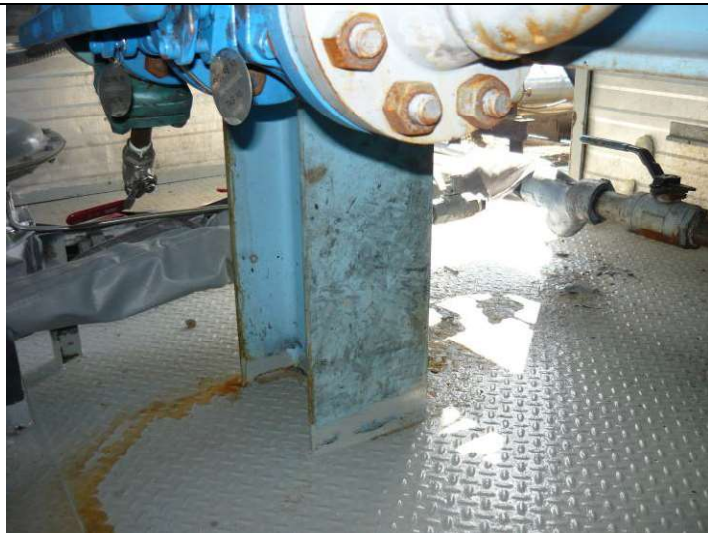
Anchor Bolts Hammer tap to ensure secure. Look for cracking in treads or signs of deformation.	X				Saddle is welded to skid floor, No deformation or cracking present.
Concrete foundation Check for cracks, spalling, etc.				X	
Ladder / Platform Describe general condition, ensure support is secure to vessel, describe any hazards.				X	
Nozzle Assess paint, look for leakage, and ensure stud threads are fully engaged. Record any damage, deflection, etc. Are nozzles gusseted?	X				Nozzle paint is in good condition no leaks present. No Stud threads present, no damage or deflection present. No gussets present.
Gauges Ensure gauges are visible, working, no leakage, and suitable for range of MAWP/ Temp.	X				Pressure gauge (0-1400 kPa) Not Suitable for MAWP, PSV is not set with in this range pressure. Temperature Gauge (-20-120°C) Suitable for range Gauges are clear and visible. (Pressure Gauge has 1/2 its liquid)

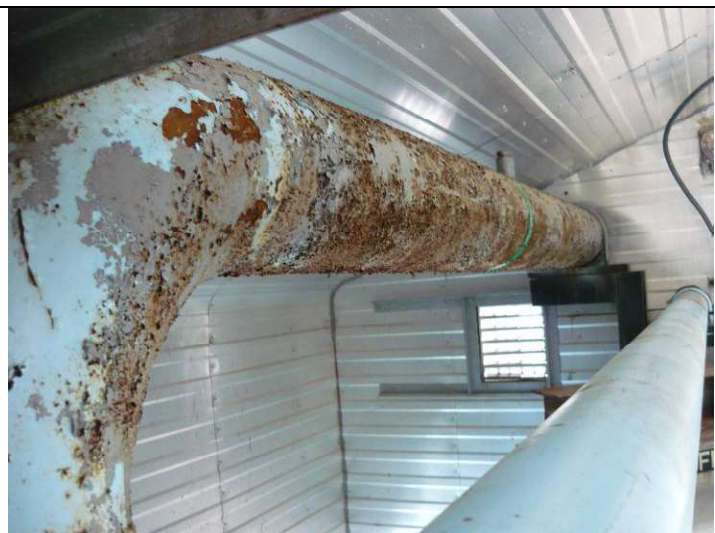
External Piping Ensure pipe is well supported. All clamps, supports, shoes, etc. in place. Look for evidence of structural overload, deflection, etc. Paint condition, external corrosion?	X				Piping is well supported and in place. No loose clamps or supports. No evidence of structural overload or deflection. Outlet line has heavy scaling from paint failure, repaint.
Valving Ensure no leaks are visible. Valves are properly supported and chained if necessary.	X				Valves are properly supported, no leaks present.
PSV Ensure PSV is set at pressure at or below that of vessel. Discharge piping is same size as inlet to valve and is properly supported and routed. Ensure no block valves between PSV and vessel or if there are they are locked open.	X				PSV is set at MAWP of vessel. PSV Discharge piping is larger than inlet piping and is properly supported and routed. No block valves present PSV Seal is intact Location: Upper shell

Outlet Piping (Paint)
