**Canadian Natural Resources Limited
GENERAL PRESSURE VESSEL INFORMATION**

Job 10.112902

District: Grande Prairie AB.	Skid No.
Facility: Clear Hills Gas Plant	Location (LSD): 16-11-88-13W6M
Vessel Name Equipment Number: Sales Cyclone Separator	
Orientation: Vertical	
Status: In Service	Regulatory Inspection

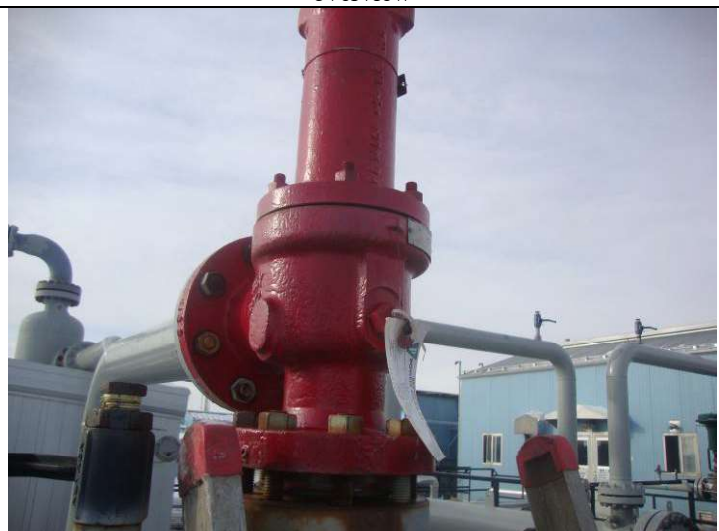
Valving Ensure no leaks are visible. Valves are properly supported and chained if necessary.	X				Valves are supported properly – no leaks.
PSV Ensure PSV is set at pressure at or below that of vessel.	X				Location: outlet piping - Set below MAWP of vessel. No block valve between vessel and PSV. Discharge piping same size as valve outlet. Seal in place.
NDE methods Was UT/ MPI done on vessel (MI coordinator to review results)	X				Ultrasonic corrosion survey carried out - no metal thickness detected below nominal minus corrosion allowance.
Other					
<p>Recommendations or corrective actions : Vessel is Fit for Service or describe corrective actions required) (MIC to review corrective actions with Operations, discuss with Chief Inspector where necessary, and get remedial action implemented) Recommendations: No recommendations. Summary: This vessel is in good condition, visual external and ultrasonic thickness inspection carried out – no metal thickness detected below nominal minus corrosion allowance. Short term corrosion rate based on greatest thickness loss (nozzle) 0.075mm per year. Retirement Date to “T”min is year 2106. Vessel is fit for service.</p>
