Ē												
Canadian Natural Resources Limited GENERAL PRESSURE VESSEL INFORMATION Job # 105.00642												
District: Grand Pra	nirie		Skid No. Nil									
Facility: Clear Hills	Location (LSD): 16-11-88-13 W6M											
Vessel Name Equipment Number: Sales Cyclone Separator												
Orientation: Vertica	al											
Status: In service				Regulatory I	nspection							
PRESSURE VESSEL NAMEPLATE DATA												
"A" or "G" or	r "S" (Sask.) or BC R	CRN Number:										
	P-5547.21											
Vessel serial number	r: C01-6525-1			Size: 30" x 20"								
Shell thickness: 50.8	8mm			Shell material: SA 516 70 N								
Head thickness: 48.	3mm			Head material: SA 516 70 N								
Tube wall thickness:				Tube material:								
Tube diameter:	Tube length:											
Channel thickness:				Channel material:								
Channel unickness: Shell: 13790 kPa Design pressure				Operating pressure		Shell: 6300 kPa

A465949

Photo Table for A465949

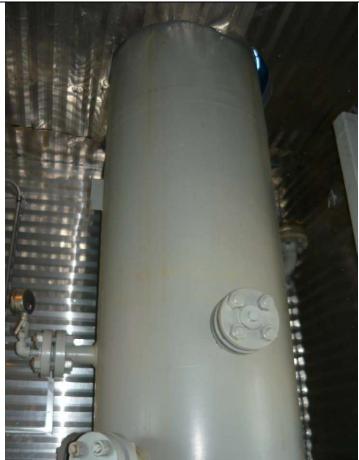
Bottom Head Scaling

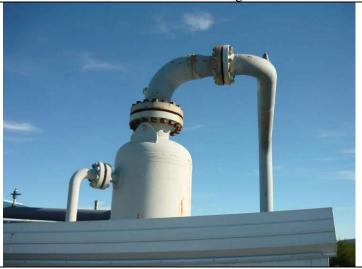
Vessel Overview

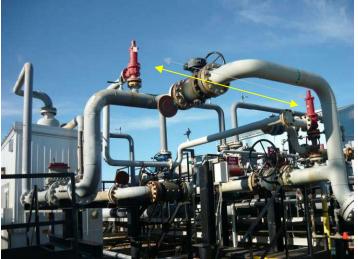
Roof Seal not intact

Recommendations: 1) Service PSV 2) Install a roof seal.

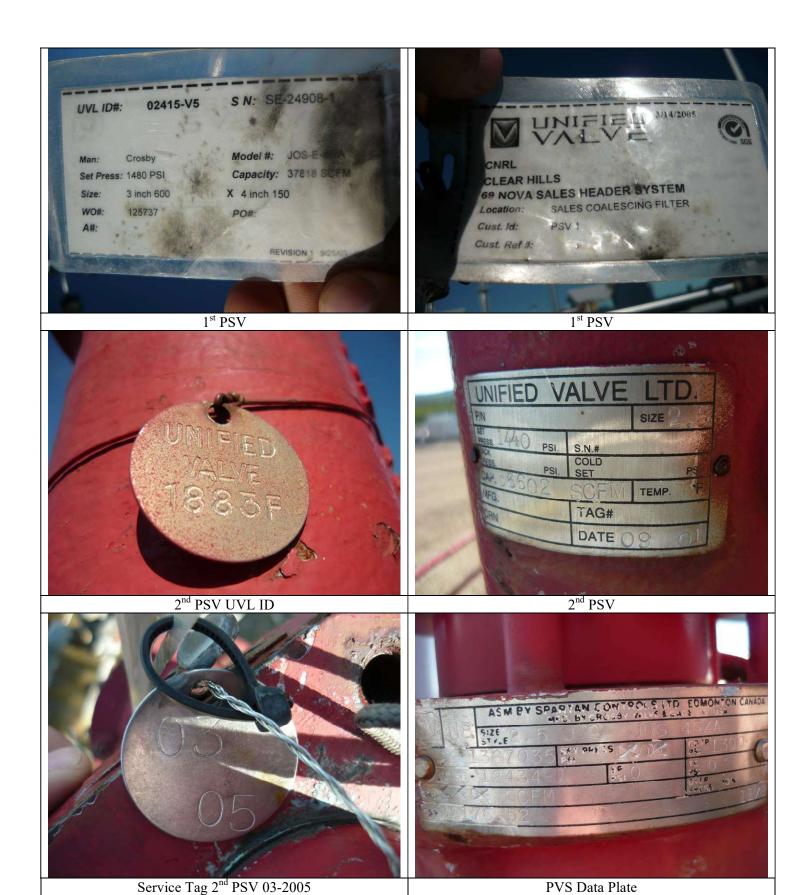
Two PSV's on the same sales line (left=1 right =2) second PSV was recorded on excel list.
