**Canadian Natural Resources Limited
GENERAL PRESSURE VESSEL INFORMATION**

Facility: Saddle Hills Gas Gathering	Location (LSD): 03-36-74-07 w6m
---	--

Vessel Name Equipment Number: **Inlet Separator**

Status: In Service	Regulatory Inspection
---------------------------	------------------------------

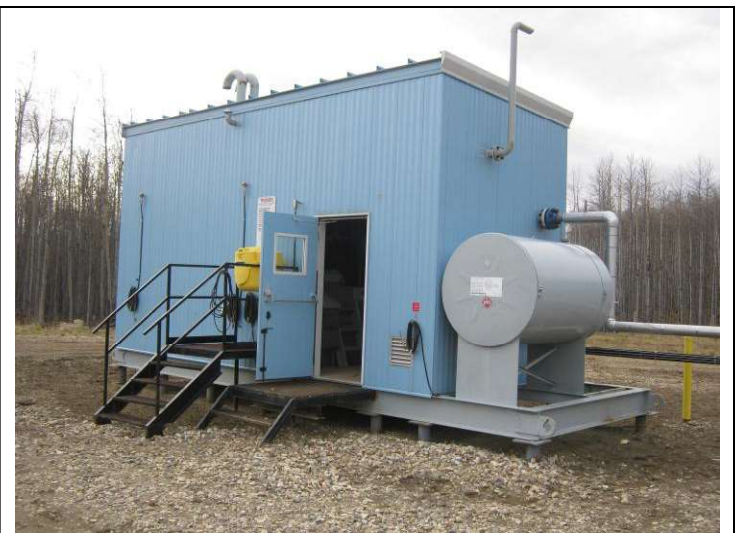
Overview – Skid

External Inspection Items	G	F	P	N/A	Comments
Insulation Verify sealed around manways, nozzles, no damage present, and there is no egress of moisture.				X	Vessel is not insulated.
External Condition Assess paint condition, areas peeling, record any corrosion, damage, etc (record location, size and depth of corrosion or damage)	X				Paint in good condition. No exposed metal. No damage.
Leakage Record any leakage at flanges, threaded joints, weep holes on repads, etc.	X				No leaks observed.
Saddle/Skirt Assess condition of paint, fire protection, concrete. Look for corrosion, buckling, dents, etc. Look at vessel surface area near supports. Verify no signs of leakage at attachment to vessel and attachment welds are acceptable. Ground wire attached?	X				Vessel skirt is bolted to skid floor. No evidence of corrosion at shell to skirt weld – no leaks. Paint in good condition – no exposed metal. No distortion. No buckles. Skid package is mounted to pilings above ground level. Skid package has ground wire attached.

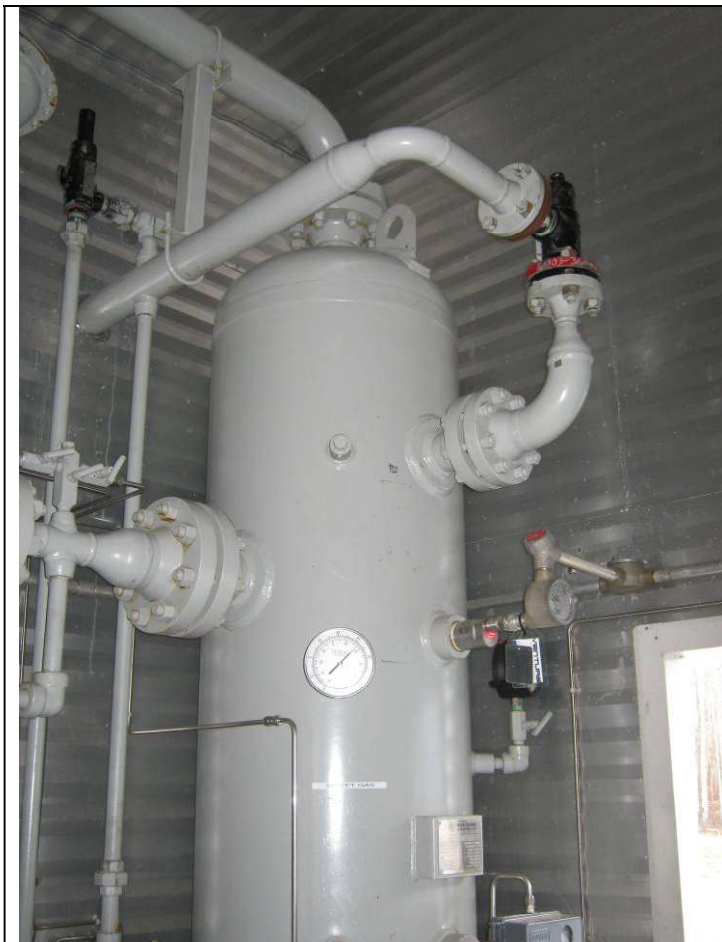
Overview – Upper shell and PSV location

External Piping Ensure pipe is well supported. All clamps, supports, shoes, etc. in place. Look for evidence of structural overload, deflection, etc. Paint condition, external corrosion?	X				Piping is well supported. All clamps, supports and shoes are in place. No structural overloads or deflections noted. Paint in good condition.
Valving Ensure no leaks are visible. Valves are properly supported and chained if necessary.	X				Valves are properly supported. No leak detected.
PSV Ensure PSV is set at pressure at or below that of vessel.	X				Located on upper shell – set below MAWP of vessel. Discharge piping is same size as valve outlet. Valve is properly supported and routed. PSV seal in place. No block valve between PSV valve and vessel.

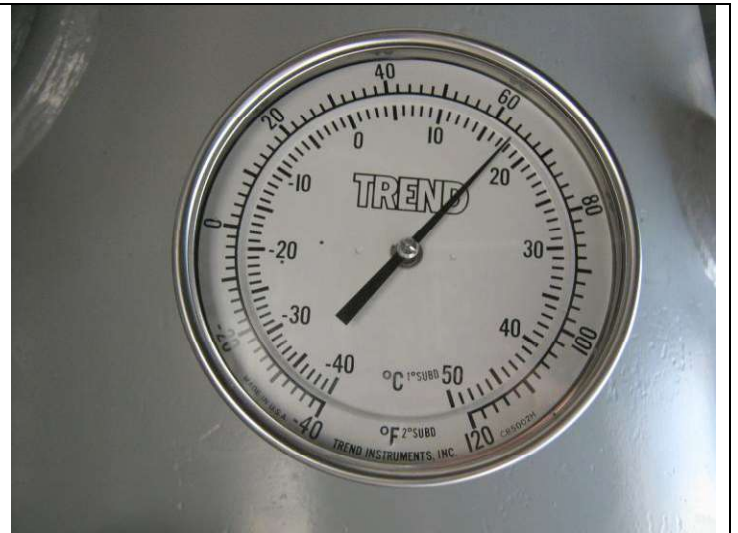
Temperature gauge

Anchor Bolts Hammer tap to ensure secure. Look for cracking in treads or signs of deformation.	X				Anchor bolts are securely fastened.
Concrete foundation Check for cracks, spalling, etc.				X	Steel skid.
Ladder / Platform Describe general condition, ensure support is secure to vessel, describe any hazards.				X	No ladder or platform attached.
Nozzle Assess paint, look for leakage, and ensure stud threads are fully engaged. Record any damage, deflection, etc. Are nozzles gusseted?	X				Threaded nozzle joints are fully engaged. Studs are fully engaged to nuts – no short bolts. PSV nozzle is gusseted. Remainder of nozzles no gussets. No damage. No deflections. Paint in good condition. No exposed metal.
Gauges Ensure gauges are visible, working, no leakage, and suitable for range of MAWP/ Temp.	X				Pressure, temperature and liquid level gauges attached. Pressure gauge: 0 to 10340 kPa. Within range of MAWP. Temperature gauge: -40 to 50°C. Within range of MAWT. Clean, clear and in working condition. No leaks.
