Canadian Natural Resources Limited GENERAL PRESSURE VESSEL INFORMATION Job # 05.001766												
District: Fort St. Jo	hn BC	Skid No.										
Facility: Lagarde C	Location (LSD): 01-21-87-15-W6M											
	ment Number: Glycol											
Orientation: Vertical												
Status: In Serv			Regulatory Inspection									
PRESSURE VESSEL NAMEPLATE DATA												
"A" or "G" o	r "S" (Sask.) or BC R	CRN Number:										
	A 3182406	M 2316.21										
Vessel serial numbe	r: 96-8306-OREPL/01	Size: 24 in. x 32 ft.										
Shell thickness: 28.6		Shell material: SA 516-70N										
Head thickness: 27.0	)2mm	Head material: SA 516-70N										
Tube wall thickness	:			Tube material:								
Tube diameter:				Tube length:								
Channel thickness:		Channel material:										
Design pressure	Shell: 1440 PSI	Operating pressure		Shell:	0- 1500 PSI							
Design pressure	Tubes:			Tubes:								
Design Temp.	Shell: 130 Deg F			Operating temperature		Shell: 0 – 250 Deg F

## Photo Table

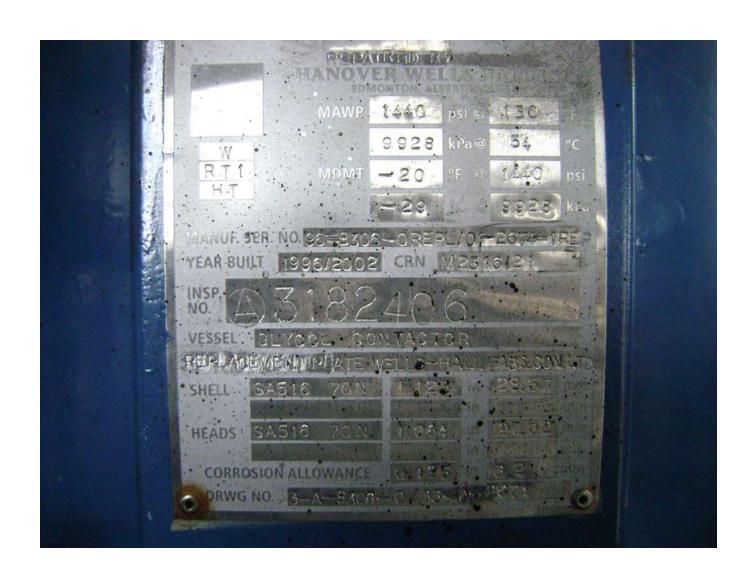
vessel overview
