**Canadian Natural Resources Limited  
GENERAL PRESSURE VESSEL INFORMATION**

**Job # 10.110674**

Facility: <b>Saddle Hills Gas Gathering</b>	Location (LSD): <b>15-34-75-07 w6m</b>
---	--

Vessel Name Equipment Number: **Line Heater**

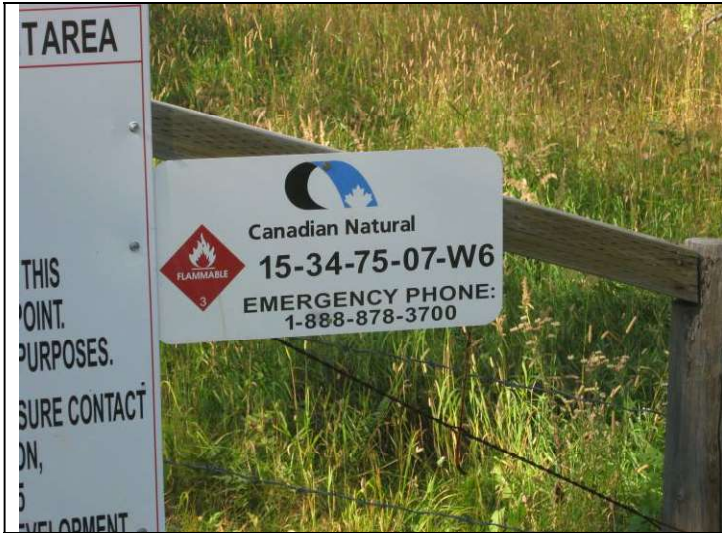
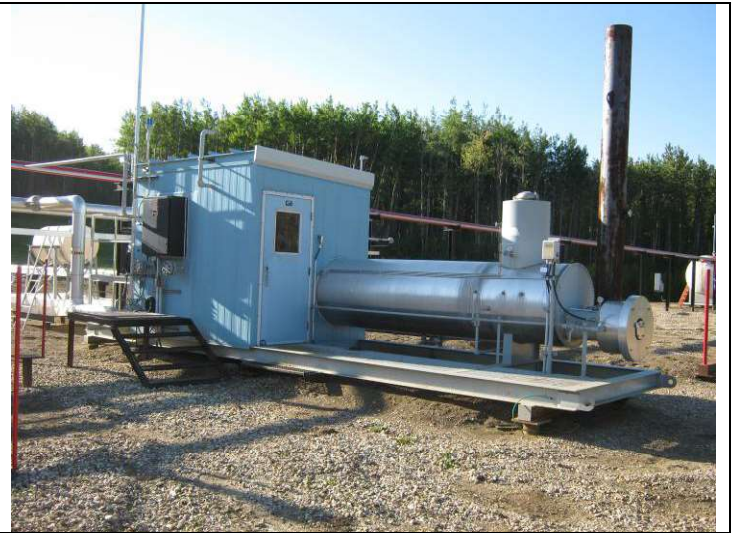
Overview – Skid

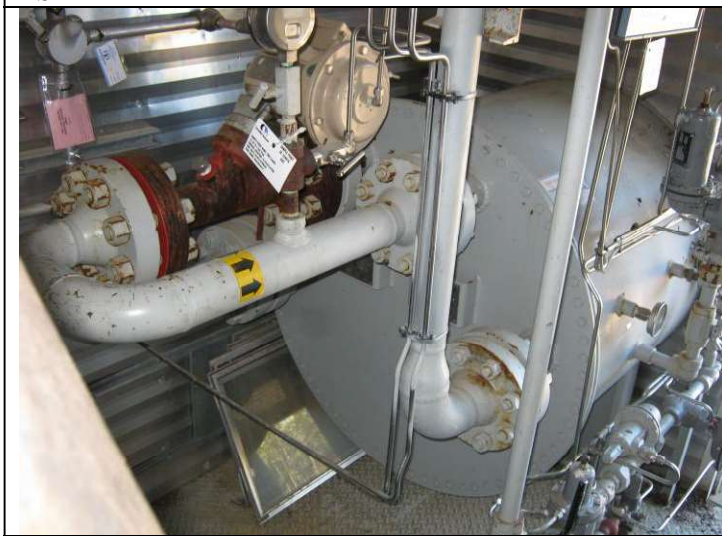
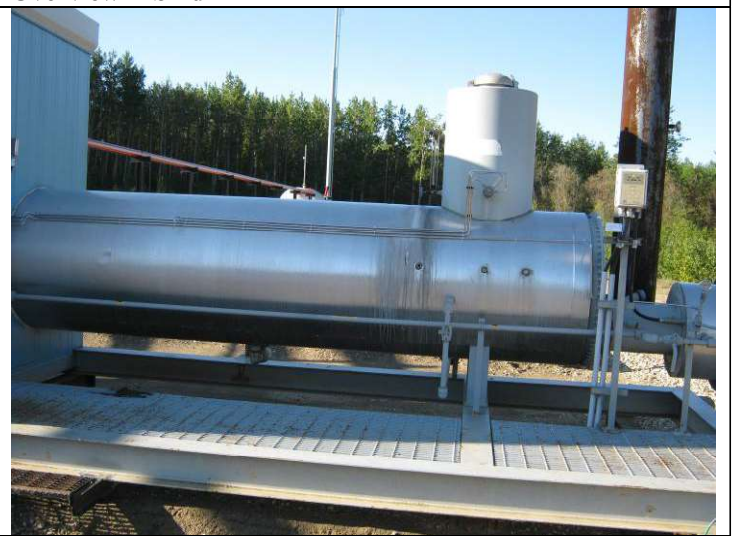
Overview - Vessel

Overview – Vessel

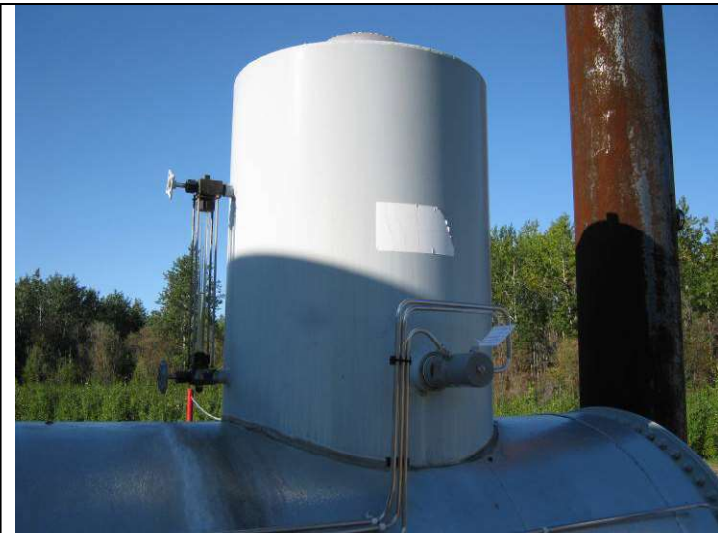
Expansion tank with liquid level

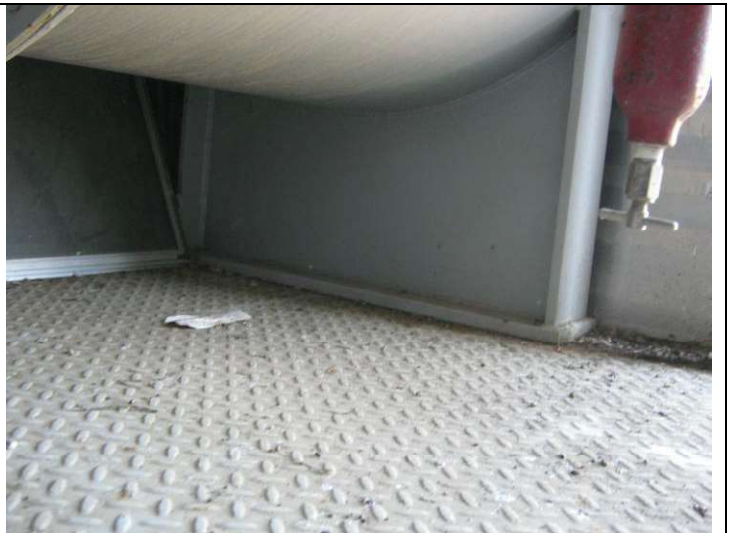
Saddle

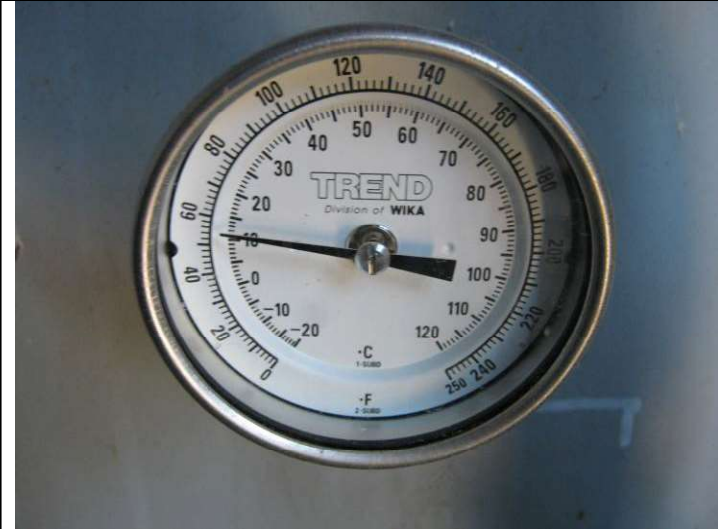
Shell temperature gauge

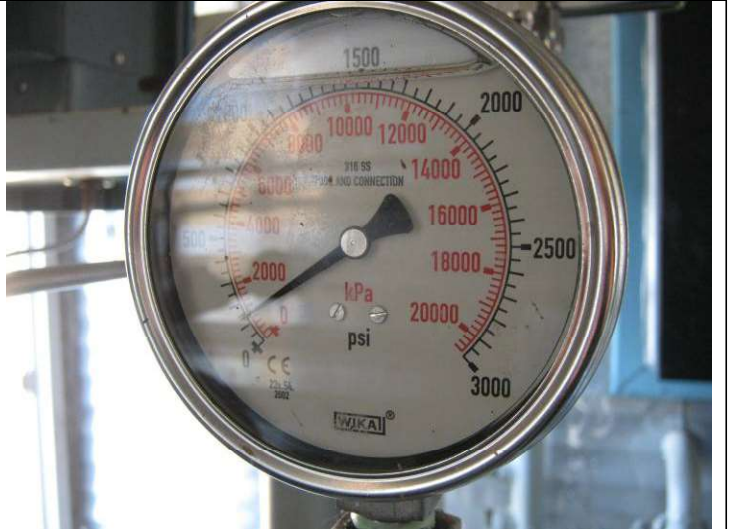
Pressure gauge

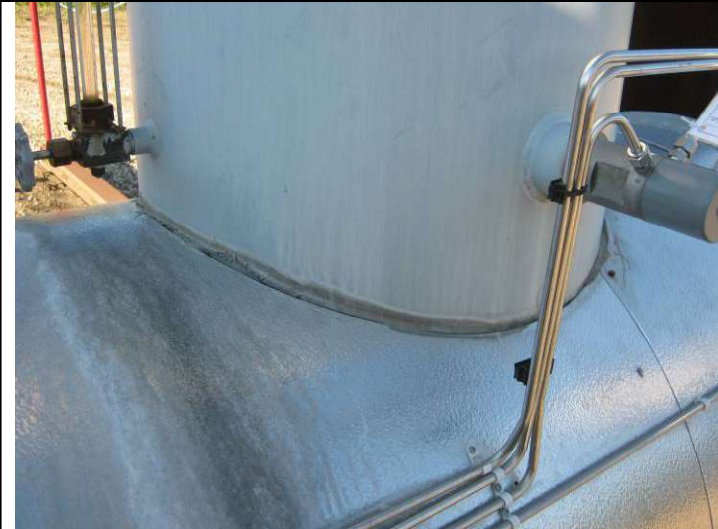
External Inspection Items	G	F	P	N/A	Comments
<b>Insulation</b> Verify sealed around manways, nozzles, no damage present, and there is no egress of moisture.		X			Vessel is 80% insulated. <b>Cladding is not sealed at expansion tank</b> Wall closure sealed – no egress of moisture.
<b>External Condition</b> Assess paint condition, areas peeling, record any corrosion, damage, etc (record location, size and depth of corrosion or damage)	X				Paint in good condition – no exposed metal. No damage. No corrosion.
<b>Leakage</b> Record any leakage at flanges, threaded joints, weep holes on repads, etc.	X				No leaks observed.
<b>Saddle/Skirt</b> Assess condition of paint, fire protection, concrete. Look for corrosion, buckling, dents, etc. Look at vessel surface area near supports. Verify no signs of leakage at attachment to vessel and attachment welds are acceptable. Ground wire attached?	X				Vessel saddle is bolted to skid. No evidence of corrosion at shell to saddle weld – no leaks. Paint in good condition – no exposed metal. No distortion. No buckles. Skid package is mounted to pilings above ground level. Skid package has ground wire attached.

Closure not sealed around expansion tank

<p><b>Recommendations or corrective actions : Vessel is Fit for Service or describe corrective actions required)</b> (MIC to review corrective actions with Operations, discuss with Chief Inspector where necessary, and get remedial action implemented)</p> <p><b>Recommendations: 1. Seal cladding at expansion tank.</b></p> <p><b>Summary:</b> Vessel is in overall good condition, visual external inspection and ultrasonic corrosion survey performed – pipe metal thickness detected below nominal minus corrosion allowance. Thickness calculations carried out to ensure sufficient metal exists for safe operation.</p> <p><b>Vessel is fit for service.</b></p>
