**Canadian Natural Resources Limited
GENERAL PRESSURE VESSEL INFORMATION**

Facility: **Saddle Hills Gas Gathering** Location (LSD): **16-28-75-07 w6 (DH) 09-28-75-05w6 (SL)**

Vessel Name Equipment Number: **Line Heater**

Status: **In Service** **Regulatory Inspection**

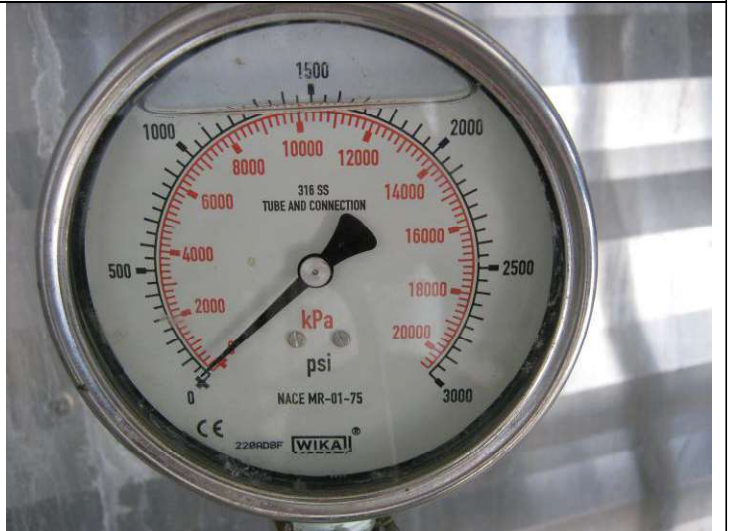
Pressure gauge

Anchor Bolts Hammer tap to ensure secure. Look for cracking in treads or signs of deformation.	X				Anchor bolts are securely fastened.
Concrete foundation Check for cracks, spalling, etc.				X	Steel skid.
Ladder / Platform Describe general condition, ensure support is secure to vessel, describe any hazards.				X	No ladder attached.
Nozzle Assess paint, look for leakage, and ensure stud threads are fully engaged. Record any damage, deflection, etc. Are nozzles gusseted?	X				Threaded nozzle joints are fully engaged. Studs are fully engaged to nuts – no short bolts. Nozzles are not gusseted. No damage. No deflections. Paint in good condition – no exposed metal.
Gauges Ensure gauges are visible, working, no leakage, and suitable for range of MAWP/ Temp.	X				Pressure and liquid level gauges attached. Clean, clear and in working condition. No leaks. Pressure gauge: 0 to 20685 kPa. Within range of service.

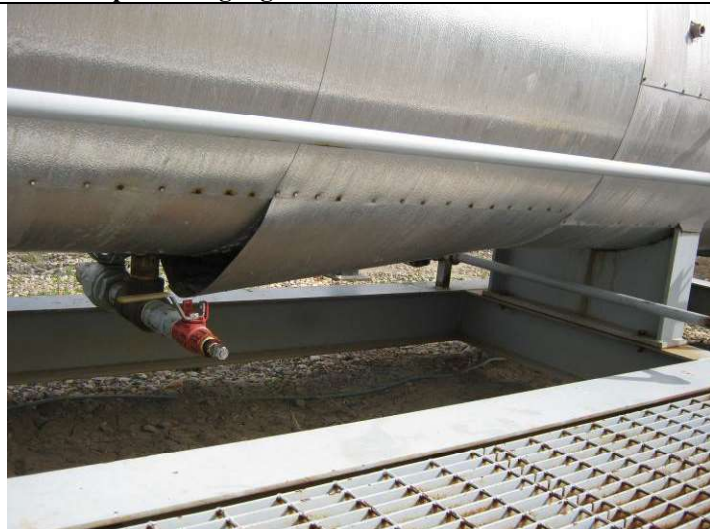
External Inspection Items	G	F	P	N/A	Comments
Insulation Verify sealed around manways, nozzles, no damage present, and there is no egress of moisture.		X			Vessel is 80% insulated. Cladding on bottom shell is loose with exposed insulation. Wall closure sealed – no egress of moisture.
External Condition Assess paint condition, areas peeling, record any corrosion, damage, etc (record location, size and depth of corrosion or damage)	X				Paint in good condition – no exposed metal. No damage. No corrosion.
Leakage Record any leakage at flanges, threaded joints, weep holes on repads, etc.	X				No leaks observed.
Saddle/Skirt Assess condition of paint, fire protection, concrete. Look for corrosion, buckling, dents, etc. Look at vessel surface area near supports. Verify no signs of leakage at attachment to vessel and attachment welds are acceptable. Ground wire attached?	X				Vessel saddle is bolted to skid. No evidence of corrosion at shell to saddle weld – no leaks. Paint in good condition – no exposed metal. No distortion. No buckles. Skid package is mounted to pilings above ground level. Skid package has ground wire attached.

Bottom shell - Loose cladding and wet insulation

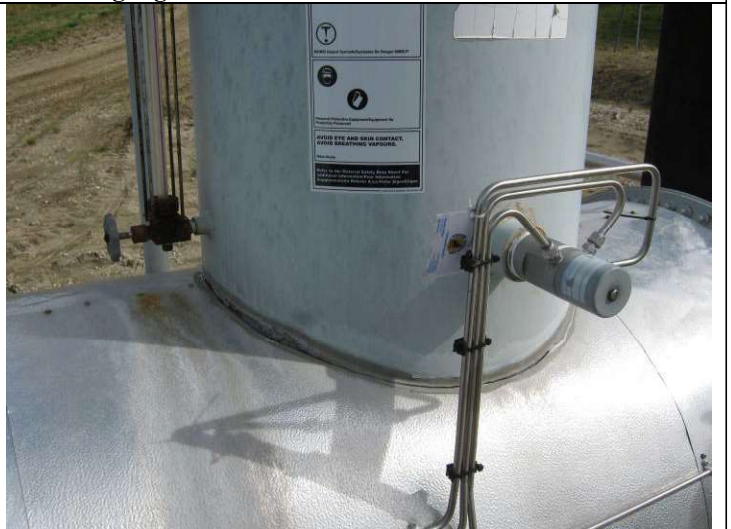
Closure not sealed around expansion tank
