**Canadian Natural Resources Limited
GENERAL PRESSURE VESSEL INFORMATION**

Facility: **Saddle Hills Gas Gathering** Location (LSD): **13-27-75-07 w6m**

Vessel Name Equipment Number: **Line Heater**

Status: **In Service** **Regulatory Inspection**

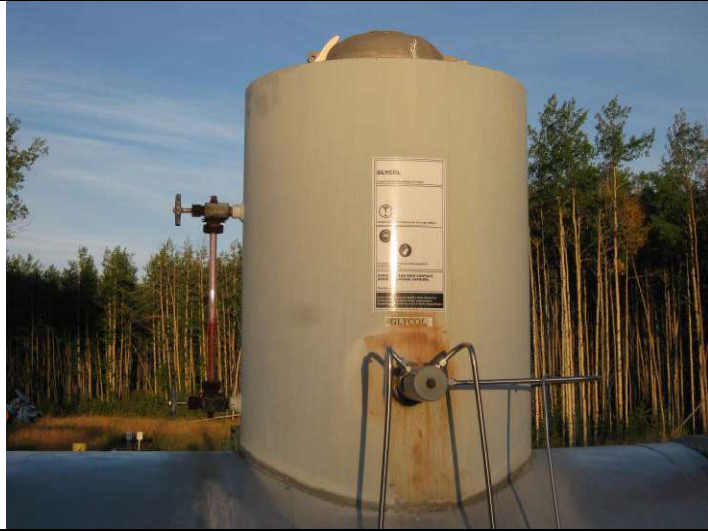
Expansion tank with liquid level

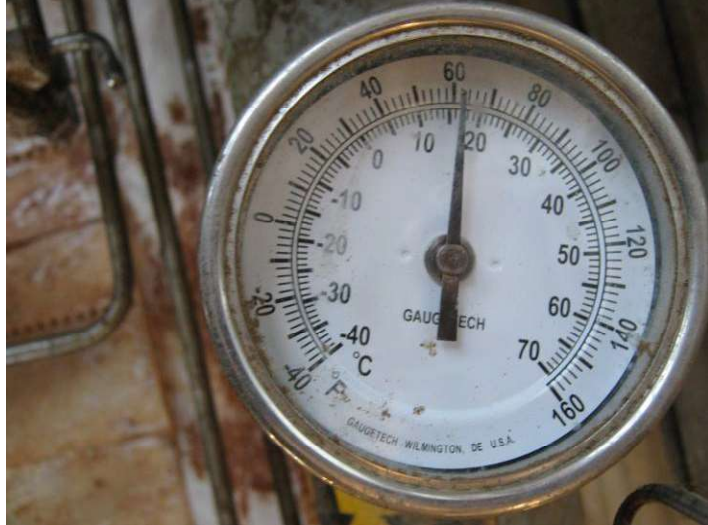
Inlet temperature gauge

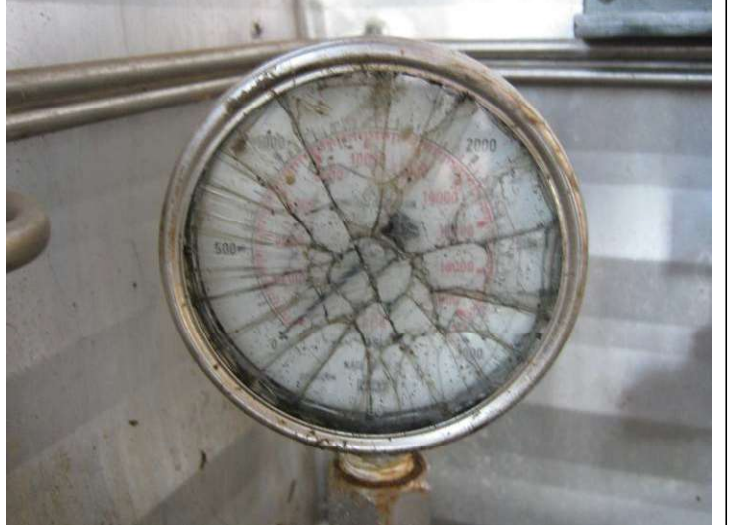
Inlet pressure gauge

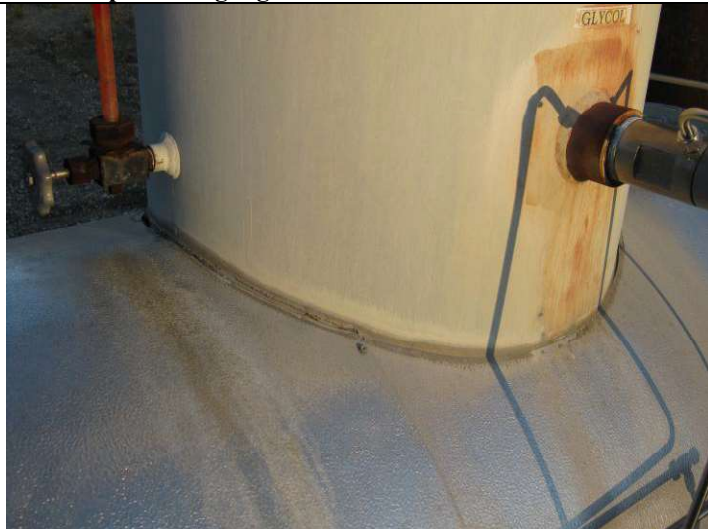
External Inspection Items	G	F	P	N/A	Comments
Insulation Verify sealed around manways, nozzles, no damage present, and there is no egress of moisture.		X			Vessel is 80% insulated. Cladding is not sealed at expansion tank Wall closure sealed – no egress of moisture.
External Condition Assess paint condition, areas peeling, record any corrosion, damage, etc (record location, size and depth of corrosion or damage)	X				Minor paint abrasion to 5% exposed metal. No damage. No corrosion.
Leakage Record any leakage at flanges, threaded joints, weep holes on repads, etc.	X				No leaks observed.
Saddle/Skirt Assess condition of paint, fire protection, concrete. Look for corrosion, buckling, dents, etc. Look at vessel surface area near supports. Verify no signs of leakage at attachment to vessel and attachment welds are acceptable. Ground wire attached?	X				Vessel saddle is bolted to skid. No evidence of corrosion at shell to saddle weld – no leaks. Paint in good condition – no exposed metal. No distortion. No buckles. Skid package is mounted to pilings above ground level. Skid package has ground wire attached.

Closure not sealed around expansion tank
