VESSEL INSPECTION SUMMARY

Report #: 141148-PM-18 Inspect Date: 02/03/2010 1 of 4 Page: IRISNDT #: 141148

Client:	Client: CNRL				District: St. Albert				Field: Endiang				
Facility:				Uı	Jnit / Skid #: N/A			-	LSE		034-15W4		
Jurisdiction #:				quip Tag #: N/A			-	Serial #	#: 26	904A			
CRN #:				Nat'l Bd #:			Year Built: 1984			984			
Manufacturer:	Manufacturer: Western Rock Bit Co. Ltd. Equipment Description: Propane Bullet												
	In Service - Date Removed From Service: Service: Sweet												
MAWP Shell:	1724	kPa	_ @ _	46	°C	Height/L			77	in.		Code Stamp:	\boxtimes Y \square N
MAWP Tube:			_ @ _			Size/Diar	neter.: _		in.	O.D.		Insulated:	
MDMT:			_ RT:	RT-2		Vo	olume: _	6	8.6	m³		PWHT:	
Support Type:	Sad	dle	_									Manway:	\boxtimes Y \square N
C.A.:			_ Coate	ed: 🔲 Y	Y 🗌 N Clad: 🗌 Y 🗍 N J.E.: Remote Access: 🗌								
Comp	onent			Mate	erial		Nomin	al Thk	Diame	eter	OD/ID	Tube Side	Shell Side

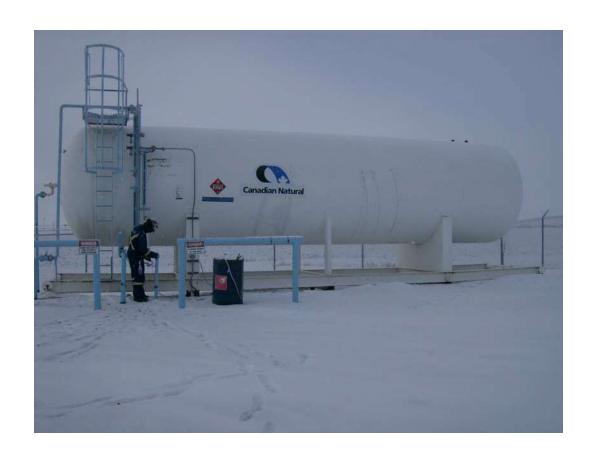
A0218190_Overview_03Feb10

External Visual Observations	<u> </u>				Ivialiuai Neview Nequ	ned by Cust	oniei Kepiese	illative -	
An external visual inspection was performed on the vessel and the findings are as follows: The vessel was operating at time of inspection. No process leaks or vibrations were noted The paint is on shell and piping in very good condition with very isolated areas of paint flaking down to clean bare metal. All piping, flanges and bolting were in good condition. Manway is in good condition with some paint flaking with mild general corrosion. Bolting shows general corrosion where paint has failed but in acceptable condition.									
Ladder and platform is in good condition and secure The vessel is supported by saddles welded to shell and welded to metal skid. Vessel is secure and level. External UT was performed with no significant wall losses noted. Could not access PSV's. Refer to the attached photos, UT data and drawing for inspection findings. The vessel appears to be in good operating condition for continued service based on the external visual observations and UT thicknesses recorded and that overpressure protection has been verified.
