Ultrasonic Inspection Report

Job #:	Report #:	Inspection Date:
-	UT-BV-1	June 26, 2012

•								
Clien	nt: C	CNRL					Location:	Grand Forks Battery LSD:04-0			1-013-13	W4M
Procedur	e: L	JT-0001	1 Item I		spected: Vessel Free		Water Kno	Water Knock Out A0242049				
Cod	e: A	ASME Se	ection V	ction VIII Div 1

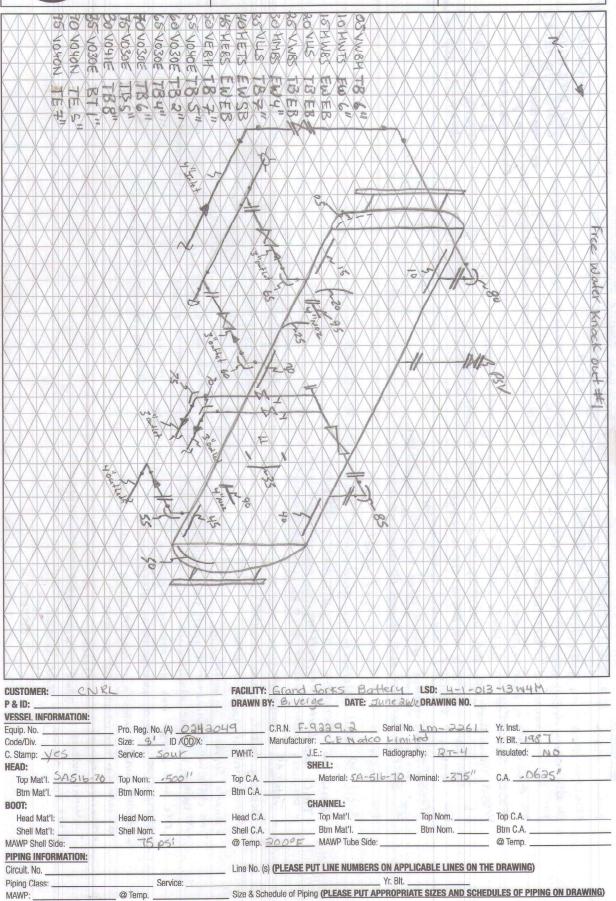
All readings were found to be at or above nominal on the shell and heads. Extreme pitting was found on two of the drain elbows. TML 60 (middle drain elbow) recorded reading of 0.154" and TML 65 (West end drain elbow) recorded reading of 0.184". These readings are unchanged from previous 2009 UT Survey. Decision was made to internally recoat the nozzles and schedule to replace in kind at next opportunity.

Continue to carry out UT corrosion survey and Visual inspection at the required inspection frequency. Schedule to have the drain elbows replaced in kind at next opertunity.
