## Field Inspection Report

Client	CNRL		Date of Inspection	June 26, 2012					
Prov. Reg.#	A0242049		Inspection Type	VI, VE, UT					
Equipment	Free Water Knock Out #1		Location	Grand Forks Battery					
Tag/Equip. #			LSD	04-01-013-13W4M					
Vessel Status	In Service		Comp./Unit #						
Manufacturer	C.E Natco Limited		MAWP / Temp	75 PSIG @ 200 F					
Serial #	LM-2261	CRN #	F 9229.2	MDMT@ Pressure					
Corrosion Allowance	0.0625"	Shell Material	SA-516-70	Shell Thickness	0.375"				
Year Built	1987	Head Material	SA516-70	Head Thickness	0.500"				
Diameter	8' OD	Length		Height		RT	RT-4	HT	
Service	Sour	Next Inspection		Next Insp. Type					
ASME Stamp	Yes	Next Inspection		Next Insp. Type					
PSV Tag #		CRN#	01832.52	Set Pressure	75 PSIG				
Manufacturer	Consolidated			NB#		ASME Stamp			
Type/Model		Serial	87C2443	Inlet Size	3"				
Capacity		Service Company	Tarpon	Outlet Size	3"				
Service Date	June 2012		Next Service Date						
Valve Location	<ul style="list-style-type: none"> <li>• On Vessel</li> <li>On Piping</li> <li>Vents to Flare</li> <li>Vents to Atmosphere</li> </ul>	Valve Connection	<ul style="list-style-type: none"> <li>Threaded</li> <li>• Flanged</li> <li>Welded</li> </ul>	AB

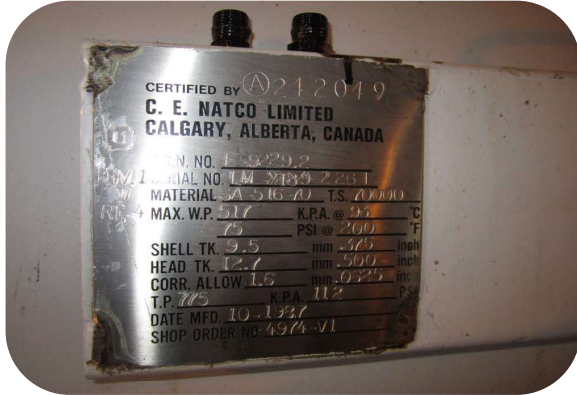
A0242049\_Name plate\_26June2012

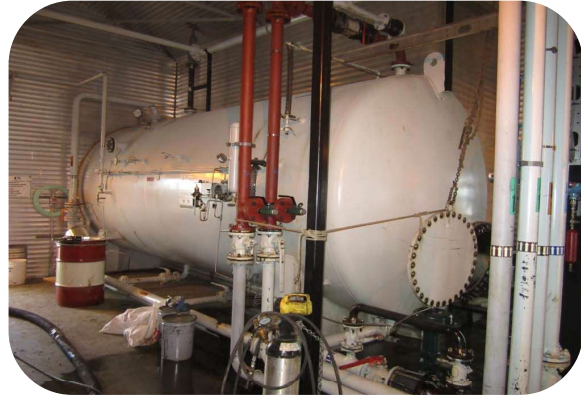
A0242049\_South side shell view\_26June2012

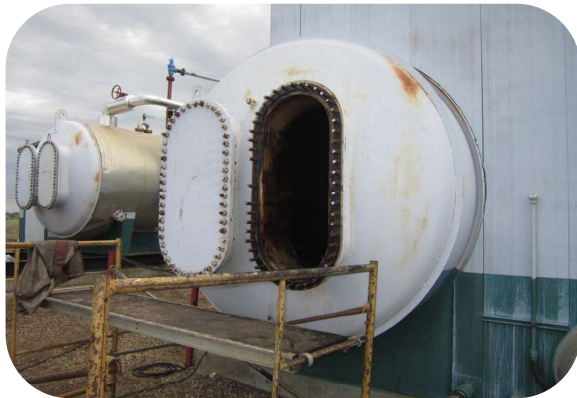
A0242049\_West head manways\_26June2012

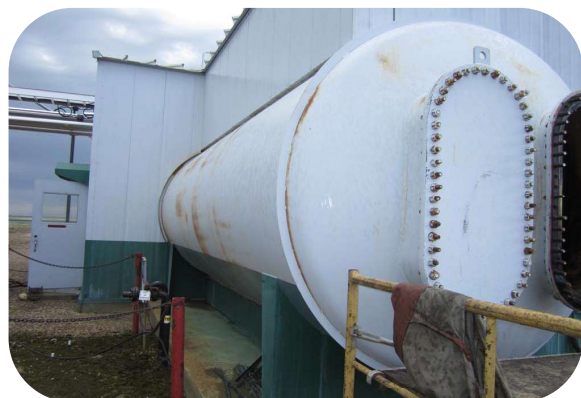
A0242049\_North West side shell\_26June2012

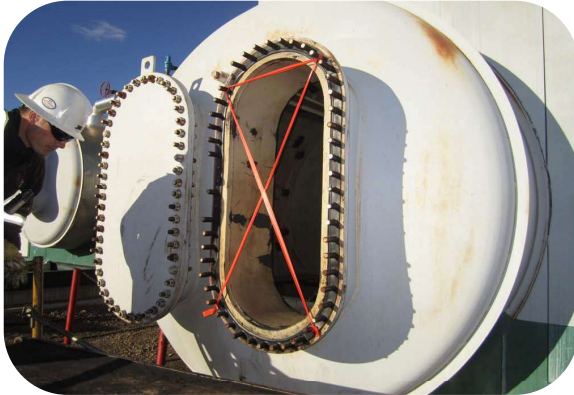
A0242049\_Manway gasket in good condition\_27June2012

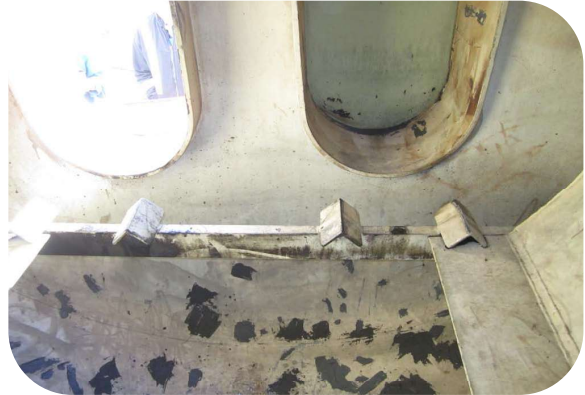
A0242049\_West Head internal knuckle region\_27June2012

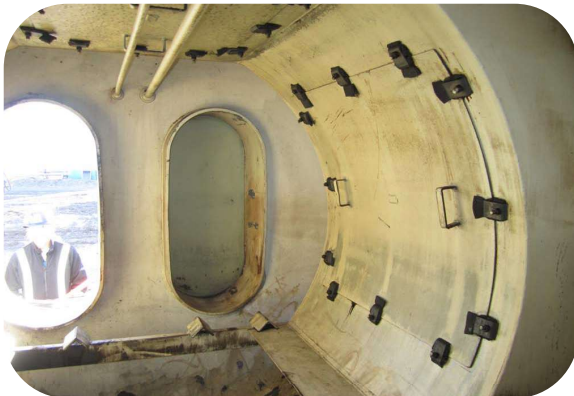
A0242049\_Horse Shoe diffuser intact\_27June2012

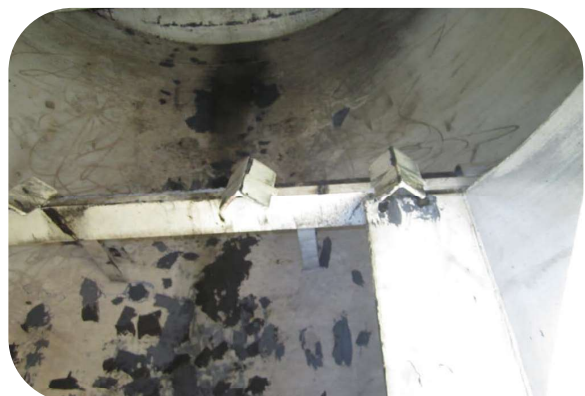
A0242049\_Old Firetube supports\_27June2012

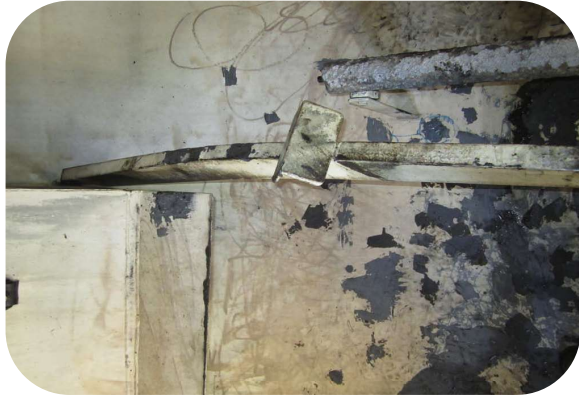
- Manway gasket surfaces were in good condition.
- Internal shell coating was in good shape with no corrosion or pitting noted.
- Firetube internals were intact and secure. Support has old mechanical damage from when firetubes were used before but causes no concern at all.
- All internal nozzles were in good shape.
- Internal Anode was in good shape, the supports were intact and secure.
- Horse shoe diffuser was intact with all bolting in place and secure.
- Oil collection box was in good condition.
- Thermal couple was intact and secure.
- Chevron wafer plate was intact, in good shape with all bolting hardware in place and secure.
- No deflection or deformation of the shell, head or nozzles noted.

A0242049\_Damage to Firetube support from previous use\_27June2012

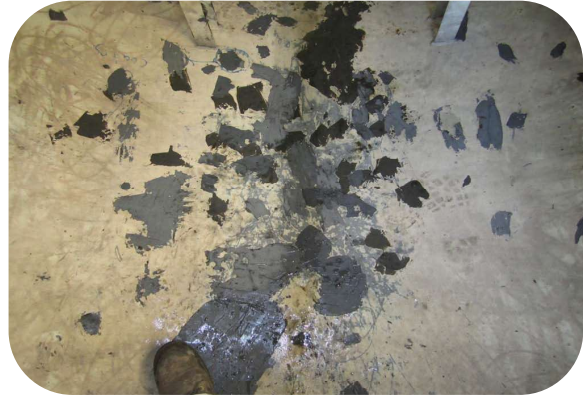
A0242049\_Previouse coating repairs still in good shape\_27June2012

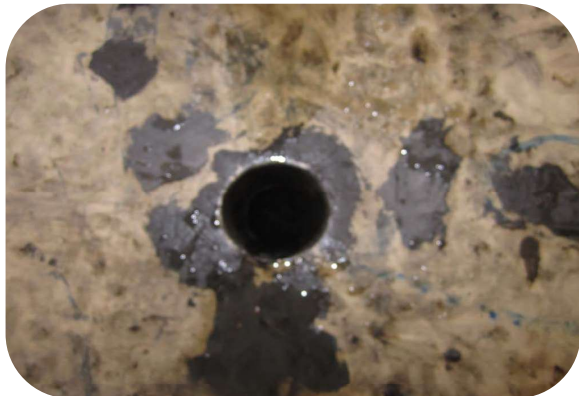
A0242049\_Internal nozzle in good condition\_27June2012

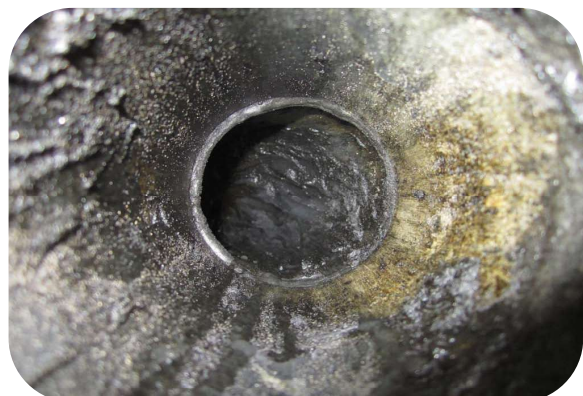
A0242049\_Internal view of nozzle\_27June2012

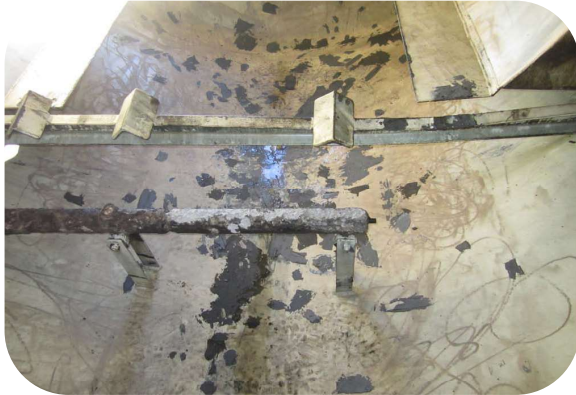
A0242049\_Hot end internal  
Anode\_27June2012

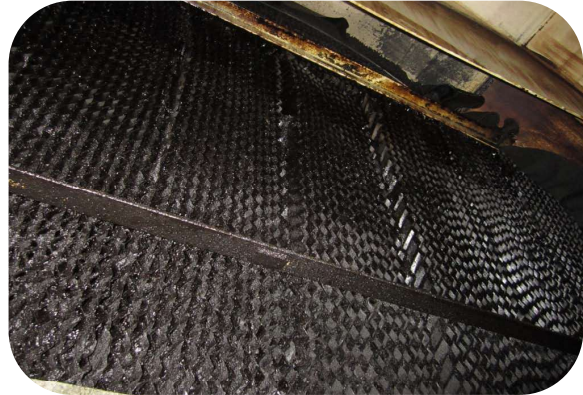
A0242049\_Hot end Chevron Waffle  
Plate\_27June2012

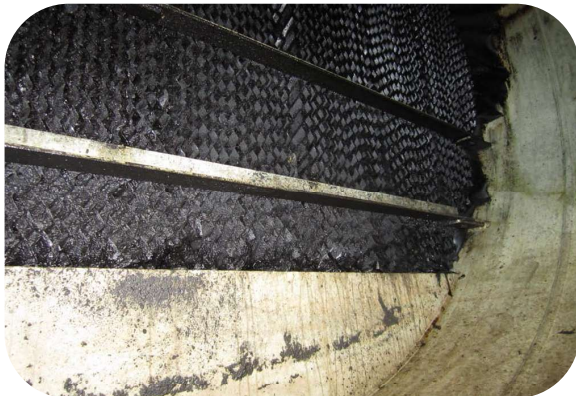
A0242049\_Hot end Chevron Waffle plate  
supports intact\_27June2012

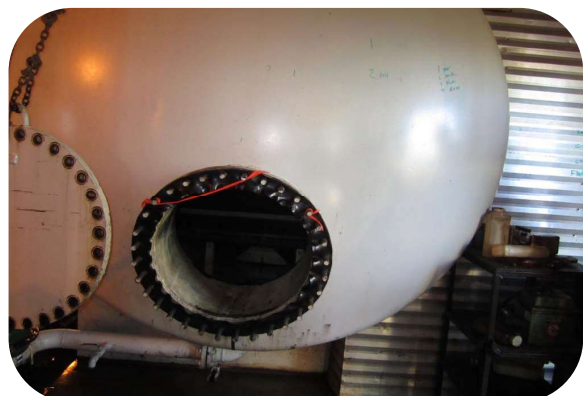
A0242049\_East Head manway and  
cover\_27June2012

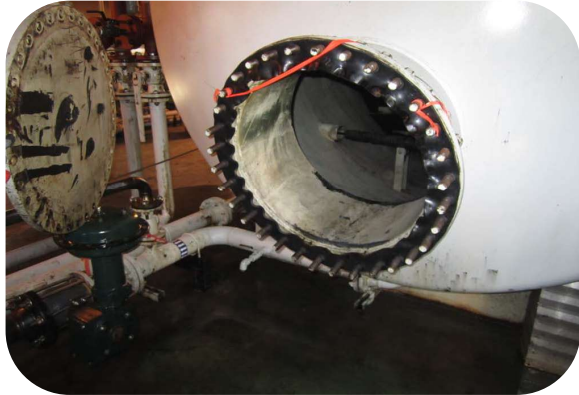
A0242049\_East manway gasket in good shape\_27June2012

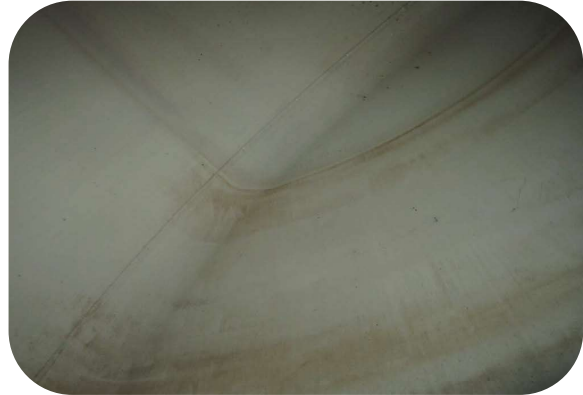
A0242049\_Cold end internal coating\_27June2012

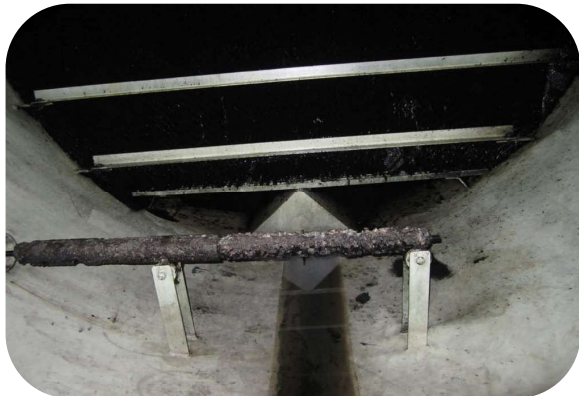
A0242049\_Cold end internal Anode\_27June2012

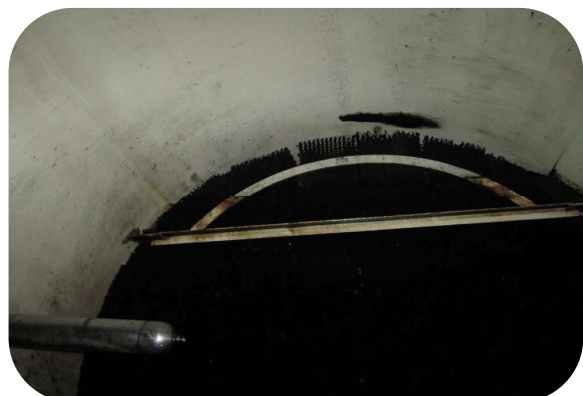
A0242049\_Cold end view of Chevron Waffle plate and supports\_27June2012

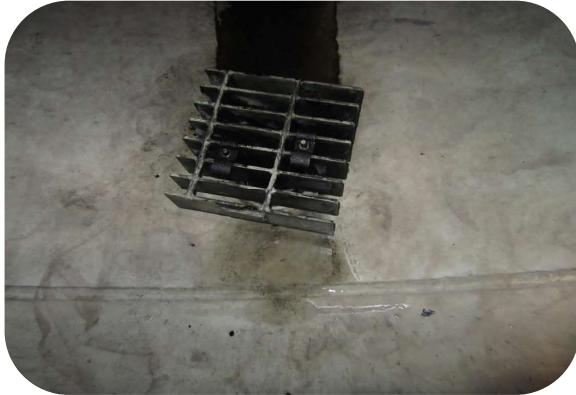
A0242049\_Cold end Vortex\_27June2012

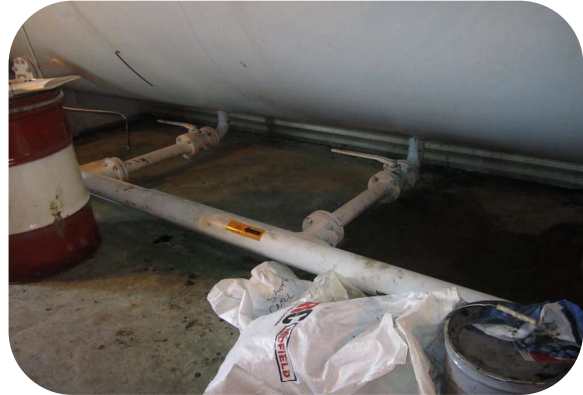
- PSV was located without restrictions, Service date and set pressure acceptable.
- UT survey found no areas of concern on shell or heads but Extreme pitting noted on Middle and West drain elbows, see attached UT Report.

- Previous coating repairs had been carried out on both drain elbows in 2009.
- Decision was made to recoat both nozzles again and pre-plan for both drain elbows to be changed out at next inspection frequency.

A0242049\_TML locations 60 and 65 with  
extream pitting noted\_26June2012

**Schedule to have both drain elbows removed and replaced in kind at the next required inspection frequency. Continue to carry out visual inspections and UT Corrosion surveys at the required inspection frequency.**

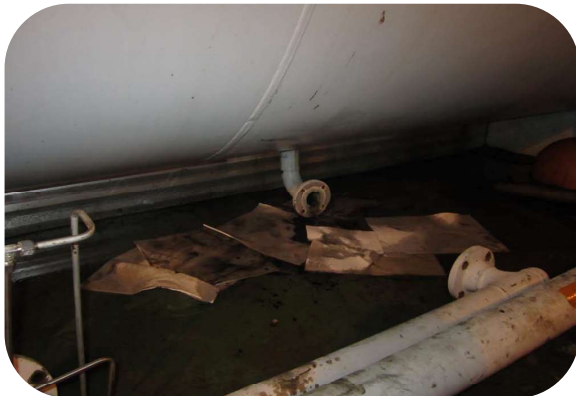
A0242049\_TML location 60, drain  
elbow\_27June2012

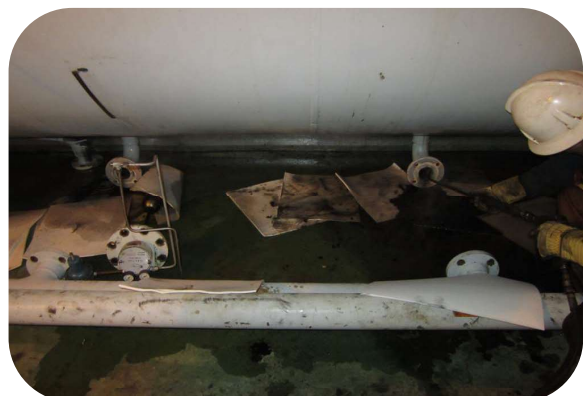
A0242049\_Repairs to TML locations 60 and  
65\_27June2012

**Decision was made to recoat both drain nozzles at time of inspection as UT readings from 2009 had not changed. Coating repairs were carried out at the time of inspection.**

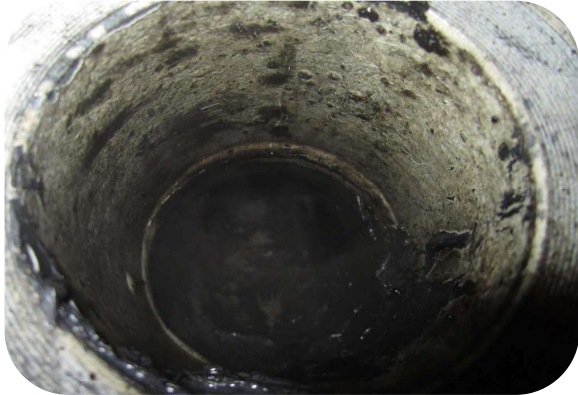
A0242049\_ Internal view of the drain elbow pitting\_27June2012

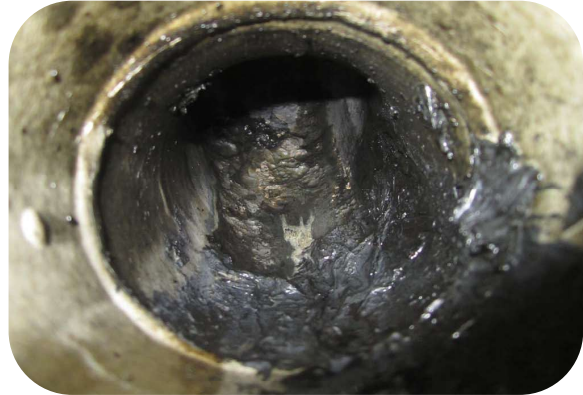
A0242049\_Extreame pitting\_27June2012

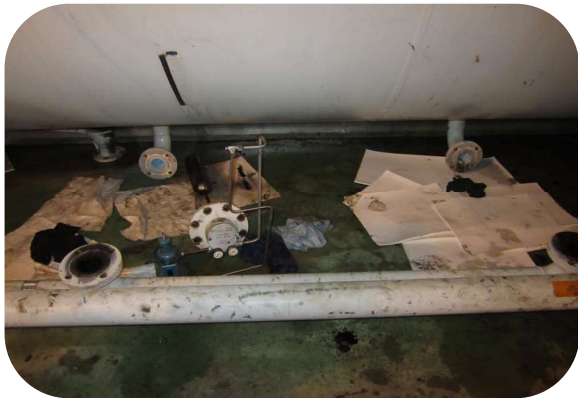
A0242049\_Coating repairs carried out on both drain elbows\_27June2012

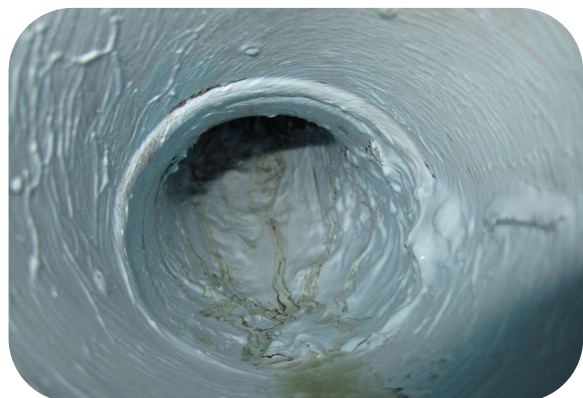
A0242049\_Drain nozzle internal coating repairs\_27June2012

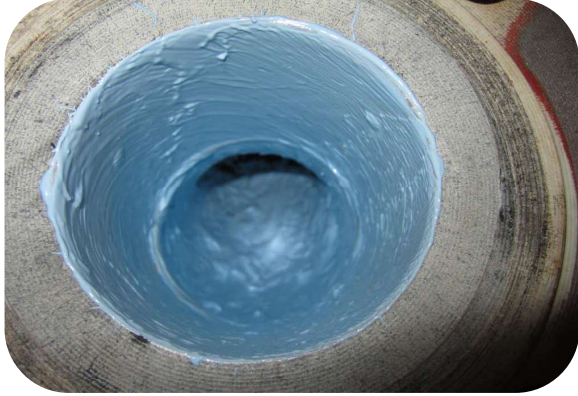
A0242049\_Drain nozzle internal coating  
repairs\_27June2012
