VESSEL INSPECTION SUMMARY

Report #: 137868-WG-13
 Inspect Date: 06/09/2009
 Page: 1 of 2
 IRISNDT #: 137868

Client: CNRL	District: Medicine Hat	Field: 07-32-012-13W4
Facility: Grand Forks	Unit: Oil Battery	LSD: 07-32-012-13W4
Jurisdiction #: A2698238	Equip Tag #:	Serial #: P90-0038-A
CRN #: K3252.2	Nat'l Bd #:	Year Built: 1991
Manufacturer: Process Industries	Equipment Description: Free Water Knock Out (FWKO)	
Status: In Service	Date Removed From Service:	Service: Sour
MAWP Shell 75 Psi @ 200 °F	Height/Length: 432 in.	Code Stamp: <input checked="" type="checkbox"/> Y <input type="checkbox"/> N
MAWP Tube Psi @ °F	Size/Diameter: 120 in. O.D.	Insulated: <input checked="" type="checkbox"/> Y <input type="checkbox"/> N
Support Type: Saddle RT: 2	Volume: ft ³ / m ³	PWHT: <input type="checkbox"/> Y <input checked="" type="checkbox"/> N
C.A. 0.0625" Coated <input checked="" type="checkbox"/> Y <input type="checkbox"/> N	Clad: <input type="checkbox"/> Y <input checked="" type="checkbox"/> N	Manway: <input checked="" type="checkbox"/> Y <input type="checkbox"/> N

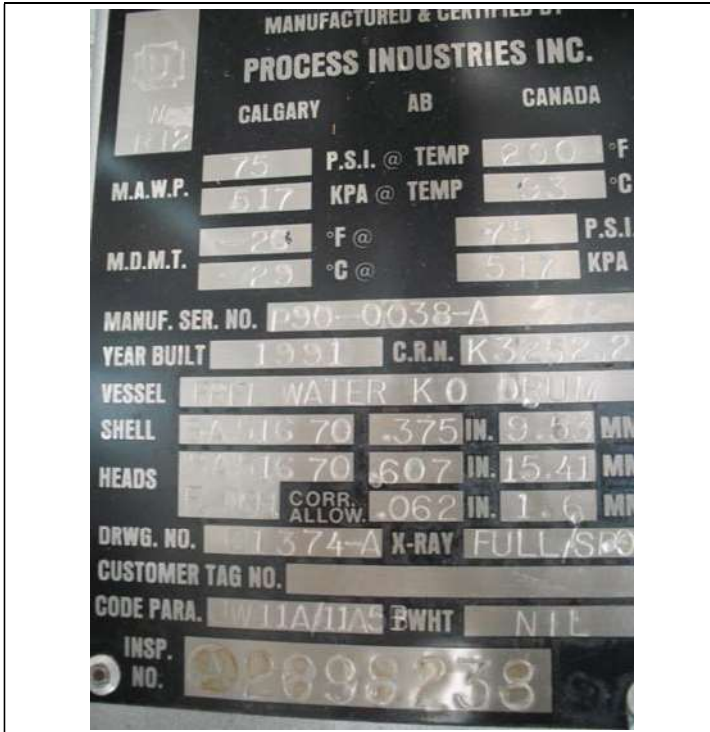
Name plate was intact and readable. PSV removed for servicing, no block valves between shell and PSV-vents to Pop Tank. This bellows PSV should have a 'plastic street elbow' (pointed down) inserted into the threaded opening in body to prevent rain/snow from entering and damaging the bellows.

Grand Forks-FWKO_Nameplate

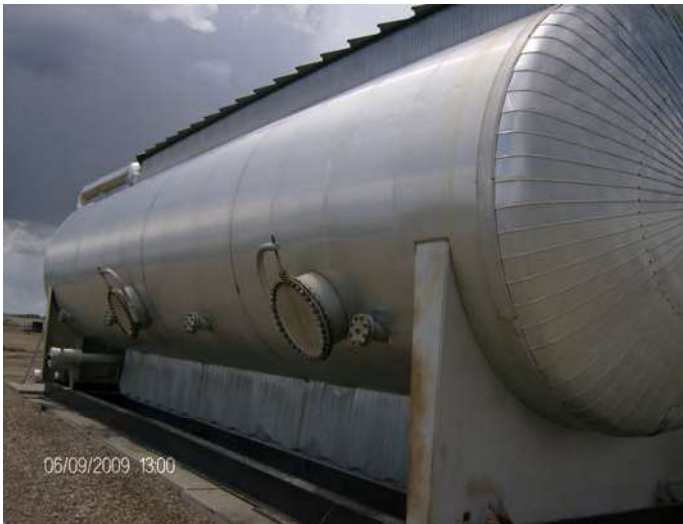
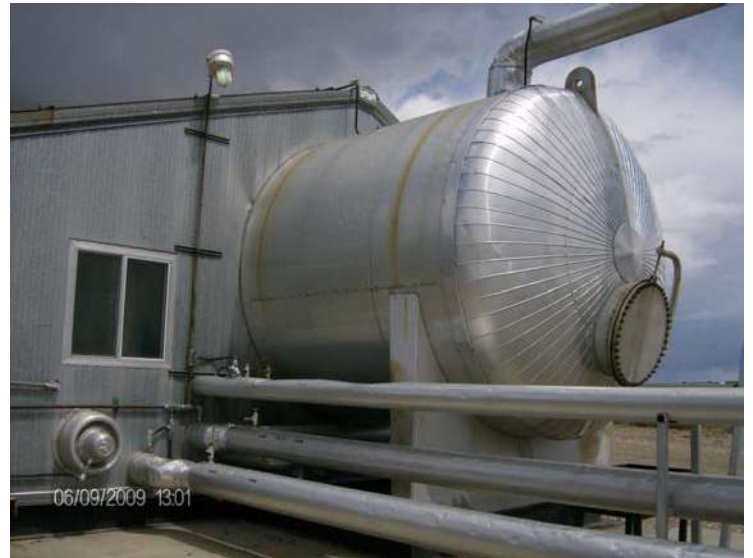
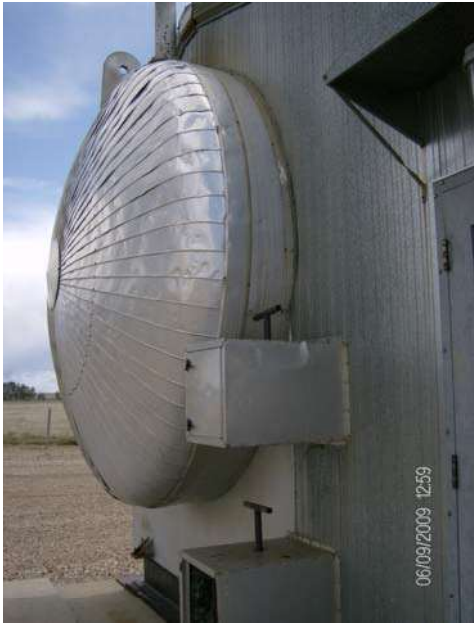
Grand Forks-FWKO Outside Bldg.

The outside Insulated portion of vessel in good condition (some dimpling from hail-West end). On East side and North/West side of vessel, bldg. to cladding seal broken and open to atmosphere. Insulation cladding of outside piping in good condition, a few crushed areas noted on West side.

Install 'plastic street elbow' on PSV as per comments. Consider re-engineering need for bellows PSV in this application. Loosen off anchor bolts at sliding end (East). Repair broken off anode wire (East end). Re-seal cladding to bldg. seam at East end and North/West end of building. Replace depleted sections of anode strings. Continue to inspect vessel at regular scheduled interval.

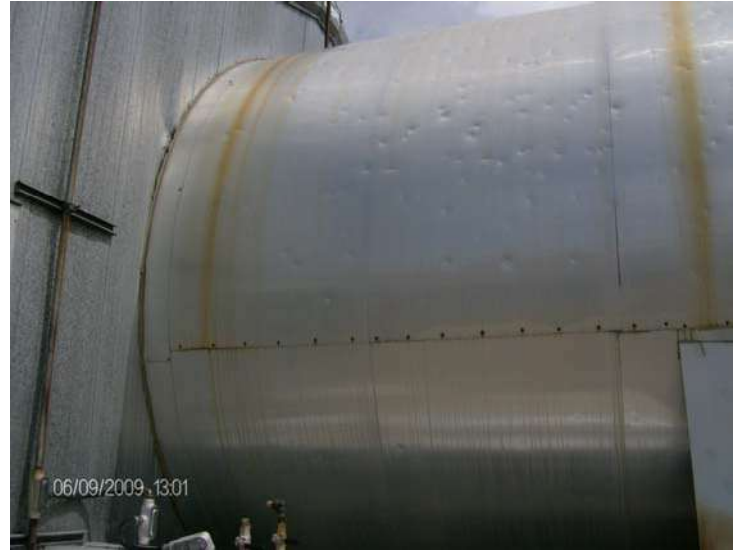
Grand Forks-FWKO Dimpled Insulation

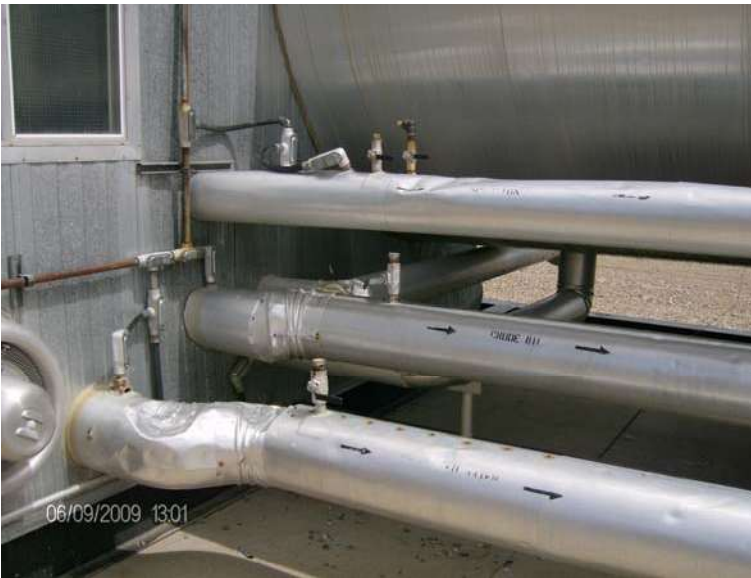
Grand Forks-FWKO Crushed Piping Cladding

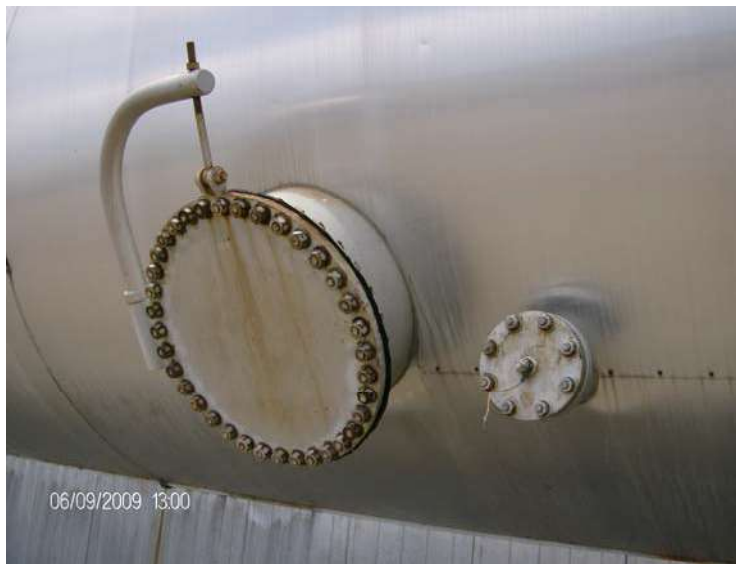
Anode wire broken off (East end). Vessel appears secure and level.

Grand Forks-FWKO Broken Anode Wire

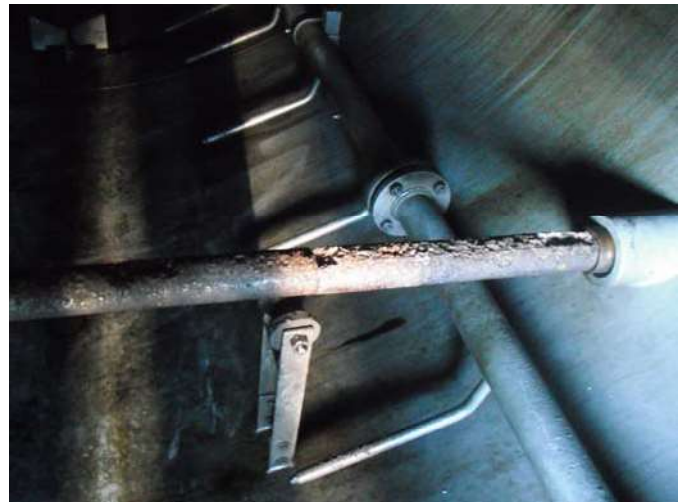
Grand Forks-FWKO Anode

Coating in good condition-no repairs required
Replace depleted sections of anode strings-operations was notified
Good condition-no other concerns
