**Canadian Natural Resources Limited
GENERAL PRESSURE VESSEL INFORMATION**

Job # 105.01033

Facility: Clear Hills Gas Plant	Location (LSD): 16-11-88-13W6M
--	---------------------------------------

Vessel Name Equipment Number: **High Pressure Inlet Separator**

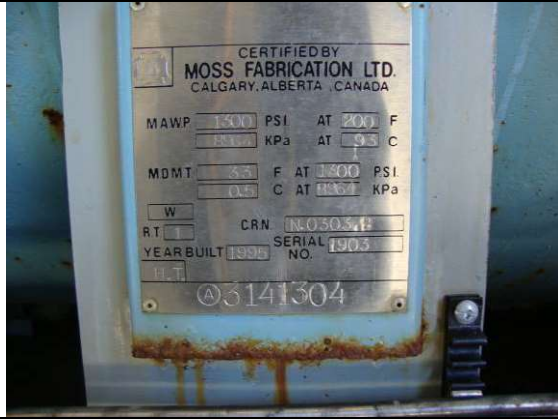
Vessel data plate

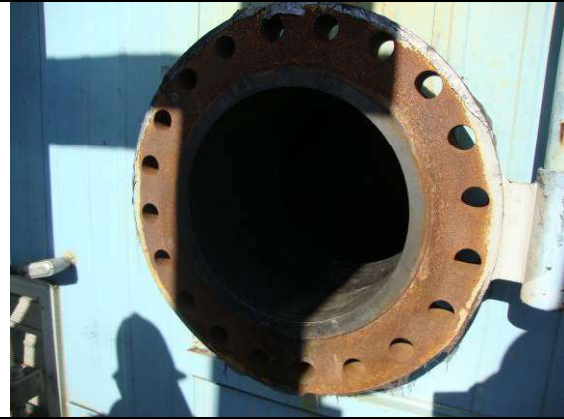
Vessel man way

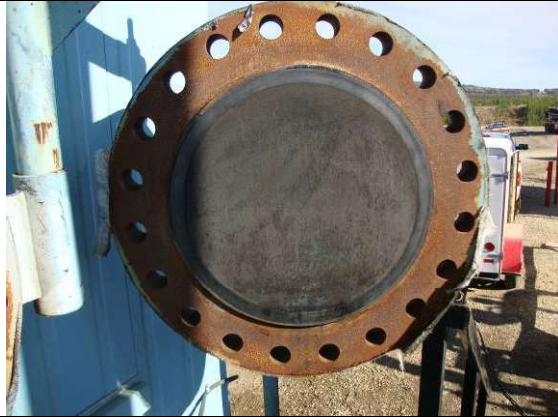
Man way cover plate

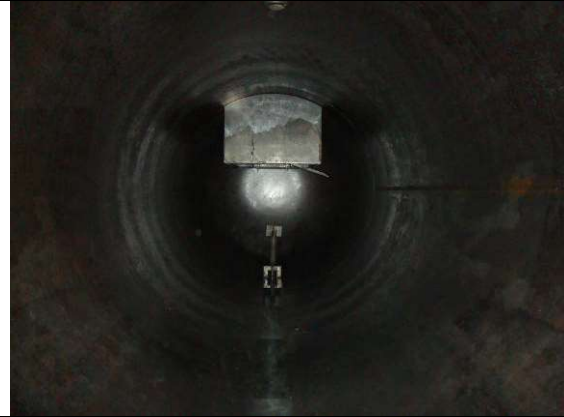
Vessel overview

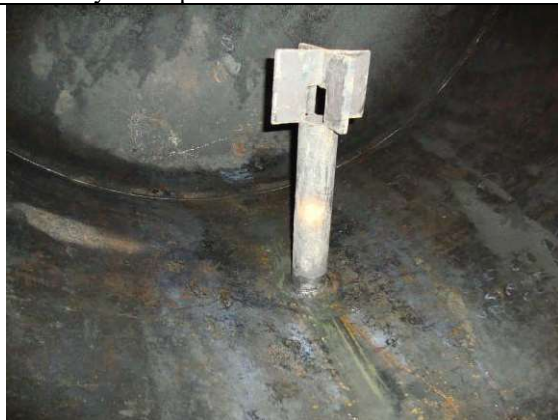
Vortex breaker

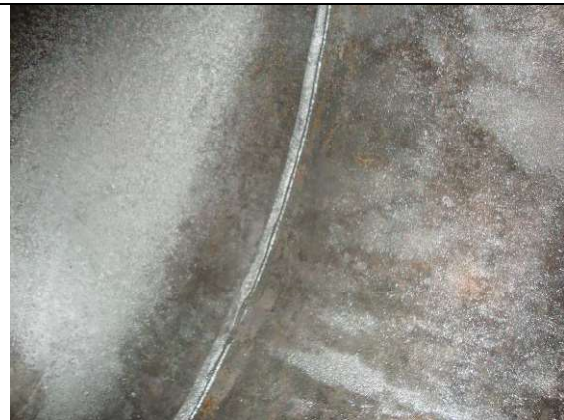
Head to shell weld

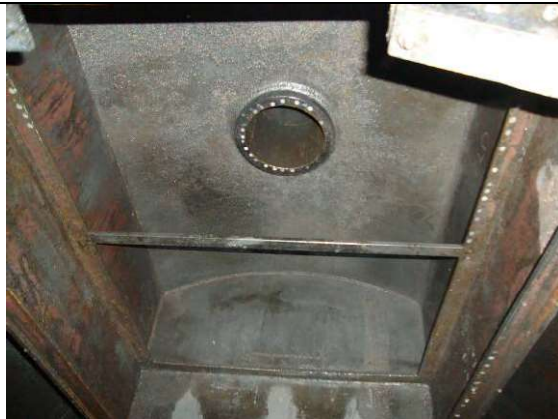
Demister pad support frame and top shell

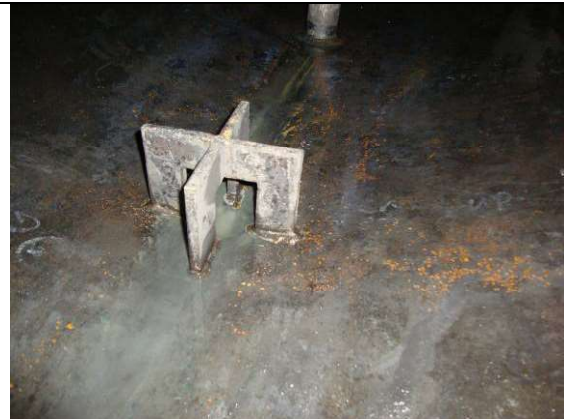
Vortex breaker

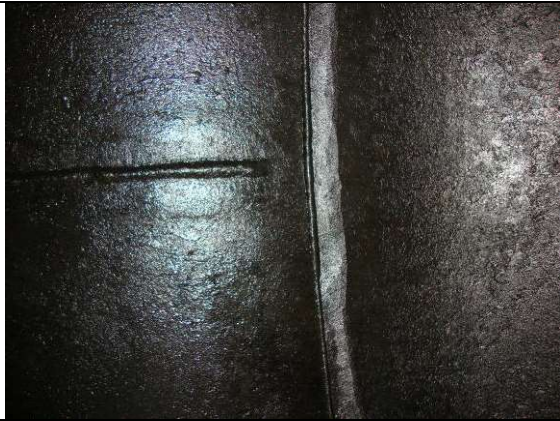
Vessel tee weld

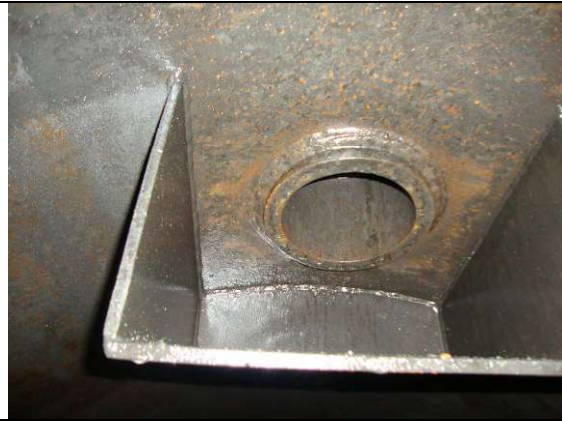
Inlet nozzle and deflector plate

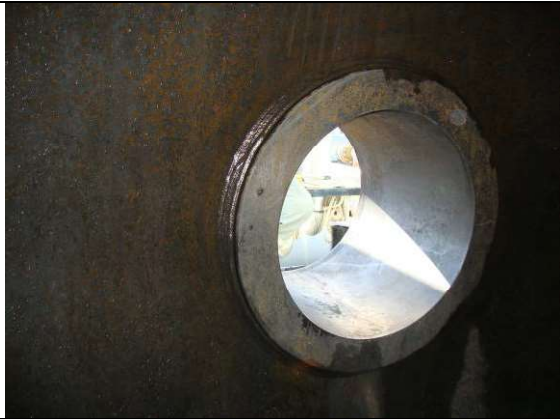
Man way attachment weld to vessel

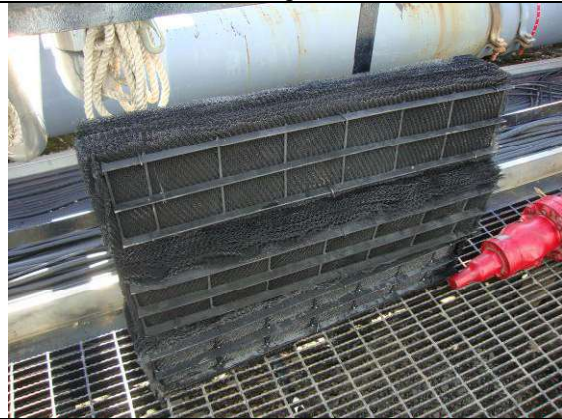
Vessel demister pad
