**Canadian Natural Resources Limited
GENERAL PRESSURE VESSEL INFORMATION**

Job # 105.00642

District: Grand Prairie	Skid No. Nil
Facility: Clear Hills Gas Plant	Location (LSD): 16-11-88-13 W6M
Vessel Name Equipment Number: High Pressure Inlet Separator	
Orientation: Horizontal	
Status: In service	Regulatory Inspection

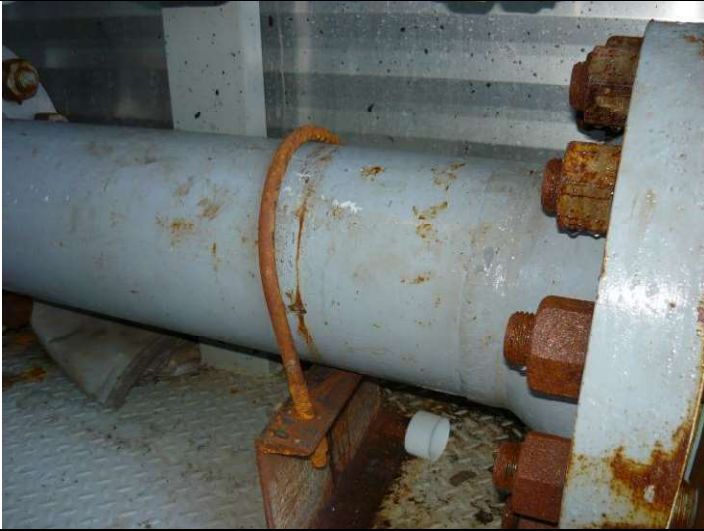
Anchor Bolts Hammer tap to ensure secure. Look for cracking in treads or signs of deformation.	X				Saddle is bolted to skid floor, No deformation or cracking present.
Concrete foundation Check for cracks, spalling, etc.				X	
Ladder / Platform Describe general condition, ensure support is secure to vessel, describe any hazards.				X	
Nozzle Assess paint, look for leakage, and ensure stud threads are fully engaged. Record any damage, deflection, etc. Are nozzles gusseted?	X				Nozzle paint is in good condition no leaks present. No Stud threads present, no damage or deflection present. No gussets present.
Gauges Ensure gauges are visible, working, no leakage, and suitable for range of MAWP/ Temp.	X				Pressure gauge (0-10300 kPa) Suitable for MAWP Gauge is clear and visible.
External Piping Ensure pipe is well supported. All clamps, supports, shoes, etc. in place. Look for evidence of structural overload, deflection, etc. Paint condition, external corrosion?	X				Piping is well supported and in place. Three loose pipe clamps on outlet line noted. No evidence of structural overload or deflection. Paint is in good condition but with areas of scattered failure, staining from these areas of corrosion present.
