GENERAL NDE REPORT

A-3141304_06_21
 2013_MT-Report-b

Client: C.N.R.L
 Address: ClearHills Gas Plant (AB)
 W.O.#: _____
 Client Rep.: Craig Liba

Description: MPI Inspection on all internal tee intersections, nozzles, Inlet diffuser, demister support cage to shell and manway weld to shell in the (High Pressure Inlet Separator) (A-3141304).

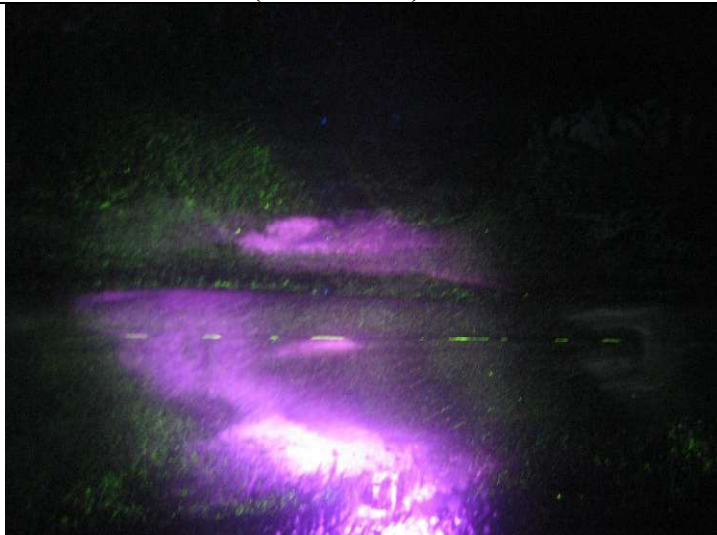
- Results:
- (1) At East shell tee intersection the circumferential weld had (9) cracks ¼” to ½” in length running circumferentially.
 - (2) All (8) lower Cracks were removed with light remedial grinding with 80Grit flapper, with substantial weld cap remaining.
 - (3) The top crack at ½” length above tee intersection was removed with light remedial grinding with 80grit flapper flush with shell.
 - (4) All were re-inspected and found acceptable.

Crack found on circumferential weld

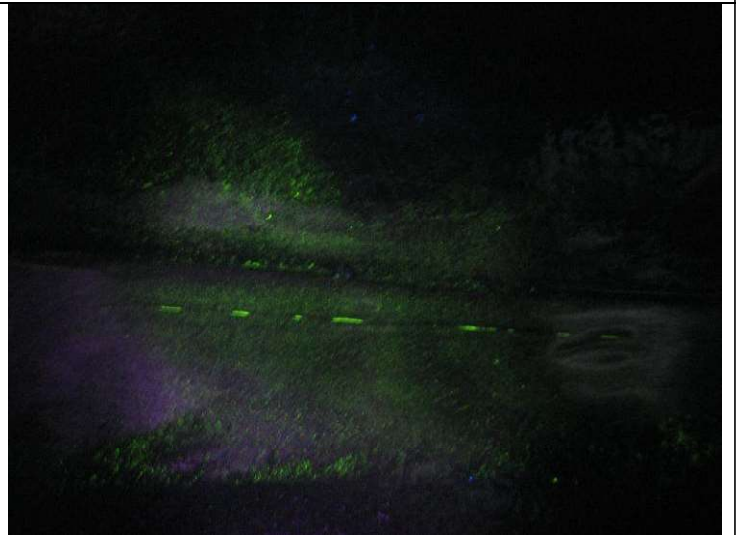
Crack found on circumferential weld 2nd View

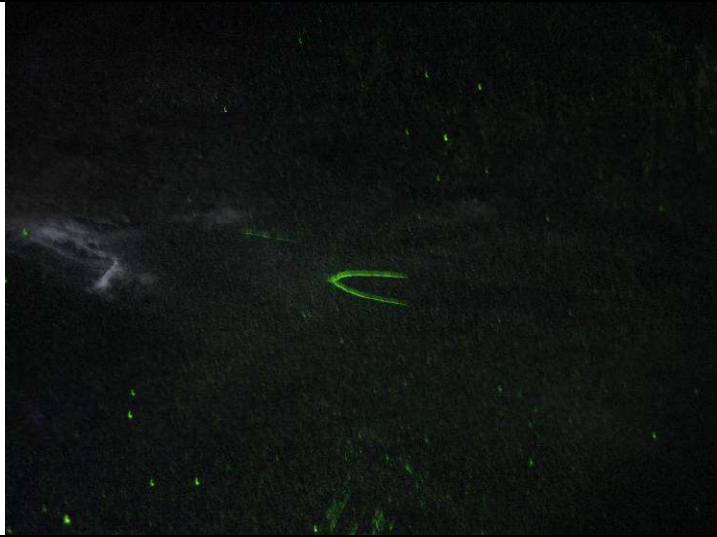
View of crack above tee intersection

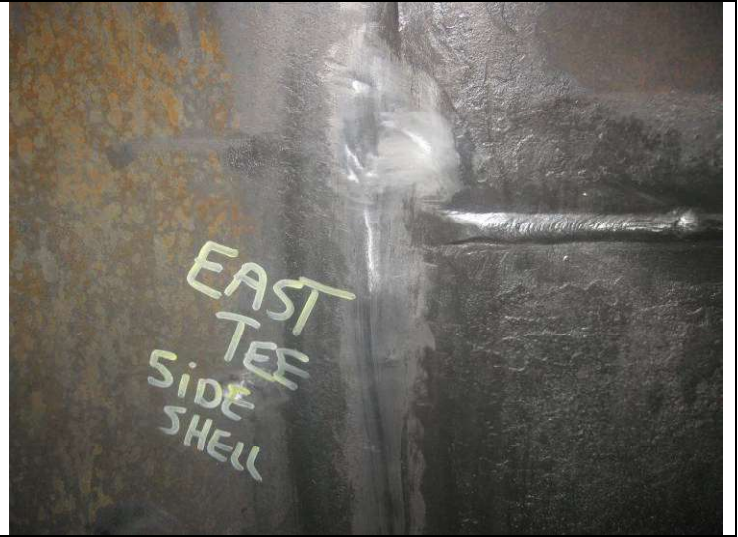
Over all view of location and area of cracks found

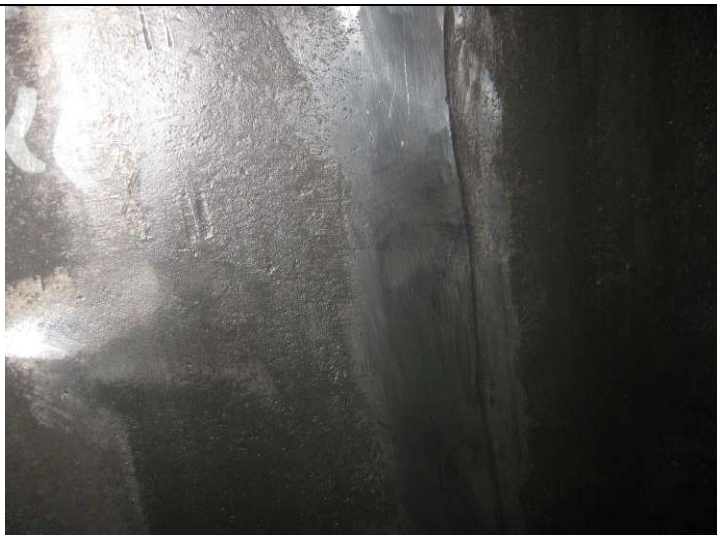
**Final view of circ weld after cracks removed with
weld cap intact.**

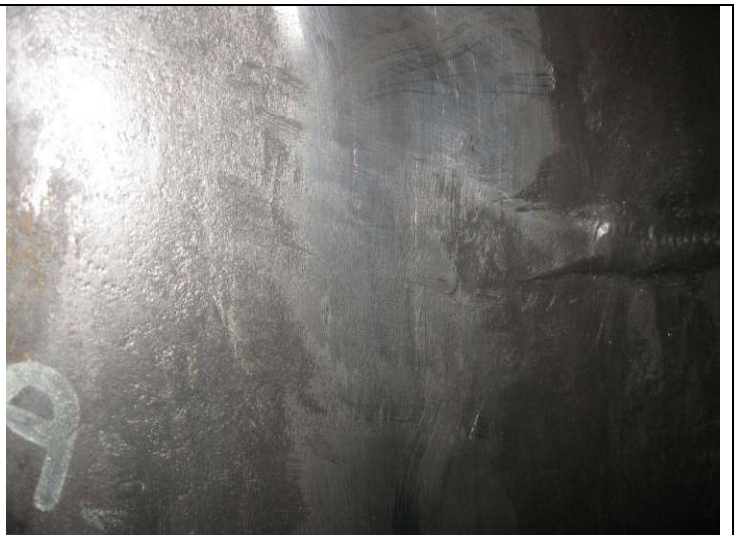
**Final view above tee intersection after crack
removed flush with shell**
